## Performance of a seismically repaired masonry building

### Abstract

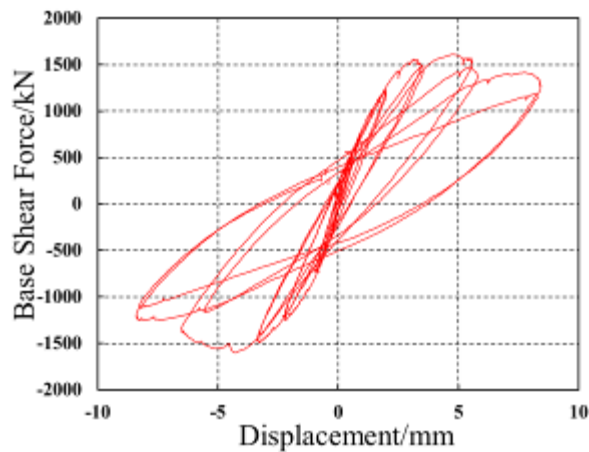
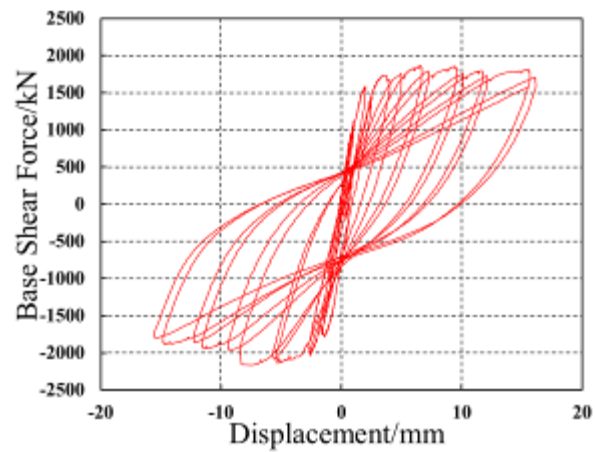
Fig. 6 – Hysteretic curves in the first story

Fig.6 shows the hysteretic curves of the first story in the weak and strong axes. In the weak direction, maximum loading is 1558.9kN in the positive loading direction, corresponding to the story displacement of 5.5mm, and in the negative loading direction, it is 1457.7kN. In the strong axis, when the story displacement reached 8.8mm, it got to the peak value of 1861.2kN in the positive loading direction and 2165.9kN in the negative loading direction.

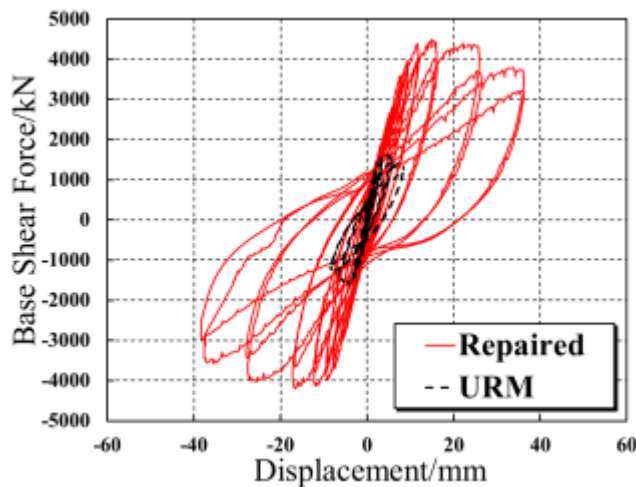
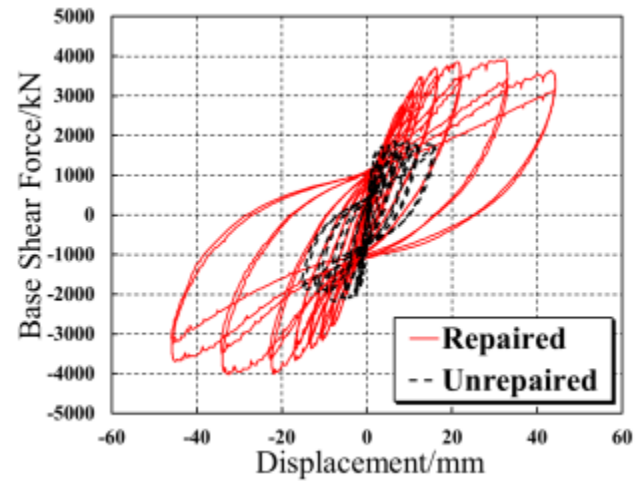
Fig. 10– Hysteretic curves in the first story compared with unreinforced masonry building (URM)

Compared in Fig.10 are the hysteretic curves in both lateral directions. The bearing capacity of the repaired building is as twice as the original one. From Table 3 where the peak loads are compared, the peak force of the retrofitted building is 2.84 times that of URM in the weak direction, and 1.85 times in the strong axis. The retrofit targets are achieved. Note from Table 3 that the strength of the strong axis is smaller than that of the weak axis. The reason is that the two directions were loaded separately. The load was first conducted in the weak direction to a large deformation to 33mm at the roof. At this moment, the walls in both directions were damaged seriously because of the strong coupling or flange effect of the walls in the strong axis. Therefore, before the test in the strong axis, there have existed extensive damages in the walls in this direction.
