Structural Damage Assessment of a Five Tiered Pagoda Style Temple in Nepal

Richard L. Wood⁽¹⁾, Mohammad Ebrahim Mohammadi⁽²⁾, Andre R. Barbosa⁽³⁾ Chandra Kiran Kawan⁽⁴⁾,
Manjip Shakya⁽⁵⁾, Michael J. Olsen⁽⁶⁾

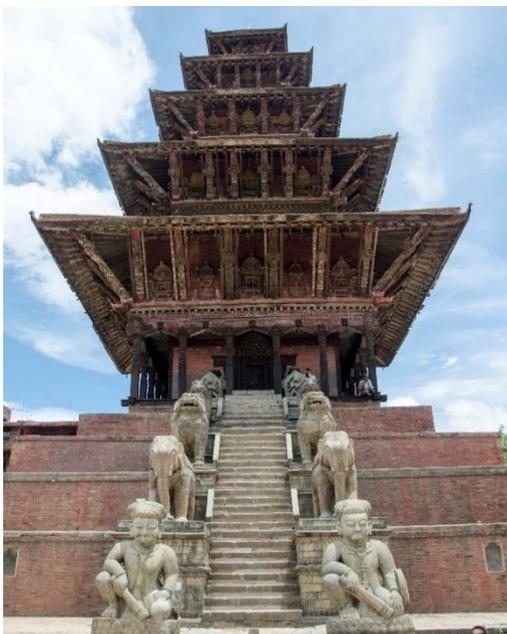
Fig. 2 – View of the Nyatapola Temple: (a) overview of the entrance from the south plaza and (b) view of the north wall with significant shear cracks.
