16th World Conference on Earthquake, 16WCEE 2017

Seismic performance of hydropower plant and highway system during the 2015 Gorkha Earthquake in Nepal

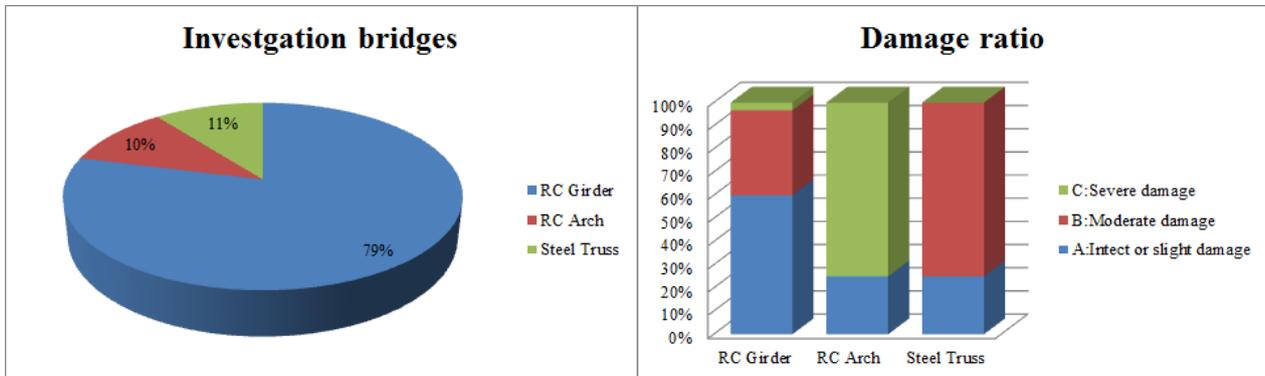
Fig.16 – Investigation bridges and damage ratio.

We can find RC Arch Bridge is one of the types which did not resist earthquakes this time. In the total four severe damaged bridges, there are three arch bridges, which built in 1960's, and located in the Arniko Highway near the Chinese Border. The damage patterns consist of inner-arch rig and sign pillar cracked due to strong shaking, bridge deck and guardrail damaged by fall rocks, taper revetment crushed. Both RC box arch bridge (Friendship Bridge and Phulping Bridge, 1*60m) and RC two-way curved arch bridge (Sukundo Bridge, 1*31.4m) was damaged severely, as shows in Fig.17 (a-c).
