## Damage trends in residential RC building after 2015 Nepal earthquake

### Abstract

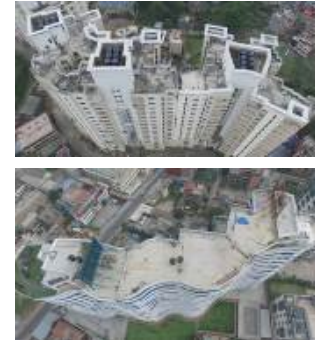
Fig. 4 – Complex building shape (KA, KE)

High-rise residential buildings constructed in and around Kathmandu Metropolitan City are primarily RC frame structures with non-structural infill brick walls (Fig. 3). Although mortar is often used to fill in the joints between the RC frames and brick walls, out-of-plane reinforcements are often not included. The buildings often have complex shapes, as shown in Fig. 4, and many have expansion joints. Most building columns are rectangular in shape (Fig. 5).

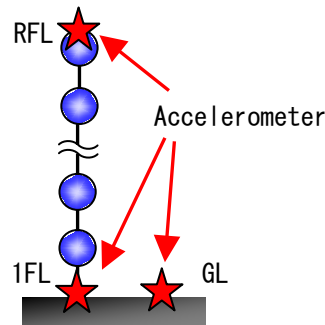
Fig. 18 – Accelerometer positions

In this investigation, microtremor measurements were carried out in seven buildings (KD, KE, KK, KP, KQ, KR, and KS). Building KS was under construction at the time of the earthquake and had an RC frame structure in place but no non-structural elements. Measurements were carried out for buildings fitted with expansion joints. Accelerometers were set at ground level, on the roof, and the first floor level. In buildings where an accelerometer could not be set on the first floor, the meter was set on the second floor.

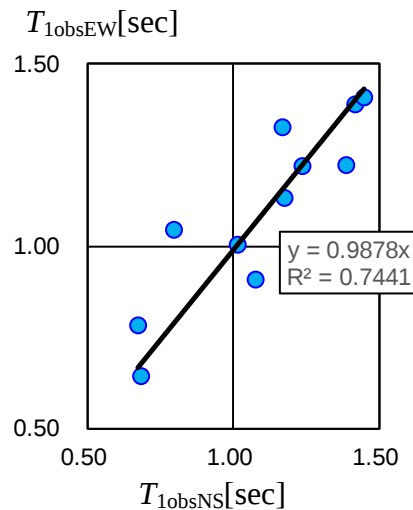
Fig. 19 – Relationship between  $T_{1obsNS}$  and  $T_{1obsEW}$

Figure 19 shows the relationship between the natural period for the north-south (NS) and east-west (EW) directions, while Fig. 20 shows the relationship between the natural period for the NS direction and the measurement point height. In these figures, linear approximate equations that are evaluated by the least-square method (LSM) and coefficient of determinations ( $R^2$ ) are also shown.

From Fig. 19, it can be seen that the natural periods for the NS and EW directions are almost the same. Even though these buildings were damaged, this result indicates that they have similar stiffness levels in each direction.

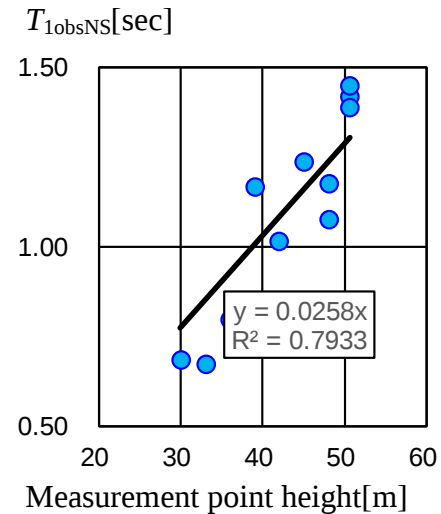
Fig. 20 – Relationship between  $T_{1obsNS}$  and measurement point height

This result also suggests that complex shapes do not affect the building vibrational properties. Additionally, Fig. 20 shows that the natural period is linearly related to the measurement point height, with a proportionality factor of 0.025. Though the period may be linearly related to the building height, it is not clear. Because there are two cases that the meter was set on the second floor (KP and KS). While this detail is shown below, this factor is smaller than that for India's "Criteria for Earthquake Resistant Design of Structures" (hereafter Indian Standard).

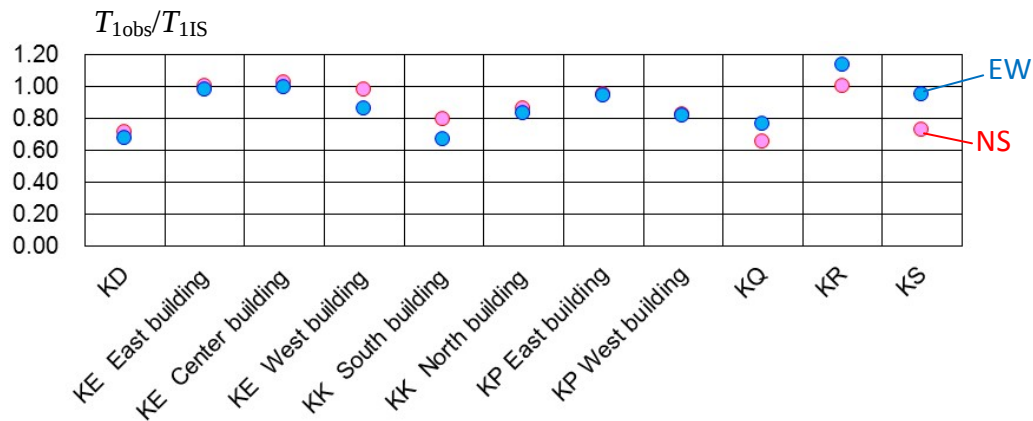
Fig. 21 – Comparison of  $T_{1obs}$  and  $T_{1IS}$

In Fig. 21, the observed natural periods for each building ( $T_{1obsNS}$  and  $T_{1obsEW}$ ) are compared with those calculated using Indian Standard using the expression  $T_{1IS} = 0.075h^{0.75}$ , where  $h$  is the building height. From this figure, it is clear that  $T_{1obs} / T_{1IS}$  is less than 1.0 in many cases. Considering that  $T_{1obs}$  includes damage effects, this result indicates that  $T_{1obs}$  failed to match the Indian Standard.

- (6) Natural periods were evaluated based on microtremor measurements. The relationship between  $T_{1obs}$  (observed natural period) vs. measurement point height ( $T_{1obs}=0.025 \times$  measurement point height) and  $T_{1IS}$  (natural period based on the Indian Standard) was examined. The results suggest that  $T_{1obs}$  failed to match the Indian Standard (Maximum percentage error is about 35% and average percentage error is about 15%. (Fig.21)).
