# ANALYTICAL STUDY OF RESIDENTIAL MASONRY CHIMNEYS DURING RECENT CALIFORNIA EARTHQUAKES

B. Maison<sup>(1)</sup> and B. McDonald<sup>(2)</sup>

## Abstract

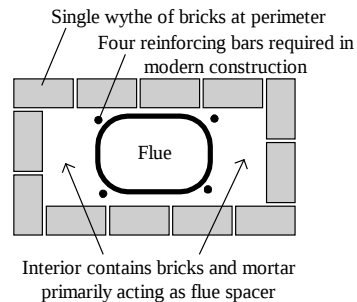
- Construction in apparent violation of the building code seemed to be an important contributor to the failures of reinforced chimneys. Poor quality grout was common and many chimneys had construction debris at the bottom of grouted spaces. Many collapsed chimneys had vertical rebar, but lacked grout to bond the steel to the masonry. Other cases it appeared that vertical rebar had insufficient splice lengths so they pulled out. Still other cases appeared to lack lateral anchoring to the building, and/or anchorage to the foundation so that the chimney overturned. Figure 1 shows the internal features of a Napa chimney that failed during the 2014 South Napa earthquake.

Fig. 1 – Masonry chimney in Napa. (a) Tall reinforced chimney constructed in 1973 that failed at the roofline and collapsed during 2014 South Napa earthquake. Hollow cavity at A indicating chimney not grouted solid. Clay tile flue at B held in place by bricks and mortar not interconnected to perimeter wythe of bricks. Note how chimney failure plane went through the joint between two flue segments. Bent rebar at C that pulled out apparently due to insufficient bond strength (total four bars). (b) Section view depicting chimney internal features.
