# Implementation of a seismic retrofitting solution for the San Pedro de Atacama church in Chile

J. Vargas<sup>(1)</sup>, C. Sosa<sup>(2)</sup>, R. Aguilar<sup>(3)</sup>, B. Yuste<sup>(4)</sup>, C. Heisen<sup>(5)</sup>

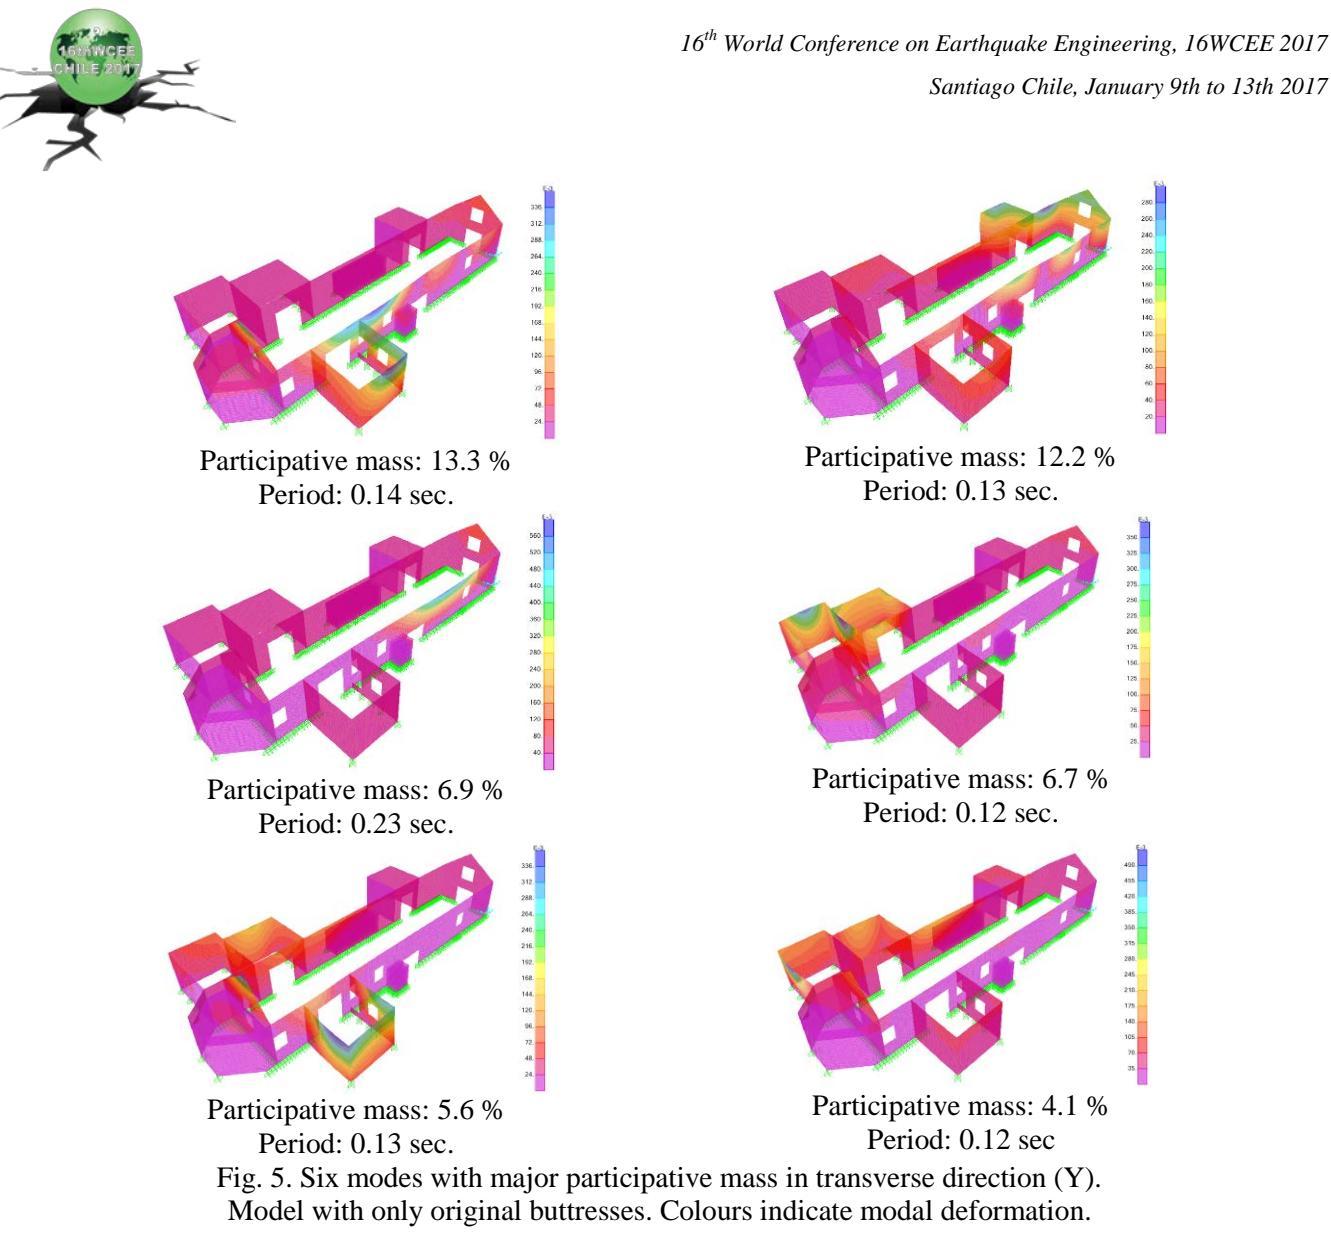
A first model was studied which considered the central west low buttress and one in the east wall close to the altar as shown in Fig. 5. These buttresses existed since the time of the original construction, as proved during the fieldworks. As expected, the buttresses controlled the displacements of the lateral walls. The vulnerable areas were identified as the central east wall and the gables. By the shape of the church, with an elongated nave, the major concern is also the out of plane behavior of the longitudinal walls.

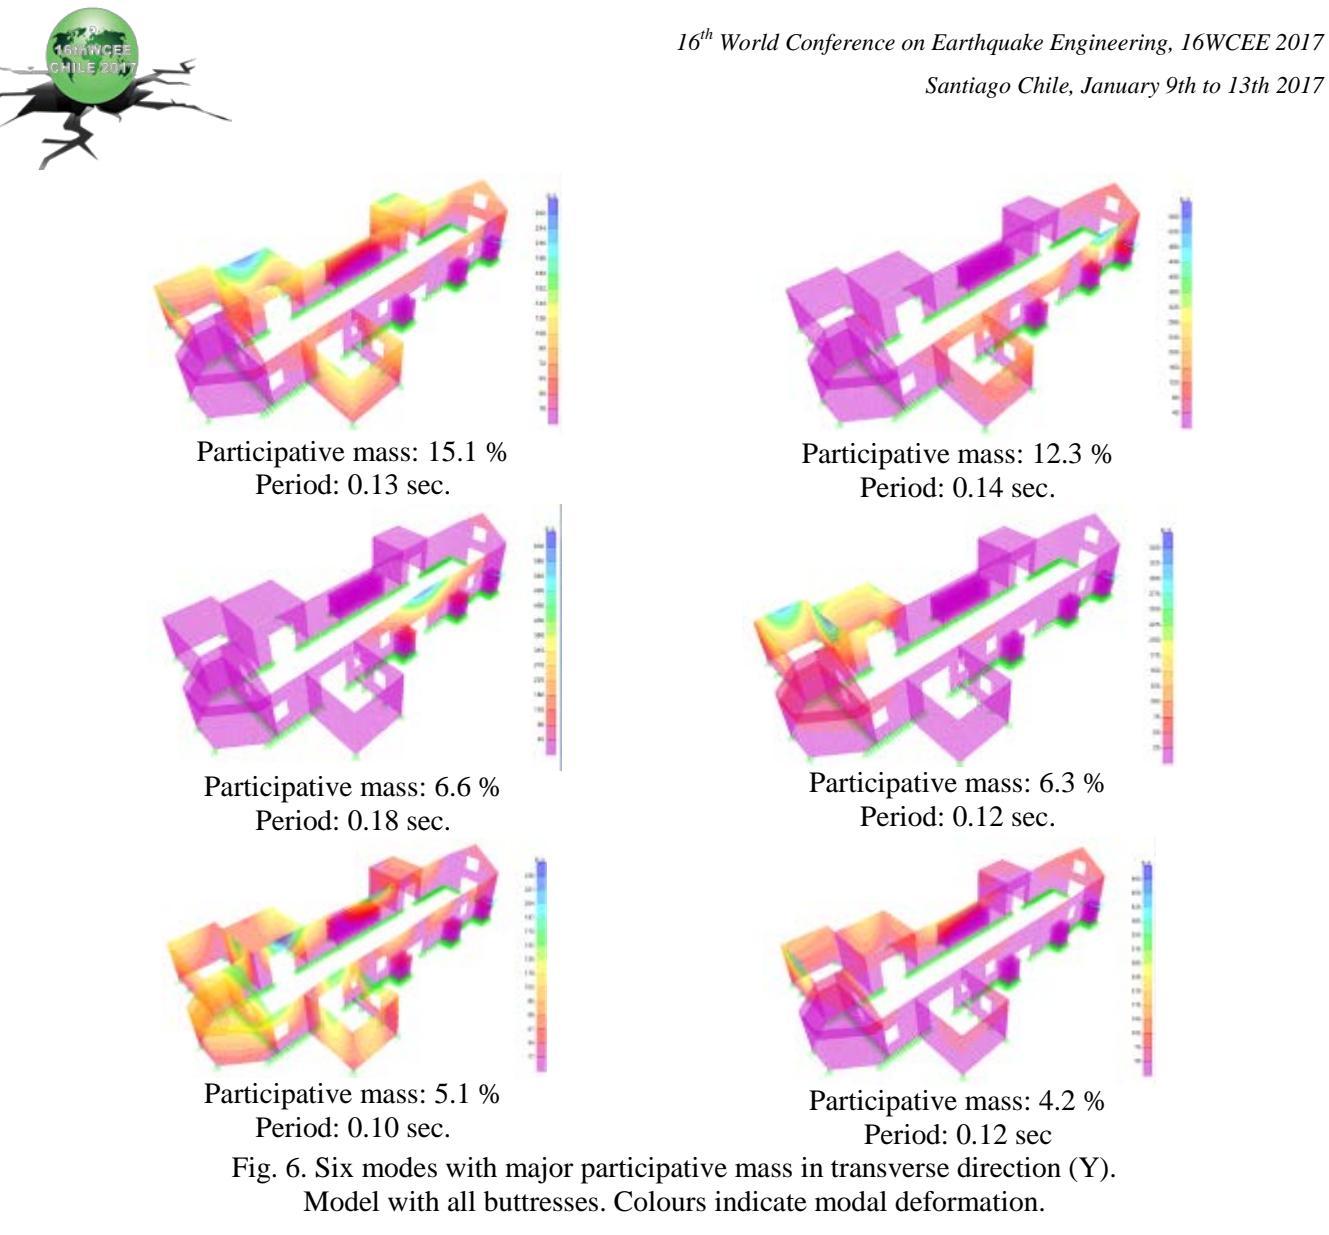
A second model was implemented considering the inclusion of all the buttresses as shown in Fig. 6. The natural period for 'Y' direction increased for the most relevant modes and the modal deformation of the east wall has less magnitude in the first mode shape. The presented six modes for each model allow understanding better the seismic behavior of the church with the two new buttresses. However, these few number of modes are not representing a high effective mass participation. In order to represent an effective mass close to 90% will be necessary to show more than 400 modes.

Two new buttresses are reintegrated into the 22 m long and 1.20 m thick east wall of the temple. The buttresses have a stepped typology and rise on a foundation of 0.80 m deep, built with stone boulders and lime mortar. Masonry rises with  $0.60 \ge 0.40 \ge 0.10$  m adobe bricks which are hooked to the wall of the temple every 3 rows at a depth of 0.30 m.

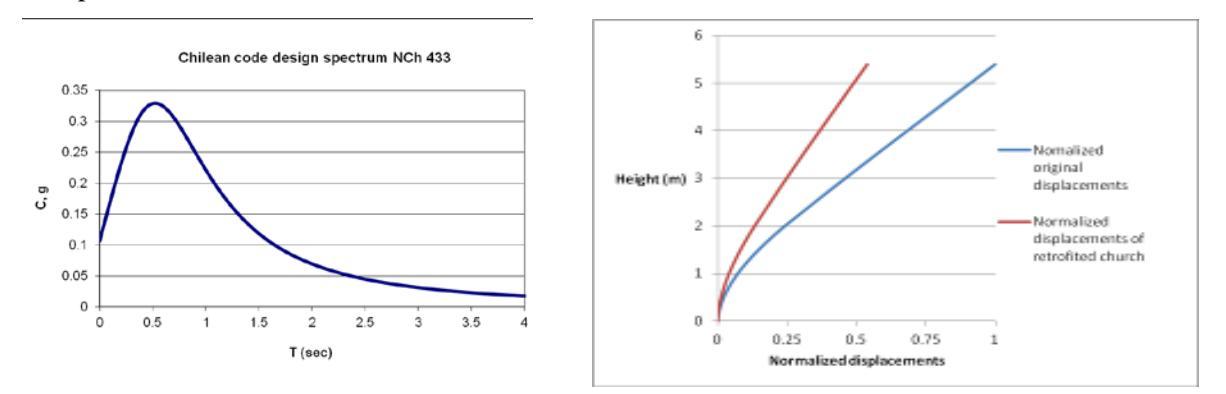
The seismic assessment of the church was carried out using a spectral linear analysis with the two previous described models. In Fig. 7 it is possible to compare the displacements of the two models as a result of a linear relationship behavior in the central part of the east wall using the Chilean Standard NCh433 [7] spectral acceleration. The results evidences that the displacements after installing new buttresses are close to half the original displacements.

Fig. 7. Lateral deformation comparison in the top part of the middle east wall.
