Structural Characterization of RC Buildings of Kathmandu Valley after Gorkha Earthquake 2015

Rajan Suwal¹, Hugo Rodrigues², Humberto Varum³

ABSTRACT

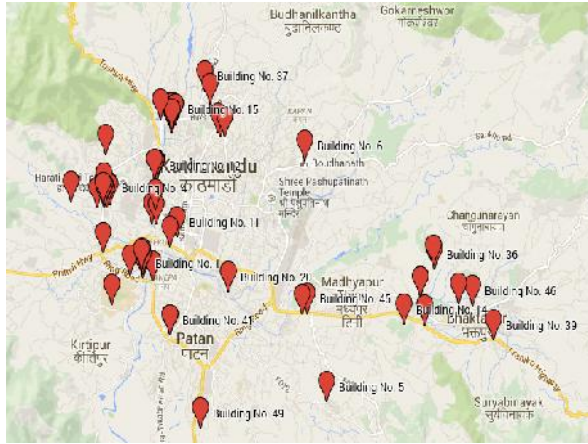
Figure 3.1.a : Location of assessed building in google map

For the research work the damaged buildings located in Kathmandu valley were surveyed. Figure 3.1.a is the plot of those damaged building in google map. The plot shows that the damaged buildings are scattered all over the three cities, Kathmandu, Lalitpur and Bhaktapur.

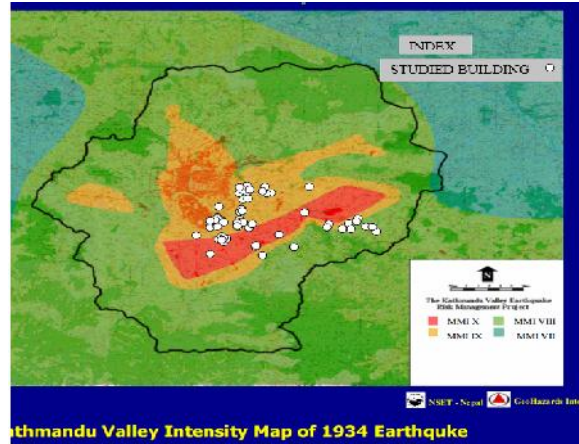
Figure 3.1.b : Kathmandu valley intensity map with damaged building location

The probable level of earthquake shaking that the building may face is determined by identifying the location of the building in the seismic hazard map. For this, the available earthquake intensity distribution map of Kathmandu valley developed by UNDP/UNCHS(Habitat)1994 , "Seismic Hazard Mapping and Risk Assessment for Nepal" based on the intensity distribution of 1934 earthquake of Nepal. Comparing the location of damaged building of Figure 3.1.a in hazard map of Figure 3.1.b, one can depicts the intensity of IX MMI (Modified Mercalli Intensity) [4].

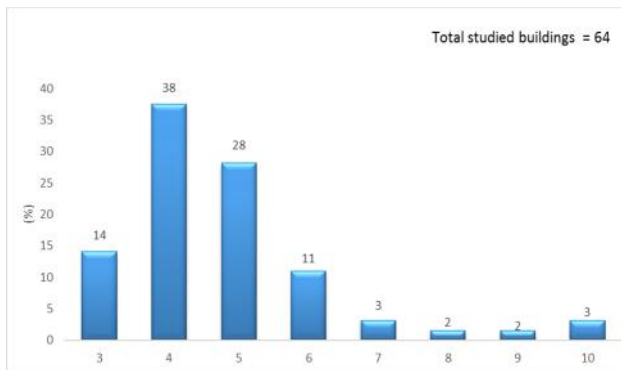
Figure 3.1.e : Damage percentage of buildings in different number of stories

Some information was collected by just looking the building from outside and the results are plotted from available data. Figure 3.1.e shows the scatterness of the building in Kathmandu valley according to number of stories. The result indicates that most of the buildings surveyed are four (including three and half) and five stories (including four and half) which occurred damage in earthquake. Two and half and three storied buildings are considered as three storied in chart and they are 14% numbers building among the considered 64 buildings. There are 11 % of buildings of six stories which were damaged by earthquake. There are less numbers of higher storied buildings.

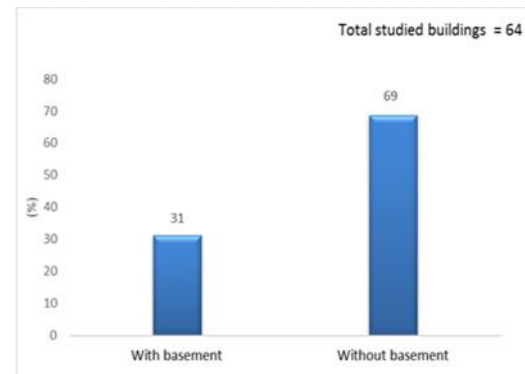
Figure 3.1.f : Status of basement (building with and without basement)

In Kathmandu valley out of total studied 64 buildings, 31 % of buildings are with basement and 69% of buildings are without basement. Basements are being used as vehicle parking and storage purpose.

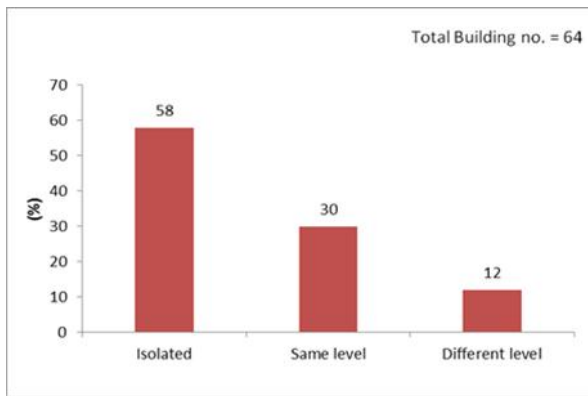
Figure 3.1.g: Height of building with respect to adjoining buildings

The floor heights of building with respect to adjoining buildings are presented in Figure 3.1.g. The result shows that about 58% of buildings are isolated, 30% of buildings are in same level and 12% of buildings have level difference (either higher or smaller). It indicates that ponding effect is less likely in the surveyed area.

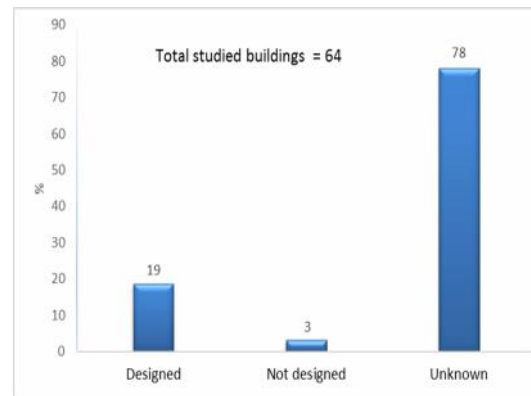
Figure 3.1.h : Structurally designed or not desined building

It is difficult to point out that the building was structurally designed from external outlook. Out of studied 64 buildings, 78% (50 numbers) of buildings are not known whether they were designed or not. They were almost not designed structurally. It is found that only 19% buildings are clearly known that they were structurally designed (see Figure 3.1.h).

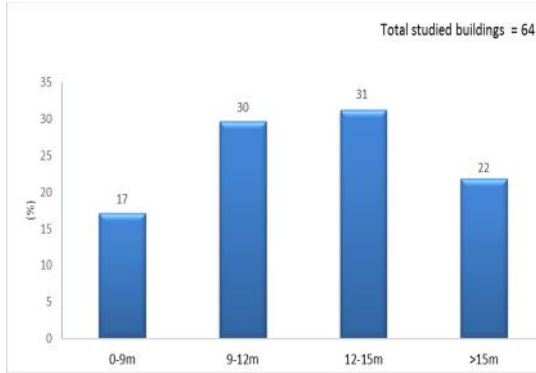
Figure 3.2.a : Predominant height of building

In the surveyed building of Kathmandu valley most of the damaged building height lies in between 9 -15 m tall (two and half to four and half or five stories) (see Figure 3.2.a). This is because of these height buildings are available in city more.

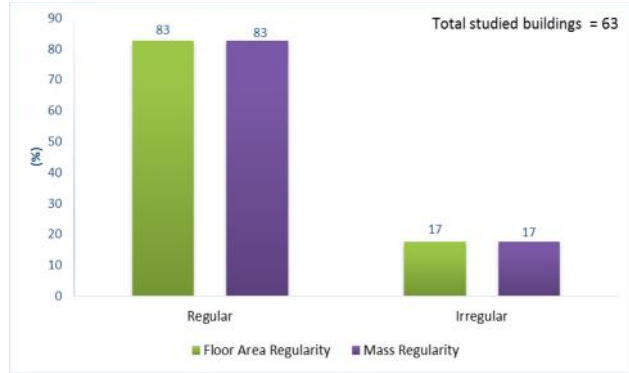
Figure 3.2.b : Regularity of building in elevation

The visual inspection of the buildings shows that in the elevation of building seems to be regular. Out of considered 63 buildings 83% buildings have almost regular floor area and mass. This means most of the buildings are almost same area in different stories. In this case it is considered that staircase cover floor is not considered in the regularity of floor area and mass.

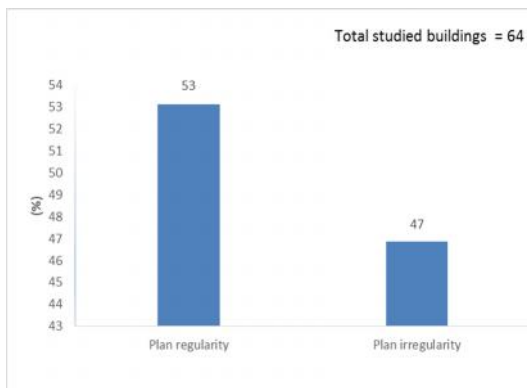
Figure 3.3.a : Regularity of building in plan

Figure 3.3.a shows that 53% building have almost regular plan (almost rectangular) and 47% building have plan irregularity (other than rectangular). Figure 3.3b shows number of bays in both major direction in the surveyed buildings. In the survey it is considered that along the road is x-direction and perpendicular to road is considered as y-direction. In the one bay building in x directions are used for shopping and residence purpose where land is expensive. The results show that two and three bay buildings are predominant in both directions. These types of bays are used mainly in common buildings. In case of the bay numbers more than four, bays along x – direction(along the road) is more than y – direction in the comparatively cheap land keeping more space in back side and wider along the road for the purpose of shopping .
