WATER TANK DAMAGE DUE TO THE 2011 EAST JAPAN EARTHQUAKE IN CONSIDERATION OF STRONG GROUND MOTION AND DESIGN CODES

Abstract

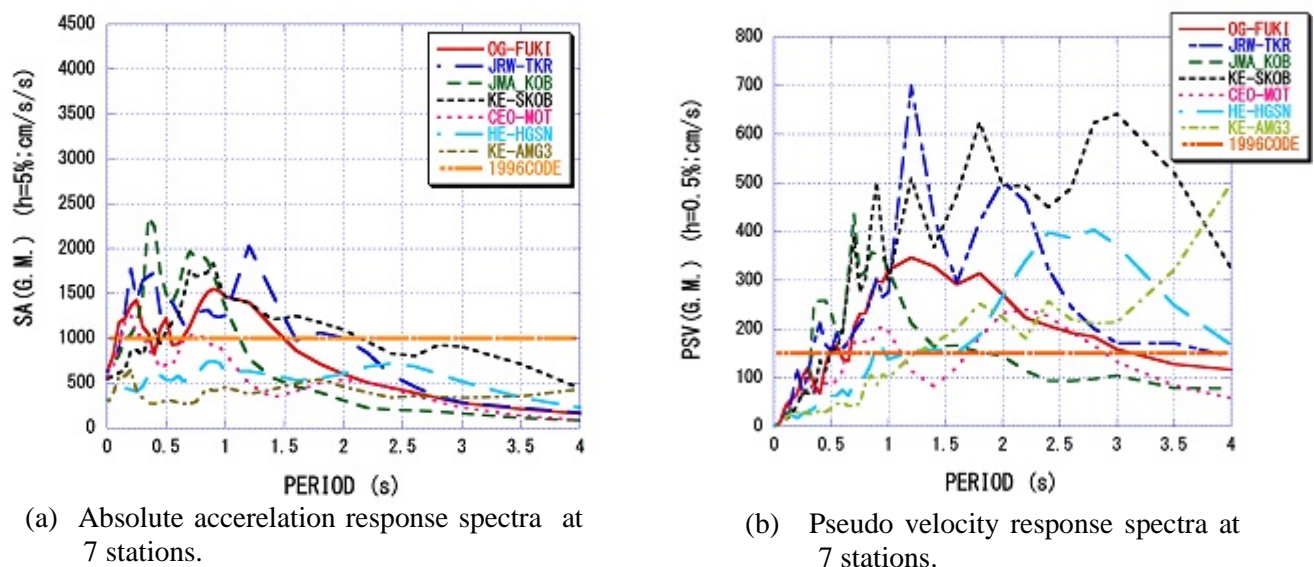
Fig.6 – Typical response spectra at the 7 stations in the southern Hyogo Pref.

By using 50 strong-motion records available at that time (e.g., [20],[21]), we calculated SA and PSV at each station for the same period ranges and damping factors as mentioned in Subsection 4.3. Fig. 6(a) and (b) show the curves of SA and PSV for the records at 7 typical stations.

From Fig. 6(a) it can be seen that the SA level in the short-period range between 0.15sec and 0.4sec is about 500-2000cm/s/s and at most two times larger than the maximum design value 1000cm/s/s. On the other hand, From Fig 6(b) it can be seen that the PSV level in the period range between 1.4 and 4.0sec reaches up to 600-700 cm/s, and remarkably exceeds the maximum design value 150cm/s, and that it is clearly larger than the level of the 2011 Earthquake shown in Fig. 3(b).

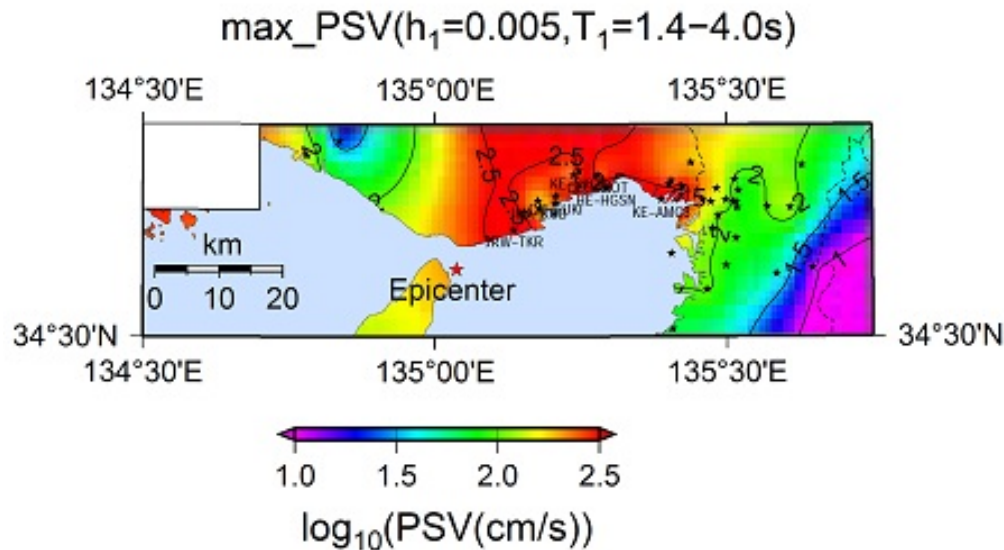
Fig. 7 – The contour map of PSV in the hatched zone in Fig.5 from the Earthquake

Similarly to the Subsection 4.3, we made the contour maps of response spectra, and Fig. 7 shows the contour map of pseudo velocity response spectrum. From Fig. 7 it can be found that the area with very high level of PSV spreads broadly from Kobe to Osaka, and the facts are consistent with that during the 2011 Earthquake we can see much more bulging-damaged tanks than sloshing-damaged tanks (with the ratio of about 4:1), on the other hand during the 1995 Earthquake we can see only comparatively more bulging-damaged tanks than sloshing-damaged tanks (about 2:1).
