EVALUATING AND QUANTIFYING CASE STUDIES OF LIQUEFACTION-INDUCED FLOODING FROM CANTERBURY EARTHQUAKE SEQUENCE

C. Davis⁽¹⁾ and J. Hu⁽²⁾

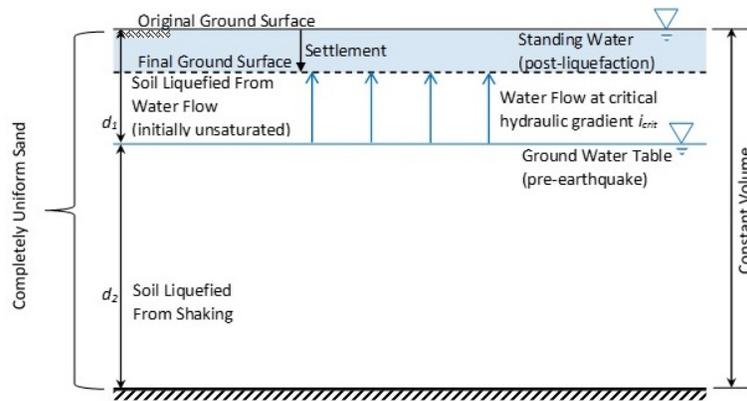
Fig. 2 – Uniform liquefiable sand deposit having pre-earthquake ground water table elevation at some depth d_1 below the original ground surface. The soils below hatched line are nonliquefiable; hatching is not an impermeable barrier. Water flow is unconstrained from sides and bottom.

Because liquefaction is a constant volume process, as the ground settles the water and soil sedimentation deposition depth above the ground increases and inundates the surface as shown in Fig. 2. In the absence of surface drainage, the water surface elevation after the liquefaction process is completed remains approximately the same as the original pre-earthquake ground surface elevation. The variation in subsurface conditions and erosion process results in differential settlement across the ground surface. The inundation depth is approximately equal to the settlement when original groundwater is near the surface. This is the process causing the flooding in Fig. 1. The liquefaction-induced flood waters did not drain for many days [2] due to damage to the drainage system.
