## THE COLLAPSE OF NEW RC BUILDINGS DURING THE MARCH 4, 1977 VRANCEA EARTHQUAKE

I. Vlad <sup>(1)</sup>

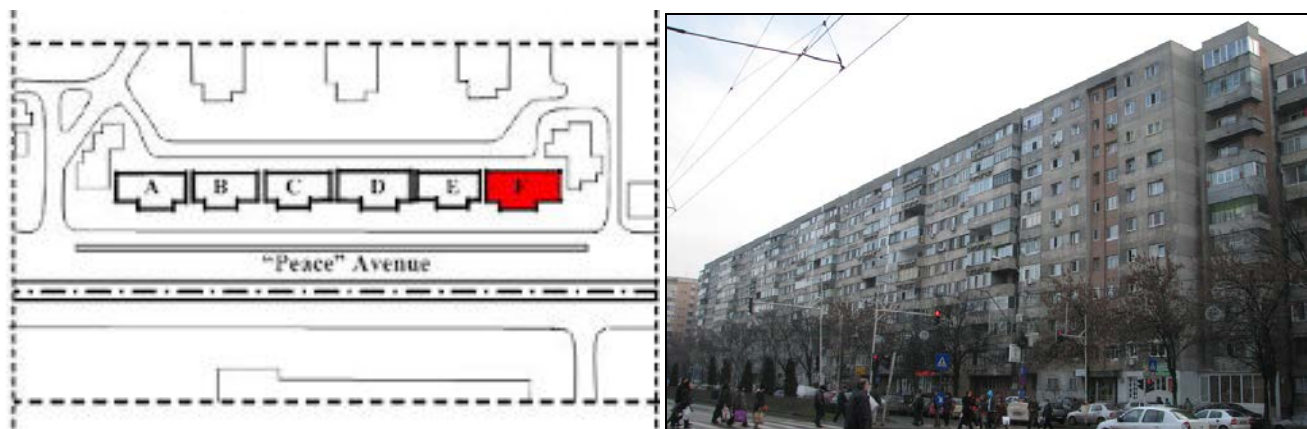
Fig. 4 – The six sections of the “OD16” block of flats

The OD16 block of flats comprises six sections (A...F), separated each other by small joints and deployed on a total length of 225 m (Fig.4).

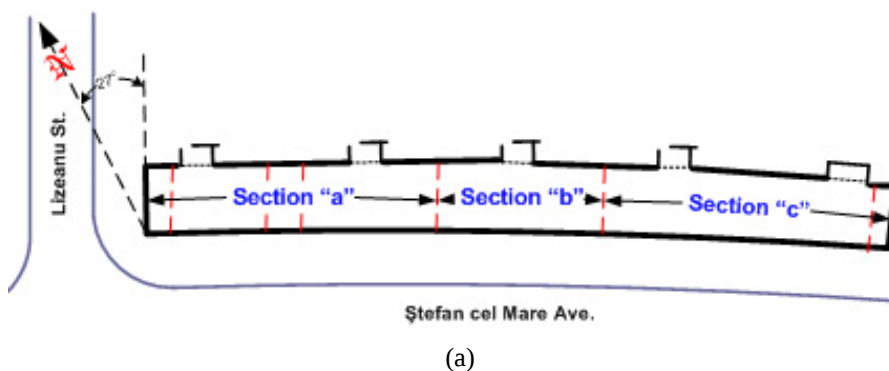
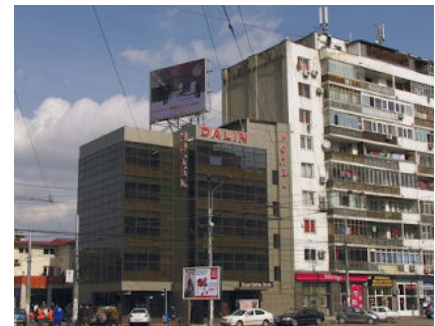
Fig. 7 – The “Lizeanu” building

During the March 4, 1977 earthquake, the western end of the section “a” has been dislocated over a length of about 10 m, area which was later demolished and where a new hotel was built (Fig.7,b). The area destroyed by the earthquake had about 12% of the total deployed area (respectively about 1,550 m<sup>2</sup> of the total 12,400 m<sup>2</sup>).
