ASSESSMENT AND RESTORATION OF AN EARTHQUAKE-DAMAGED SPORTS STADIUM IN NEW ZEALAND

The Lancaster Park (formerly AMI) stadium spectator stands in Christchurch, New Zealand were of modern reinforced concrete design and construction, with the two larger stands supported on stone-column foundations. This paper summarises the damage that occurred as a result of the Canterbury earthquake sequence (CES) of 2010-2011 and the engineering assessments that were carried out. The Canterbury earthquake sequence included several strong and damaging ground motions, with the most severe shaking being from the 22 February 2011 magnitude M_w 6.3 event at an epicentral distance of only 6km from the stadium. That event resulted in peak ground accelerations at the stadium site of approximately 0.5g horizontally and 0.75g vertically. Damage to the stands included bulging, loosening and contamination of the stone column foundations, global and differential settlement of the structures, and structural damage including extensive cracking of concrete, yielding and strain damage (and in some cases fracture) of reinforcement. Engineering assessments included mapping of observed damage, material testing and ana

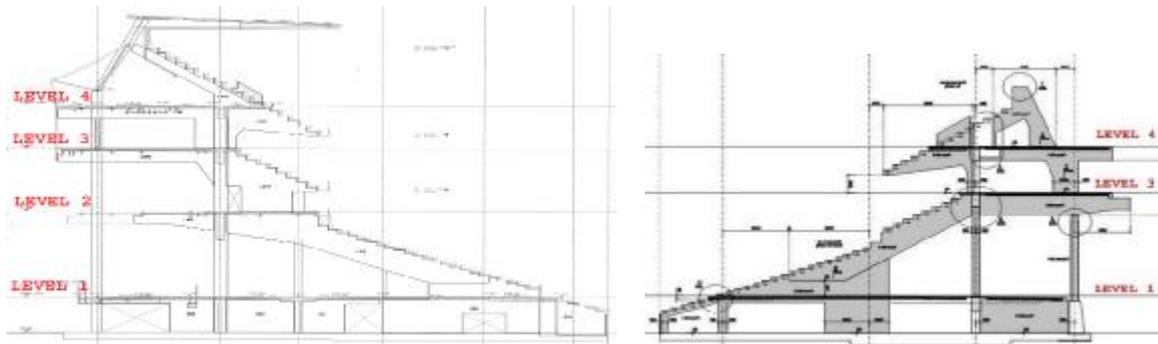
Fig. 2 – East-west cross-sections through main stands (Paul Kelly – left, Deans – right)

The stand structure comprises twenty-four grids of precast and in situ reinforced concrete radial shear wall/frame structures supporting precast concrete bleachers and hollowcore floor units with in situ topping. Radial structure is tied together longitudinally by a curved precast and in situ reinforced concrete moment resisting frame. Roof structure comprises cross-braced cantilever steel rafters with lightweight metal cladding. Radial structure provides the primary gravity load support with bleachers and floor structure spanning between radial grids. Transverse/radial loads are largely resisted by shear walls, moment framing and raker 'bracing' structure on each radial grid. The radial structure was designed for limited ductility, with hinge zones expected within the raker or moment frame beams. In the curved longitudinal direction, seismic forces are resisted by shear walls between Ground and Level 1 (Concourse level), and above Level 1 by a three-level circumferential moment resisting frame running the length of the structure. The original designers adopted a weak-beam, strong-column system with plastic hinge zones at the ends of beams at Levels 2, 3 and 4, and also at the base of the columns just above Level 1. The frame had been designed as fully ductile in accordance with relevant New Zealand design standards. The radial and circumferential structures work together for stability and to resist seismic lateral loads and torsional effects.

The foundations are a composite system comprising reinforced concrete shallow strip footings, for the lighter loaded field side structure, and a continuous raft beneath the main heavier loaded part of the superstructure. To help protect the structure against the effects of liquefaction induced foundation failure and settlement, ground improvement was constructed under the stand. This comprised vibro-replacement using a triangular grid of stone columns extending to a depth of approximately 9m below ground and covering the footprint of the stand and the associated structures. The liquefiable ground below the stand was only treated to partial depth, thereby creating a non-liquefying crust supporting the building.

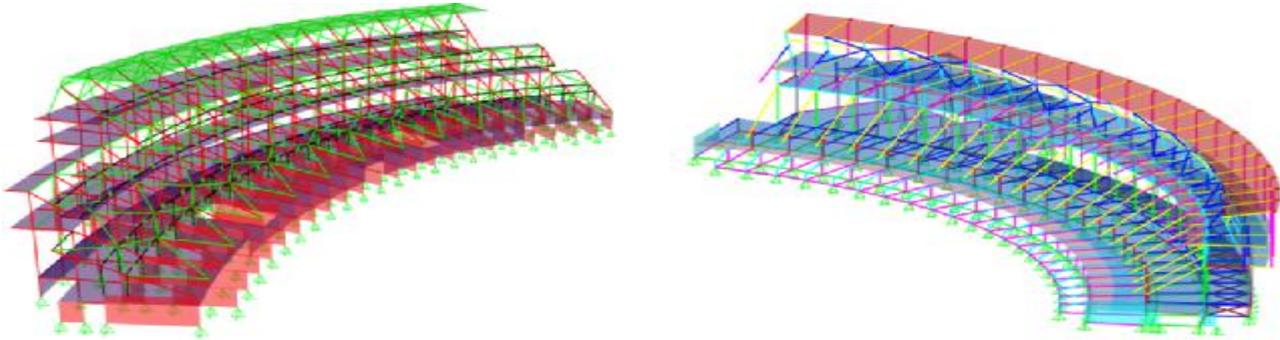
Fig. 11 – Structural Modelling (Paul Kelly – left, Deans – right)

Nonlinear static “pushover” and nonlinear time history analyses (NLTHA) were carried out on the Paul Kelly and Deans Stands using earthquake records from the 22 February 2011 earthquake. The effects of surveyed differential settlement on each of the stands were also separately analysed. Three-dimensional models of the structures (refer Fig. 11) were developed and analysed using analysis software SAP2000.

The analyses showed that, as expected, both structures were significantly stiffer and stronger transversely/radially than longitudinally. The predicted behaviour of the structures under longitudinal earthquake shaking was generally consistent with what the original designer assumed. In particular, the analyses suggested weak-beam strong-column mechanisms for the longitudinal moment resisting frame in each of the stands, with hinges forming at the ends of the beams at each level and at the base of the columns. This prediction also matched site observations of concentrated areas of damage evident at the ends of the beams, with lesser damage noted at the base of columns.
