SEISMIC BEHAVIOUR OF MULTISTOREY STRENGTHENED URM MASONRY SHEAR WALLS WITH OPENINGS: AN EXPERIMENTAL STUDY

Abstract

Keywords: URM; testing; fibre reinforced polymers; strengthening;

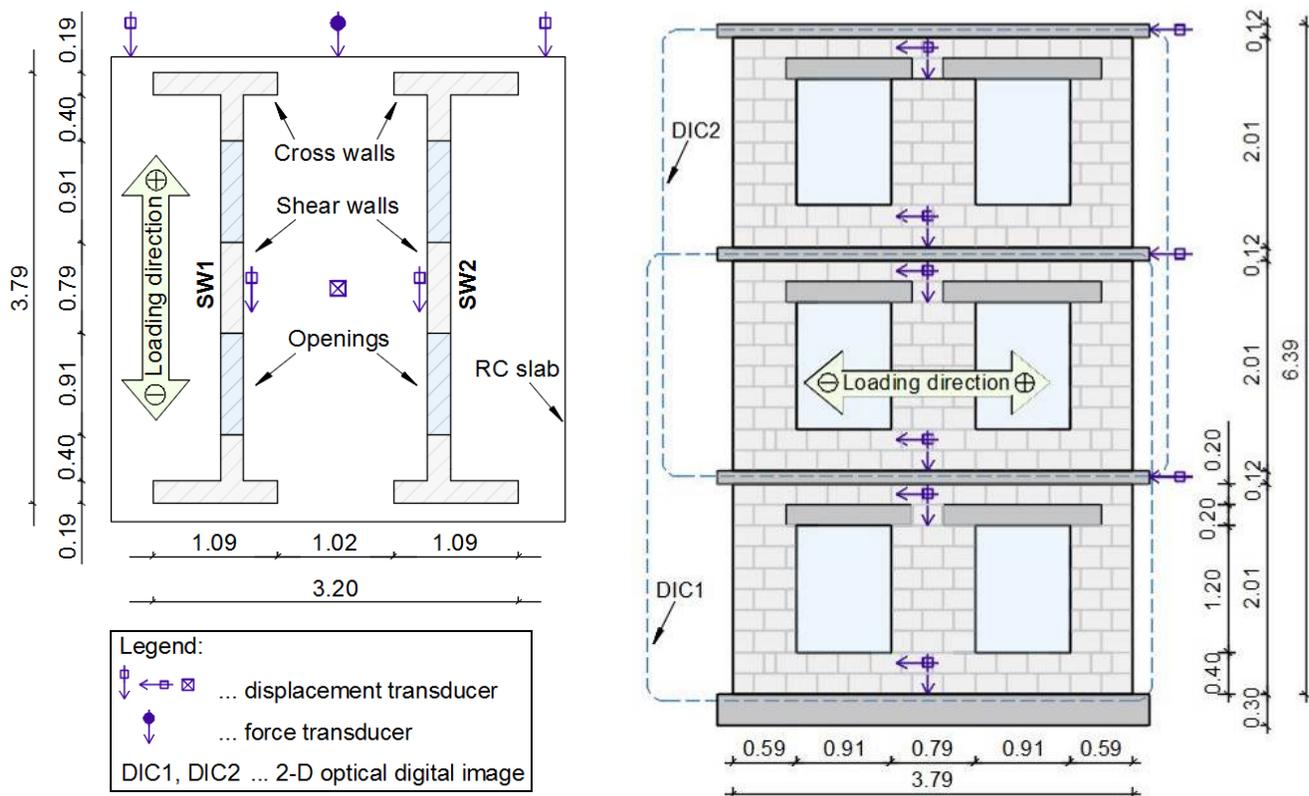
Fig. 1 - Disposition and instrumentation of the test specimen. Dimensions in meters.

Shear walls were 3.79 m long and had two openings on each floor. Above windows of height 1.20 m and length 0.91 m were r.c. lintels with a height of 0.20 m. The cross walls were 1.09 m long. The storey height was 2.01 m, so that the total height of the test specimen above foundations including r.c. slabs was 6.39 m. The masonry walls were built on a 30 cm thick r.c. slab, which had holes for fixing it to the laboratory floor. The dimensions of the test specimen in plan and elevation are shown in Fig. 1 and the entire test specimen can be seen in Fig. 3a.

During the tests the displacements of both shear walls were monitored by an optical digital image correlation (DIC) system with a measuring accuracy of 2/100 px (pixels) or about 0.04 mm. Two cameras with 5 megapixel resolution were used on each side of the specimen, and each of the cameras recorded the entire outer surface area of two storeys (the middle storey was recorded by both cameras). In order for the system to work, a random black speckle pattern was painted on the surface of the walls, as can be seen from Fig. 3a. In addition to the digital image correlation system, force transducers at each of the hydraulic actuators and a set of displacement transducers, placed at different locations, were used to measure forces and displacements, respectively. By means of displacement transducers, horizontal displacements at the sides and centre of each slab, as well as vertical compression of the walls and slip at the connection between the slabs and the walls have been measured (Fig. 1).

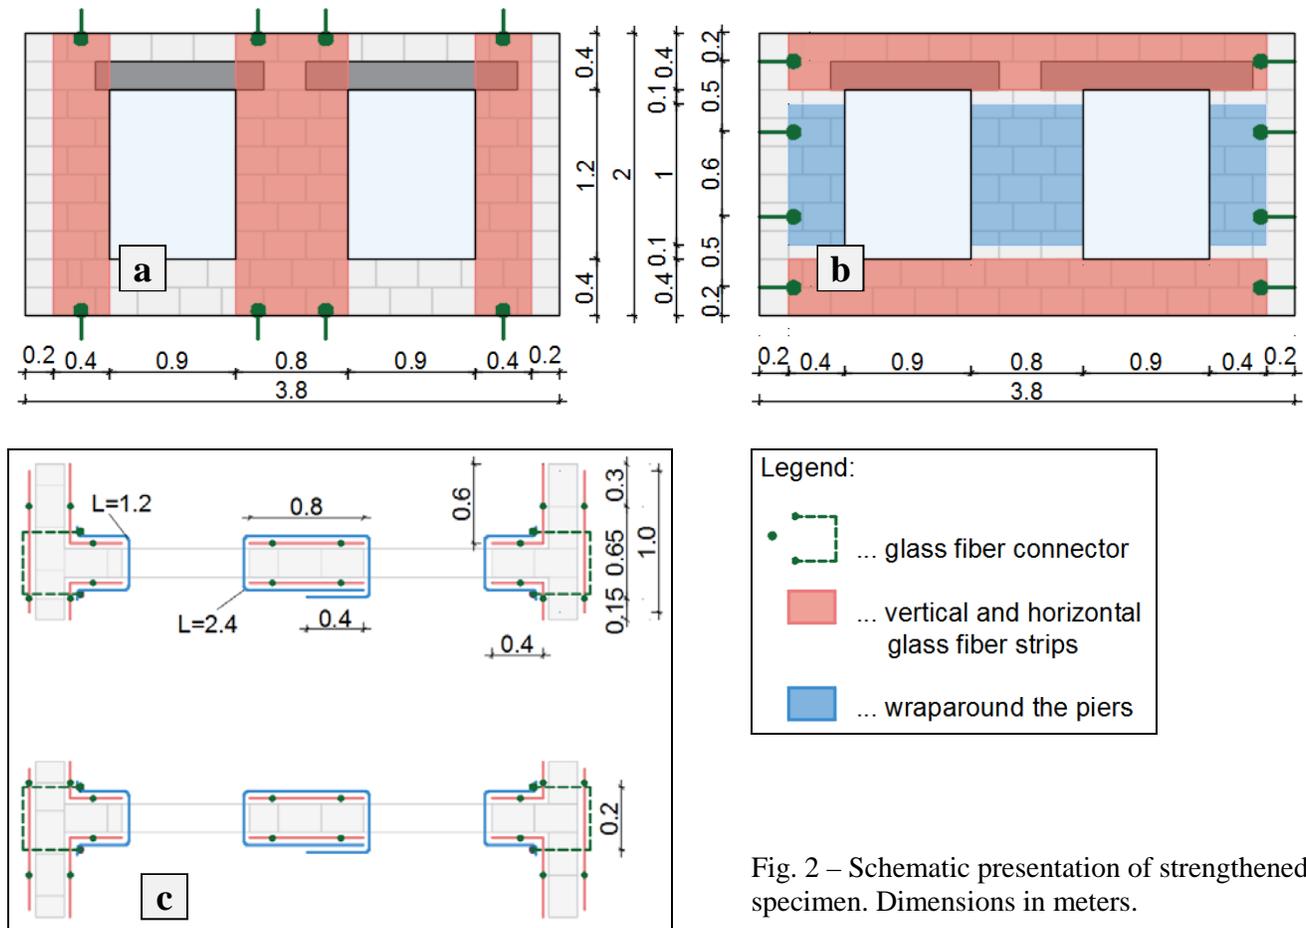
Fig. 2 – Schematic presentation of strengthened specimen. Dimensions in meters.

Strengthening of the specimen consisted of three strips of grid (Fig. 2a), placed over the entire storey height between the windows and at the sides. This was done on front and back of the walls, and the strips were anchored into the r.c. slabs above and below. The cross walls were likewise strengthened with grid over their entire surface. In the next step horizontal strips were placed above and below the windows over the entire length

and on both sides of the shear walls (Fig. 2b). The middle pier was wrapped with the GFRP grid, whereas the strips on the walls on the sides were anchored into the cross walls as is shown in Fig. 2c. More detailed information on the positions and dimensions of the glass fibre strips and glass fibre connectors are shown in the Fig. 2c.

The specimen before strengthening is shown in Fig. 3a. The details of how anchors were installed and GFRP grid laid into mortar are shown in Figs. 3b-3f. The anchors were used in three configurations: (i) for fixing the coating into concrete foundation or r.c slab, (ii) for connecting coatings from two different floors, or (iii) for anchoring coating of walls, which end in a cross-wall. Configuration (i) was used to fix the coating of the first floor into the floor slab at the bottom of the specimen and to fix the coating of the top floor into the top r.c. slab. On one end, the anchors were glued into the r.c. floor by means of epoxy adhesive, whereas on the other end, the rope of the anchor was divided into multiple strands and fanned out into the coating. The length of the fanned out fibres was 50 cm (as shown in e.g. Fig. 3c). In the case of slabs between floors 1-2 and between floors 2-3, the anchors connected the coating between the floors in configuration (ii). In this case, the anchors run through the r.c. slabs and are again anchored into the coating by fanning out the fibres as explained before. In configuration (iii), the anchors completed the wrapping of a wall with a T cross-section. Here, the web of the cross section was wrapped (as shown in Fig. 2c).

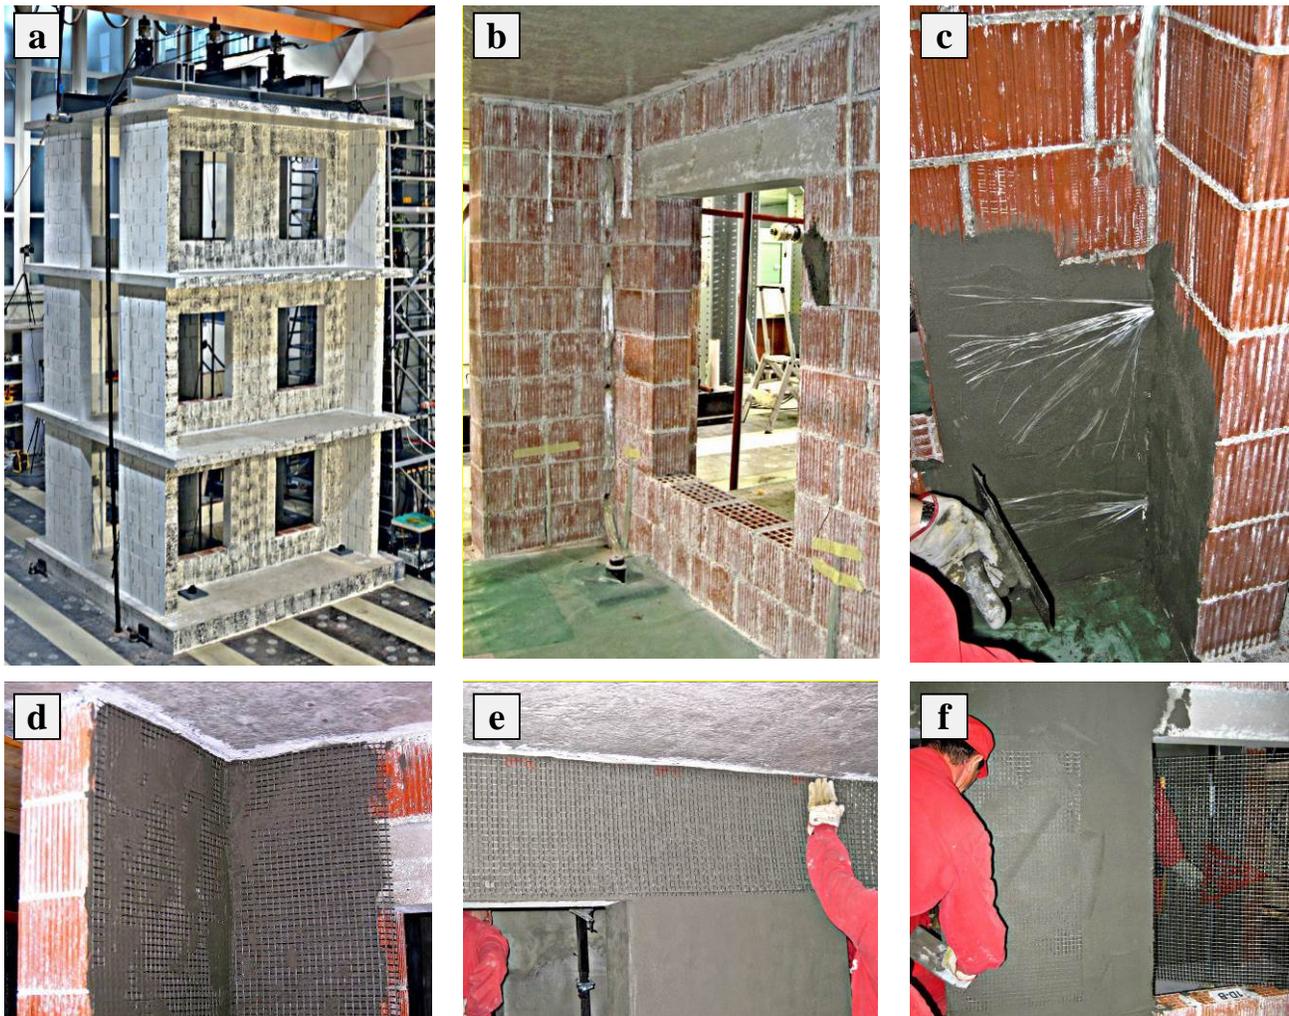
Fig. 3 – **a**: test specimen before strengthening; **b**: placing of glass fibre anchors; **c**: spreading the fibres; **d**: application of vertical strips on cross and shear walls; **e**: placing the horizontal grid; **f**: wraparound of the middle pier.

The GFRP was laid into mortar using the following procedure: first the wall was moistened with water, and then covered by the first mortar layer with thickness of about 10 mm. The GFRP grid was then gently pressed into the mortar (Figs. 3d and 3e) and covered by another layer of mortar (5-10 mm). Where there were anchors, they were placed below (applied before) the GFRP mesh.

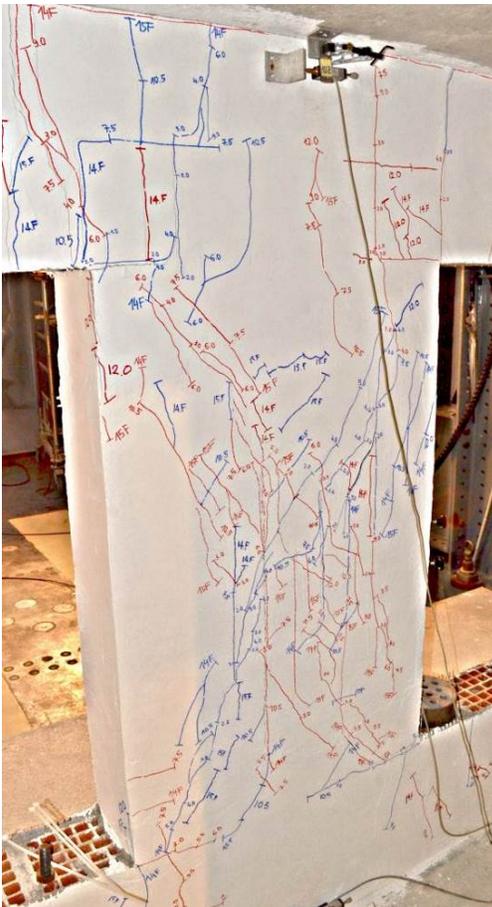
Fig. 4 - Crack propagation pattern of the middle pier on the ground floor at 0.60 % drift.

Damage of the walls increased with increasing amplitude of imposed displacement and typical diagonal shear crack pattern formed on all piers of the first and second floor (Fig. 4). Cracks occurred also in areas above and below the window openings. At the displacement amplitude of 10.0 mm, some new cracks occurred at the

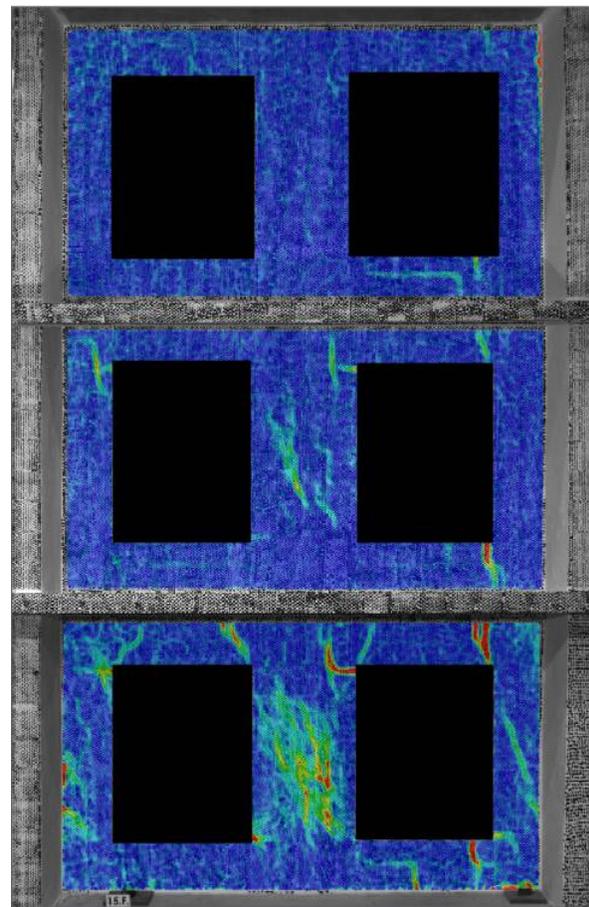
Fig. 5 - Major strain distribution of the multistorey shear wall at 0.60 % drift.

The results of digital image correlation (DIC) measurements, which enable information regarding the actual stress distribution in the shear walls as well as information on the boundary conditions of the central wall piers, have been evaluated. An image showing the major strain plot at the bottom storey drift of $\Phi = 0.60$ % is shown in Fig 5. As the strain concentrations indicate the locations of cracks and the magnitude of strain indicates their width, the similarity between the observed crack patterns and DIC measurement plots can be clearly noticed.

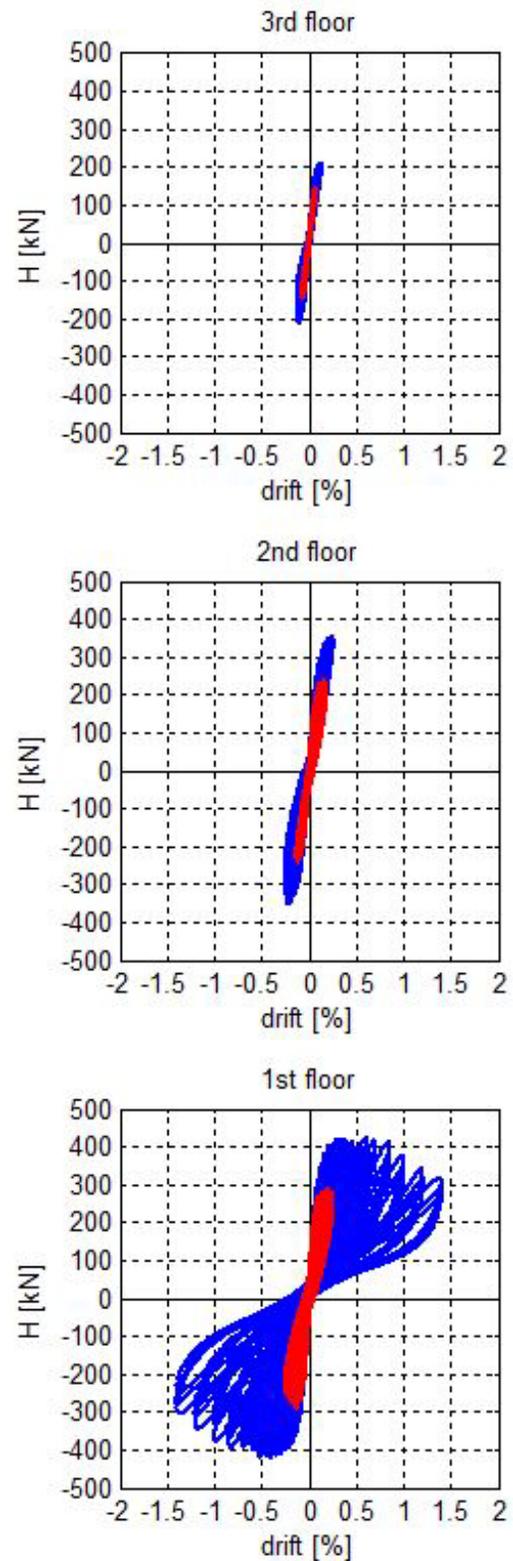
Fig. 6 - Hysteretic storey shear force – interstorey drift curves of individual floors of unstrengthened (red) and strengthened (blue) specimen.

The experimentally obtained lateral load (H) – drift (Φ) relationships are presented in Fig. 6, separately for each storey, including the hysteretic curves. Red lines are results of test of unstrengthened specimen, while the blue lines are the results of the strengthened one. The improvements due to strengthening can be easily recognized. The values of storey shear (H) and storey drift (Φ), obtained at characteristic limit states, are given in Table 3. To assess the efficiency of strengthening, the resistance and displacement capacity of the walls at two limit states (damage limit state and state at maximum resistance) have been compared.

Similarly, as in the experiment of unstrengthened specimen, the hysteretic curves show, that the majority of the damage and energy dissipation was concentrated on the bottom floor. There was some damage and dissipation of energy on the second floor, whereas the response of the top storey was essentially linear. The maximum lateral resistance, achieved in the test of the unstrengthened specimen was, in the case of the strengthened specimen, exceeded at damage limit state. The effect of strengthening is clearly seen in the improvement of the lateral resistance of the first storey by almost 50 %, which is seen in Fig. 6. At the same time stiffness of the specimen remained almost the same. The bond between the masonry walls and the strengthening layer was not a problem until the maximum seismic resistance of the specimen was reached. After this state, signs of delamination were observed and the crack propagation significantly increased. At next loading stages shear force gradually decreased. No brittle behaviour was detected, as confirmed by the hysteretic curves of the first storey.

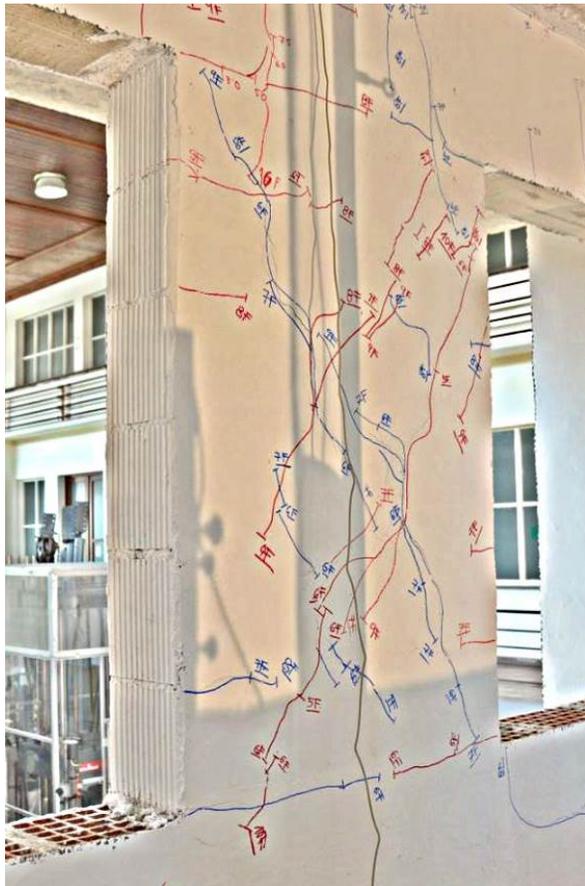
Fig. 7 - Crack propagation pattern of the middle pier on the ground floor at 0.39 % drift.

The first new visible cracks, which occurred in the testing, were observed at about 0.10 % (displacement of 2.1 mm). Few tiny diagonal cracks on the side piers of the shear walls appeared. In the next phase (drift of 0.16 %) the middle piers started to crack in a typical diagonal shear pattern. When the storey drift amounted to 0.31 %, shorter horizontal cracks on the sides of the middle piers were detected and cracks in the contacts between masonry and window r.c. lintels developed. Areas above and below the window openings cracked in different directions. Vertical cracks in the contacts of the shear and cross walls and horizontal cracks on the top of the walls where connected to the r. c. slab, were observed. As the imposed displacements were increasing according to the loading protocol (Table 2), existing diagonal cracks continued to develop and open (Fig. 7).

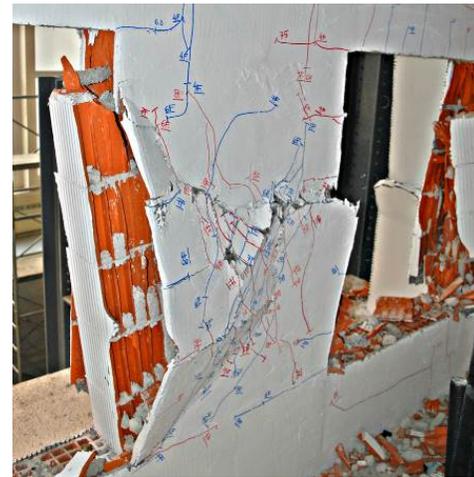
Fig. 8 – The middle pier at the end of the experiment.

At lateral displacement of 14.3 mm some individual blocks started to fall off the specimen piers. The coating delaminated from the wall in the middle and side piers. In the last phase (0.87 % drift), the walls failed in compression (Fig. 8). The vertical strips on the wall piers continued to delaminate from the wall and the glass fibre mesh ruptured.

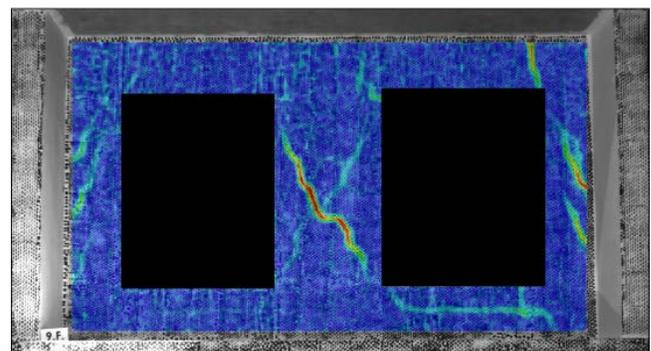
Fig. 9 - Major strain distribution of the third storey shear wall at 0.39 % drift.

Observed behaviour coincides with the DIC measurements, as shown in Fig. 9, where major strain plot at the storey drift of 0.39 % is presented.

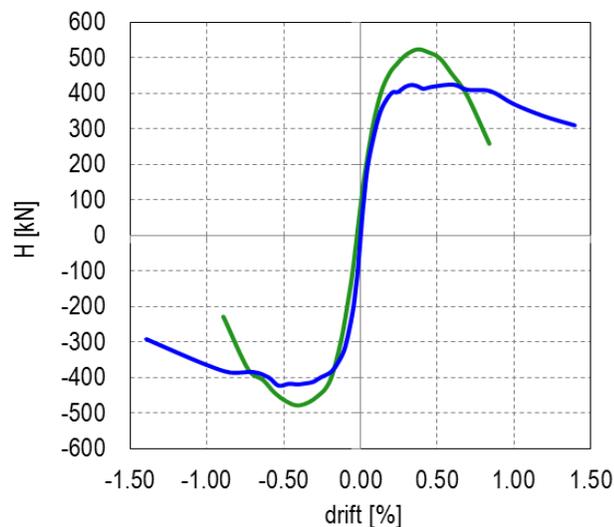
Fig. 10 - Hysteresis envelopes of first floor of the strengthened specimen (blue) and of the individual testing of third floor (green).

The experimentally obtained envelopes of the hysteresis curves, showing relationship between the storey shear force (H) and storey drift (Φ) for third floor are plotted in Fig. 10 and the values of these two parameters at characteristic limit states are given in Table 4.

Values of the storey shear force and drift at characteristic limit states of the single storey specimen in comparison with values of these two parameters of first storey in the case of whole strengthened specimen were quite similar, as shown in Fig. 10. The main difference in the results is observed for the maximum shear force, which is about 20 % higher while testing a single storey and it appears at a lower storey drift. The reason for higher strength of the third floor compared to the first floor of the strengthened specimen is probably that the first floor was significantly damaged before strengthening was applied. It is also evident from the mode of the collapse and from the increased ductility in case of wrapped walls that wrapping crucially improves behaviour of structures. More concentrated cracking (not smeared as on the first floor) and ultimately a much more brittle failure was observed in the case without wrapping.
