## INNOVATIVE PROCEDURES TO REHABILITATE SEVERELY DAMAGED CONCRETE COLUMNS AND COMPARISON WITH ALTERNATIVE METHODS

### **Abstract**

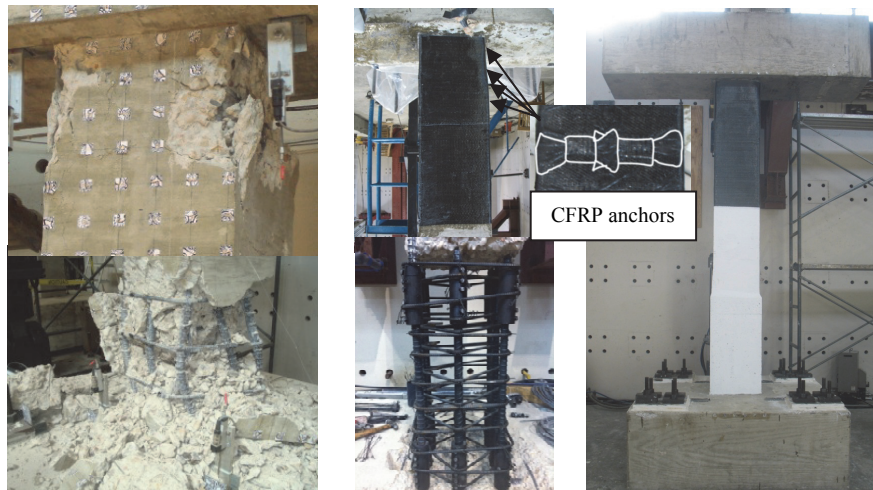
For the first column severe damage occurred at both ends with buckling of longitudinal bars and crushing of the concrete at the bottom and spalling of the cover at the top. The constant axial load applied was 150kips. The top end of the column where spalling of the cover but no buckling occurred, loose concrete was removed and mortar was used to replace the broken concrete (Huaco[7].) Fig.5 shows the damaged top and bottom hinges and the retrofit process. The damaged regions were wrapped with 2 layers of CFRP sheet (0.04in thickness each layer) at the first 24in and some intermediate CFRP anchors were installed midway between the corners. For a second 24in length was used one jacket only. At the bottom of the column, short mechanical splices were used to replace the buckled bars and to provide continuity to the longitudinal bars and cold joint was used at inferior and superior set of splices, details of the retrofit procedure is at Huaco and Jirsa[5]. This retrofitted column was tested using the same deformation pattern and constant axial load than the original.

Fig.5. First column, damaged condition and retrofit

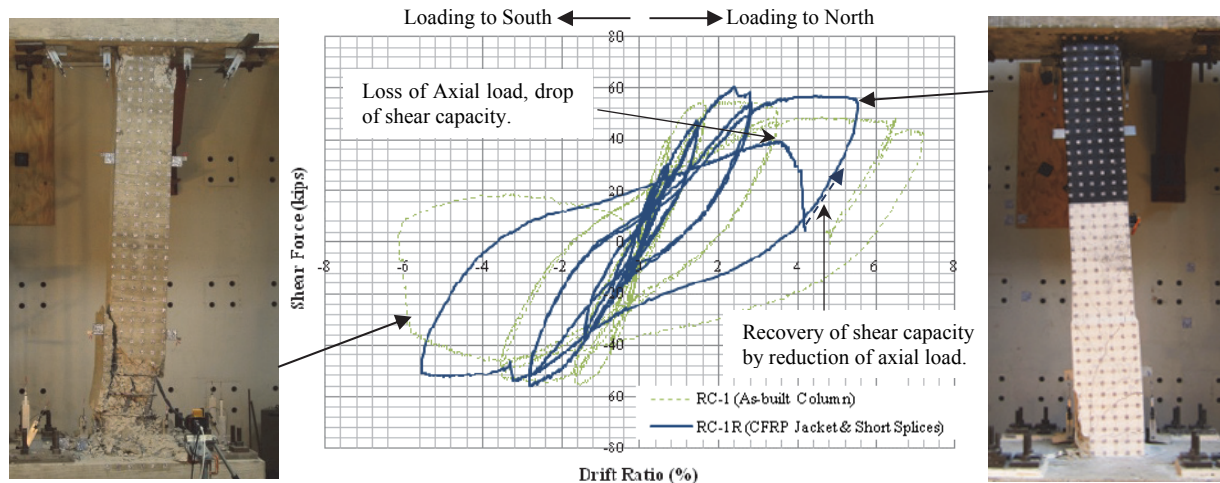
The behavior of the member finished was nearly linear up to lateral displacement of 1.66in or 1.43% drift ratio. The shear force to the North was 46.85kips, and to the South was -38.55kips. The strain of the new bars on the bottom of the column reached yield value for Grade 60 steel. The maximum shear capacity was 60.9kips North and 56kips South. The lateral deformation was 2.80% drift ratio in both directions. Degradation of stiffness and strength was seen at 5.5% drift ratio both directions. Pinching effect seemed to be appeared for pushing loading when the lateral load was dropped as can be seen in Fig.6. The cracks appeared near the bottom became wider, while on top the CFRP started to debond. The specimen was not able to sustain the 150kips axial load in the 9th cycle and the test was stopped when the lateral load dropped by 30kips. Shear failure developed in the existing concrete above the mechanical splices zone as can be seen in Fig.7. The axial load was reduced in order to increase the lateral deformation noticing an extra capacity of the bottom half of the column in shear and displacement. Fig.6 shows the behavior of the as-built column RC-1 and after retrofitting RC-1R. Values of displacement are normalized by drift ratios. It was observed that RC-1R had less stiffness than the as-built column, even though the retrofitted column had a larger cross sectional area at the bottom. This was more evident when the column was loaded in the south direction. Since large cracks opened at top and bottom of the column, it can be assumed that the existing bars were deformed more than in the original test. RC-1R had slighter higher lateral capacity than RC-1 and values of ultimate drift ratio are comparable.

Fig.6. Shear force vs. drift ratio of RC-1 and RC-1R

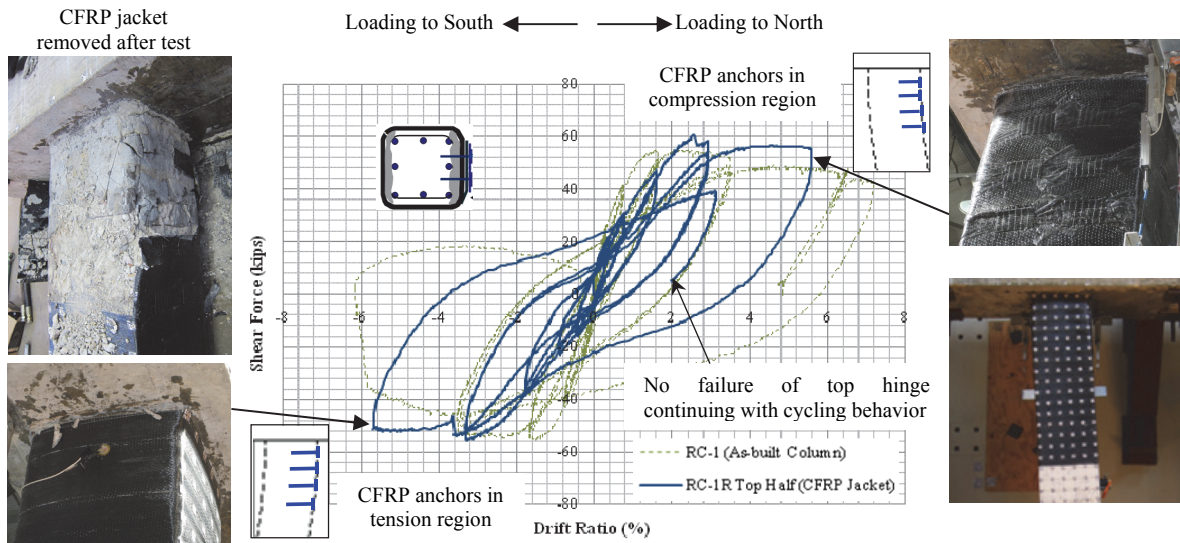
Slighter higher shear forces were observed in RC-1R top half but the stiffness at low drifts was greater for the retrofitted column, especially the specimen was loaded to the south. Loading-to-North curve is stiffer than Loading-to-South because the presence of the CFRP anchors in the south face of the specimen, see arrows above and below curves at Fig.8. When the specimen is loaded to north, the CFRP anchors is in the compression region of stress, the anchors provided compression strength capacity. However, the specimen is loaded to the opposite side, the CFRP anchor is in the tension stress region. The anchors do not provide important tension capacity to the section. Fig.8 shows the response of RC-1 and RC-1R top half (CFRP jacket). Lateral displacements are normalized by drift ratios. CFRP jacket was removed after the test and it was noticed that CFRP interior part of anchor were not pulled out and the condition of concrete core had no severe damage (Fig.8). Since the failure of RC-1R occurred on the bottom half, and the top half was in good condition, it was concluded that this top hinge had the capability to perform larger lateral displacement therefore dissipate more energy. The maximum strain reached on the 2 layers CFRP jacket was 0.0038; and 0.0014 on the 1 layer CFRP jacket. Strains in most of the longitudinal bars in the top of the column yielded reaching max strain of 0.0042.

Fig.8. Shear force vs. drift ratio of RC-1 and RC-1R Top Half

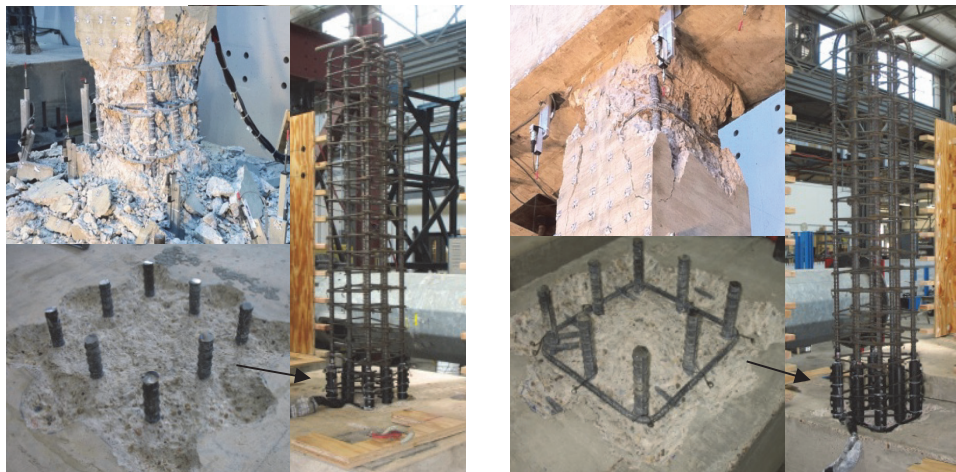
The constant axial load applied was 350kips (Huaco[7]). Axial failure was reached with the column exhibiting severe deterioration at both ends and buckling of longitudinal bars coupled with crushing of the concrete as it seen in top corners of Fig.9. The repair procedure consisted of replacing the damaged portion of the column with new bars and higher strength concrete. Mechanical splices were used to join the old with the new bars. The column was divided into two parts to be tested as cantilever columns by applying the lateral load at the middle height of the original one, having single curvature deformation which is the approximate the condition of one of the half parts of as-built double curvature deformation of RC-2. The height of each cantilever was 58in. The two hinges were tested separately as cantilever columns with no axial load applied, considering the worse tension condition for the splice to be tested inside the hinges. One half of RC-2 was repaired using short mechanical splices (6.8in length) RC-2R-SMS, and the second half was used long mechanical splices (10in length) RC-2R-LMS. Details of the rehabilitation procedure are in Huaco and Jirsa[6]. Fig 9 shows the damaged hinges, cutting the buckled bars leaving a protrusion for the application of the mechanical splices and the old and new bars gathered with the mechanical splices are shown. Cold joint was used at base. Because larger radio of splice, the concrete cover increased to 2.1in from edge of longitudinal bar, increasing the cross section to 18in x 18in. Confinement region area at splice height increased but not at bars height. The protocol of load for the test of both columns was following the procedures of FEMA 461 until 2.10% drift ratio which is above the maximum allowed drift recommended in the ASCE07-10 seismic design provisions.

Fig.9. Two new cantilever specimens from RC-2. Application of short mechanical splice (left) and long mechanical splice (right).

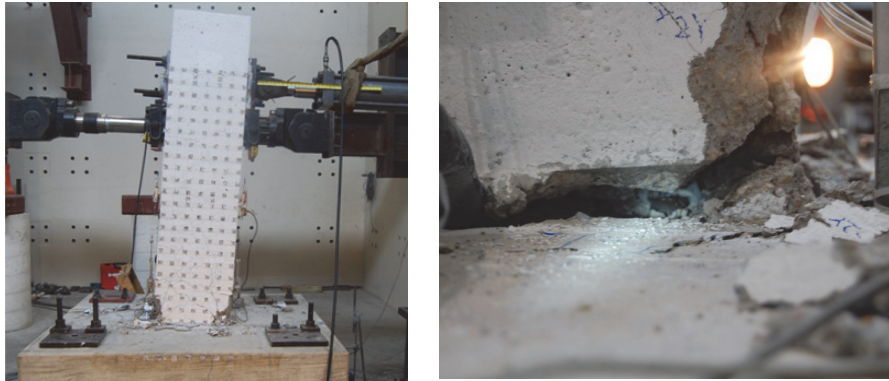
Flexural cracks developed at 0.55% drift or 0.30in (lateral displacement) in both faces of the column at the base. The lateral load was 32kips. One crack with of 0.027in was measured at the cold joint. Yielding occurred at 1.1% drift ratio with a lateral load of 50kips in the north direction Flexural cracks propagated through the column. The crack at the base opened to 0.05 in. The strain measured in the mechanical splices was 0.0009 in tension and 0.00015 in compression. The longitudinal bars strain was between 0.0025 in tension and 0.0001 in compression. No concrete spalling was observed at this point and none of the ties reached yield, pinching and larger energy dissipation was observed also, and there was a slight degradation of stiffness and strength too. When lateral deformation reached 1.40in, the shear capacity dropped 60kips to 47kips after a loud noise was heard because one of existing longitudinal bars fractured at the south-east corner of the specimen. Further increases in deformation resulted in failure of a second bar produced at 53kips and 2.0in lateral displacement. The fractured existing bar was located at the center of the three bars at tension region of the column. The response was comparable for both Loading-to-South and Loading-to-North. The test continued until the rupture of 3 existing longitudinal (Fig.10). The maximum deformation reached was 3.62 in obtaining an ultimate load of 9.5kips before last bar fractured. It was present lifting as result of the rupture of bars.

Fig.10. RC-2R-SMS at finishing of the test (left), new longitudinal bar broken and lifting at base (right)

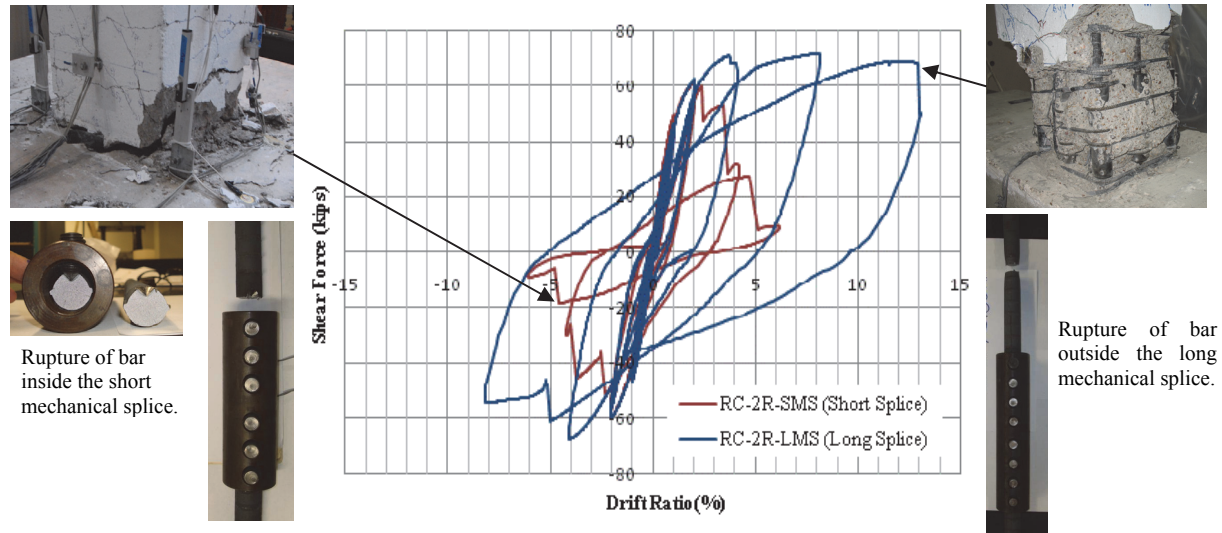
Fig.12 shows a comparison of behavior for both top and bottom retrofitted hinges of RC-2. Values of lateral displacement were normalized with drift ratios. It can be seen that both halves had the same behavior in the linear range. However, the half retrofitted with long mechanical splices reached higher lateral capacity and developed larger lateral displacement. The end point bolt of the short mechanical splice in RC-2R-SMS produced the rupture of the existing bar at lower drift ratios than in RC-2R-LMS, which had long mechanical splices with rounded bolt and fracture outside of the mechanical splice. Fig. 12 shows too the type of rupture of each type of mechanical splice [6], and the condition of the intact core for RC-2R-LMS after removing of the cover, and the spalling of cover and the final condition of RC-2R-SMS after the rupture of the three existing longitudinal bars.

Fig.12. Shear force vs. lateral displacement of RC-2R-SMS and RC-2R-LMS
