## BEHAVIOR AND DURABILITY OF CERAMIC HERITAGE MASONRY IN NEAR SOURCE FAULT ZONE

N.G. Maldonado<sup>(1)</sup>, P.E. Martín<sup>(1)</sup>, I. A. Maldonado<sup>(1)</sup>  
M. C. Domizio<sup>(1),(2)</sup>, G.González del Solar<sup>(1),(2)</sup>, Francisco Calderón<sup>(1),(2)</sup>

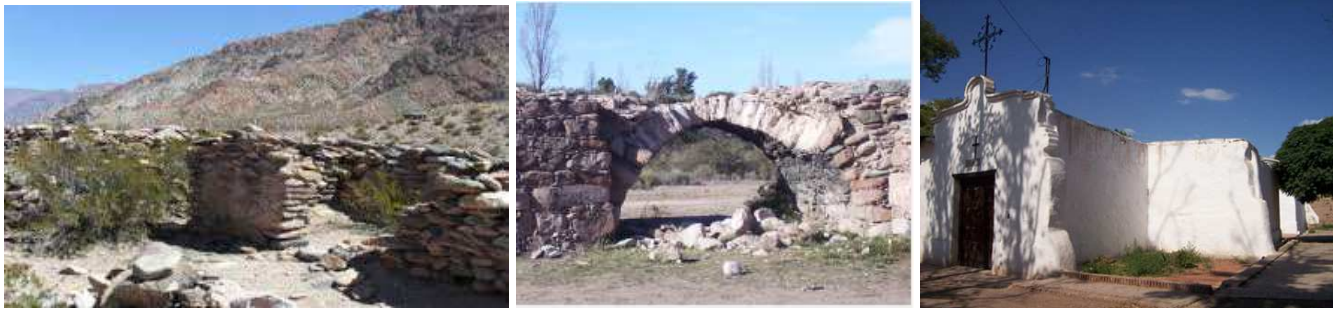
Fig. 1 – Prehispanic Pircas (Uspallata), Stone Bridge (Luján de Cuyo), Church of Jesús Nazareno (Guaymallén)

In Argentina there are very few heritage buildings prior to the arrival of the Spanish in the sixteenth century, that remain in the northwest in form of stacked flackstones (Fig. 1) or low adobe buildings. Mendoza is the oldest city in Argentina with a pre-Hispanic era and other Hispanic or colonial era. One example is the existing system of artificial irrigation through canals and ditches, built by the Huarpes Indians, taking advantage of watercourses natural slopes and geological faulting, constituting a drain-channel-path spatial unit [1].

From the point of view of heritage conservation very few buildings of natural stone masonry for the pre-colonial period can be detected in Mendoza (remains of the Inca Trail, Fig. 1).

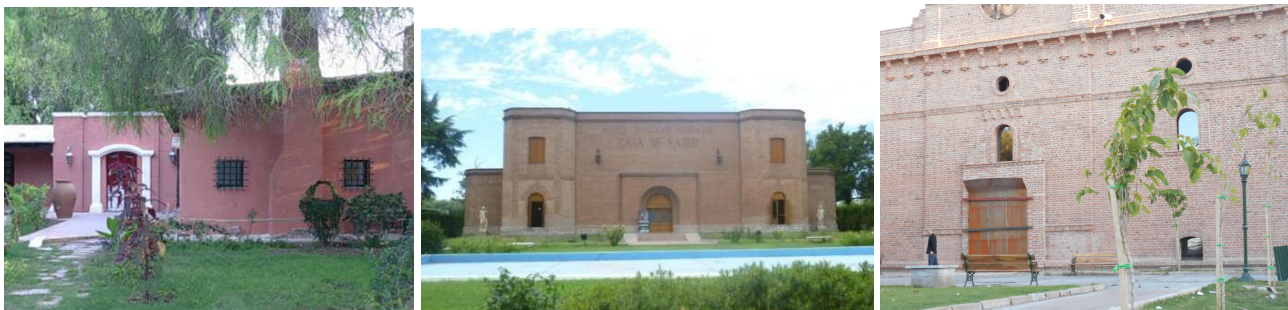
Fig. 2 – Historical Heritage of Mendoza: Molina Pico Museum (Guaymallén), Provincial Museum of Fine Arts (Luján de Cuyo), Caro Wine Vault (Godoy Cruz).

From 1860 the colonial style mixed with the classic one (Italian style) prospered with the national reorganization and from 1880 architectural movements academicians, eclectic and art nouveau in construction appeared (Fig. 2). So, Argentina is an ethnically and culturally unique country in all America from the heritage preservation point of view [2]. This was a surprise because of the celerity with which some buildings were built and others demolished for their progress.

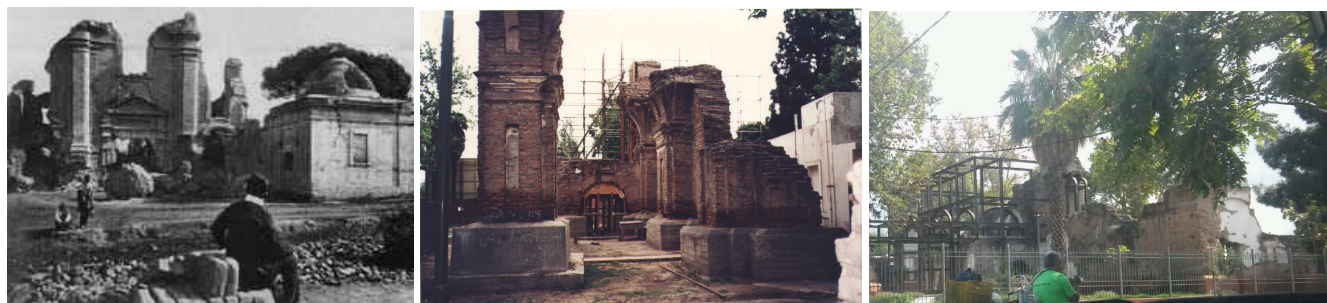
Fig. 3 – State of San Francisco Church after the earthquake of 1861, in 1999 and 2016.

severe effects, directivity). Mendoza earthquakes of 1792, 1861, 1903, 1917, 1920, 1927 and 1985 destroyed the adobe buildings and severely damaged unreinforced masonry buildings, affecting older buildings (Fig. 3).

From colonial times it only remains the ruins of fired clay masonry with lime mortar of the Church of San Francisco product of the destruction of the earthquake of 1861 (Fig. 3) and some chapels outside of Great Mendoza. Subsequent to that earthquake, heritage buildings are also rare and some of them are detected within the educational park.
