## DAMAGE EVALUATION OF ANTI-SEISMIC RUBBER BEARING USING ACOUSTIC EMISSION

Y. Kawasaki<sup>(1)</sup>, N. Teramura<sup>(2)</sup>, K. Izuno<sup>(3)</sup>

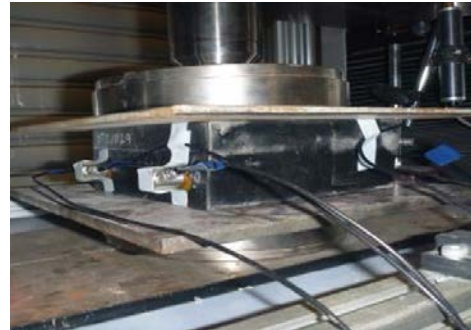
Fig. 3 – Locations of AE sensors (Left) and View of the experiment (Right)

A schematic elevation of the specimen is shown in Fig. 2. All specimens were preliminarily tested at the Civil Engineering Research Institute for Cold Region, Japan, as shown in Table 1. Five AE sensors were attached between the rubber and steel plates as shown in Fig. 2 and Fig. 3. AE sensors were fixed using plastic tape and electron wax.
