# ADDRESSING BOUNDARY DESIGN FOR REINFORCED CONCRETE WALLS, BASED ON STUDIES OF THE 2010 CHILE EARTHQUAKE

K. Telleen<sup>(1)</sup>, J. Maffei<sup>(2)</sup>, J. Heintz<sup>(3)</sup>, P. Bonelli<sup>(4)</sup>, D. Kelly<sup>(5)</sup>, M. Willford<sup>(6)</sup>

The project was conducted by the Applied Technology Council (ATC-94 project) with participation from engineers and researchers from the United States and Chile. Project objectives are to: (1) evaluate critical issues in the design of reinforced concrete walls; and (2) develop recommendations for improving wall design requirements.

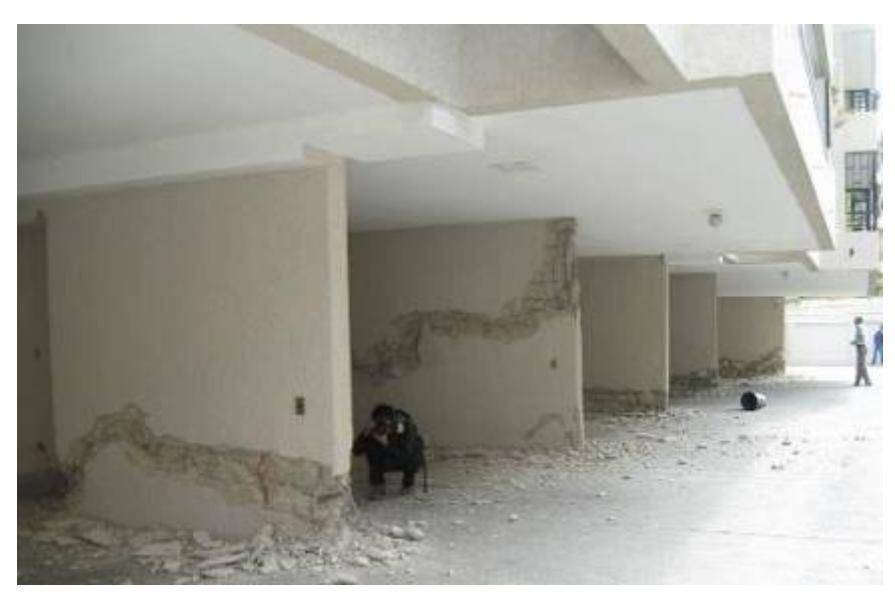
Fig. 1 – Damage to concrete walls at the ground level of a residential building. (photo by Patricio Bonnelli)

The twelve buildings studied in this project generally follow the typologies described above. Most of the studied buildings are residential buildings because of the prevalence of damage to this type of building configuration (Fig. 1). The studies also examine significant damage that occurred in an office building with plan irregularity and a perimeter pier-spandrel system.

Concrete crushing was observed over the length of walls, initiated at the ends, often in conjunction with buckling of reinforcement (Fig. 1, Fig. 7, Fig. 8). In many cases, it is difficult to distinguish whether damage is initiated by bar buckling (from plastic tension strain followed by compression, as described in the previous section) or by concrete crushing (from compression stress). (See [5] for further discussion.) Each can lead to the other, and in some ways, approaches for mitigation are similar. If the area and/or confinement of concrete is inadequate to resist compression stress demand, bars are likely to buckle when concrete crushes and/or ties fracture. If bars are not restrained against buckling, they provide limited concrete confinement and can reduce concrete area by spalling cover concrete.

- Solid wall below (or above) a series of vertically-aligned openings (Fig. 10).
- "Flag-shaped" walls, where the length of wall is reduced at the lower stories compared to the upper stories, as described in Section 2 for residential towers (Fig. 1).

In "flag-shaped" walls (Fig. 1), earthquake damage is likely to concentrate in the stories with reduced wall length because flexural, shear, and axial loads must be resisted by a reduced cross-section of wall. Analytical studies (Fig. 11) indicate that for walls with essentially unconfined concrete (having few or no hoops or cross-ties), exceedance of the strain at which concrete stress is maximum can initiate spalling and crushing of concrete at the end of the wall and rapid propagation of strength-loss across the wall section. Such progressive damage would not be captured by analyses that assume plane sections remain plane. Nonlinear models that capture such behavior showed good agreement with the apparent failure mechanisms observed in an example building that collapsed in the earthquake.

- If possible, avoid configurations with solid wall below (or above) vertically-aligned openings (Fig. 10), and "flag-shaped" walls (Fig. 1).
- For solid walls below openings (Fig. 10), extend vertical reinforcement from the wall piers above one or more stories into the solid wall below. Design the solid wall below for panel zone shear forces.
- For flag-shaped walls (and other configurations that have the potential to concentrate compression strain), adjust analysis assumptions or limits on permissible concrete compression strain. Provide adequate area of concrete (thickness of wall) to maintain low axial stress. Provide reinforcement to restrain crack opening at re-entrant corners, and special boundary element detailing at wall boundaries where yielding and/or high compression stress is likely to occur.

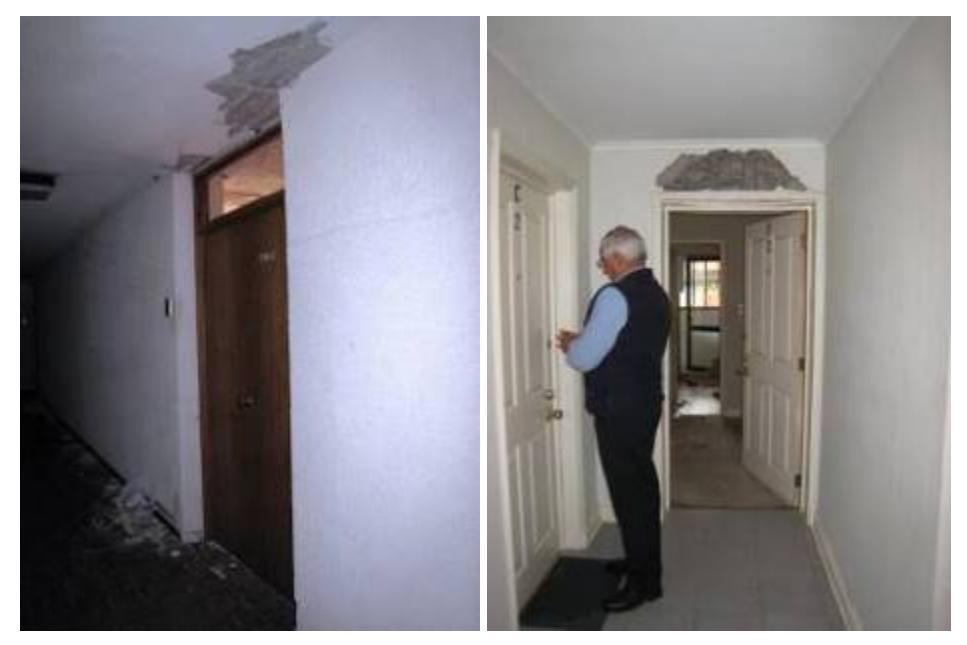
Earthquake damage can occur in slabs and beams (Fig. 2) as a result of vertical displacement at the ends of nearby walls. When the wall boundary on one side of the doorway is in tension (upward vertical displacement), the wall boundary on the other side of the doorway tends to be in compression. This induces flexural deformations in the slab or beam, which can cause large plastic rotation demands, particularly for slabs or beams that have short span length.

Fig. 2 – Slab and beam damage from wall coupling. Flexural deformations in the walls cause differential vertical deformations over a short span between ends of nearby walls. (photos by Joe Maffei)

• Account for coupling from gravity beams and slabs in the seismic analysis and design, even though such elements are not customarily designated as part of the seismic force-resisting system. When such coupling is considered, in some cases it may result in greater tension and compression strain demand, greater shear reinforcement, different flexural reinforcing pattern, and/or greater amounts and better detailing of transverse reinforcement ties to resist bar buckling and/or improve confinement.

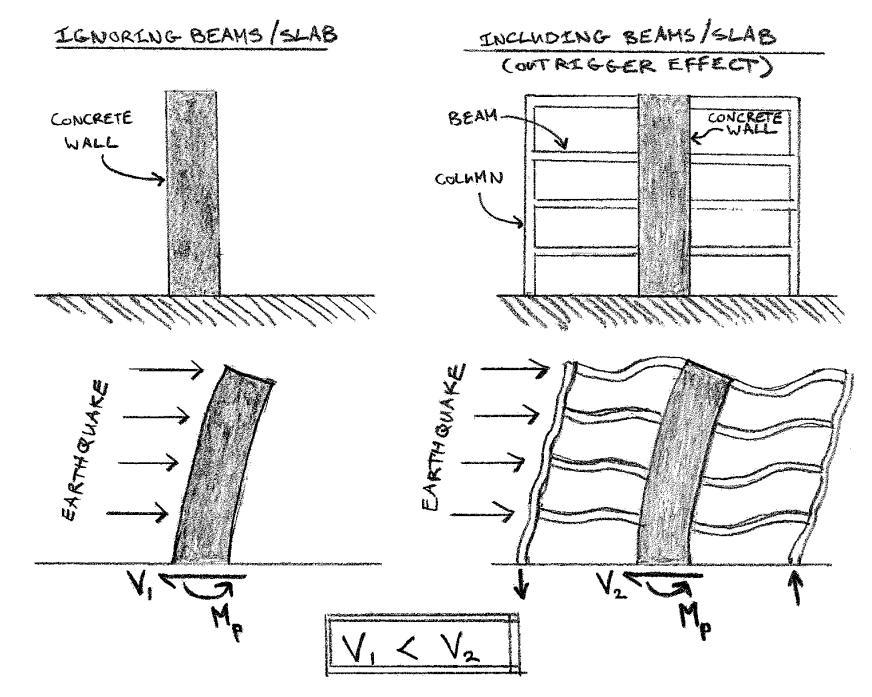
Damage can occur in walls as a result of coupling that increases shear and axial demands on the walls. Fig. 3 shows how shear demands for an individual wall can be greater for the case with beams or slabs, compared to calculated demands if the gravity framing is ignored. Fig. 4 shows a wall with bar buckling from tension and compression axial loads that result from coupling with another wall on the same line.

Fig. 3 – Effect of gravity framing on wall shear demand. (image by Karl Telleen)

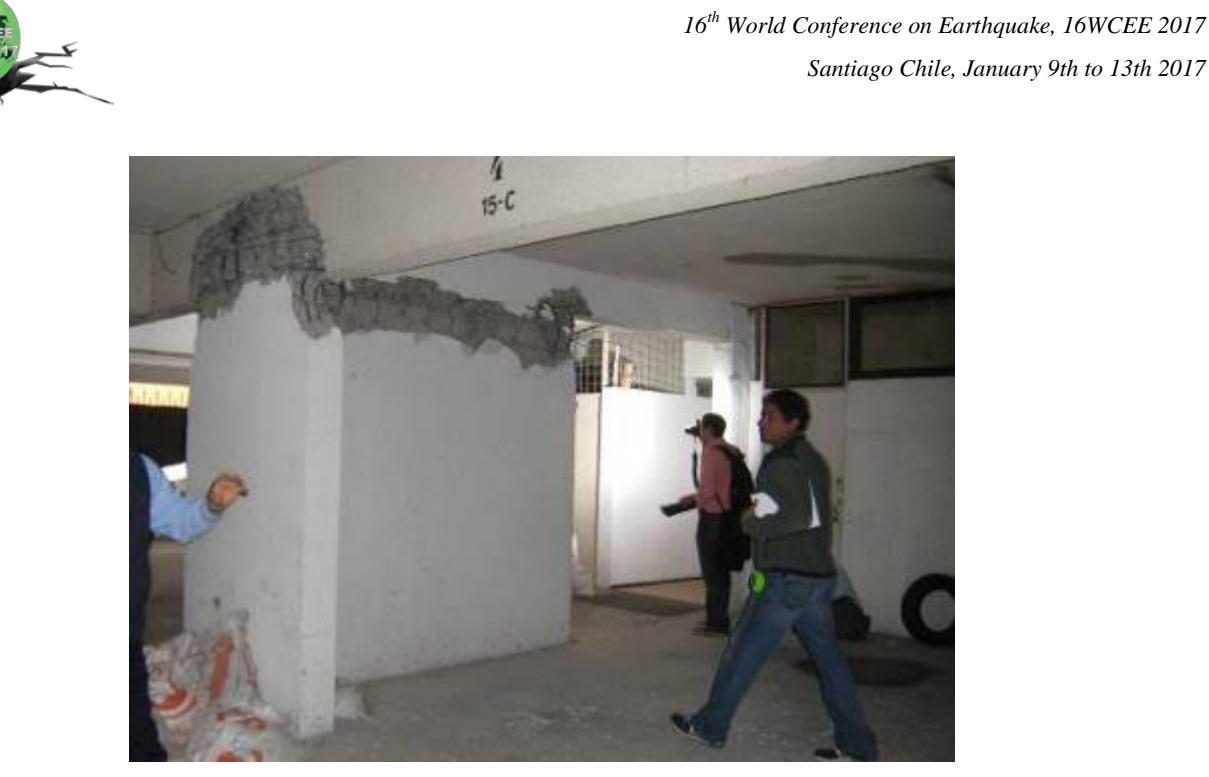
Fig. 4 – Basement-level wall damage from coupling with another wall on the same line (right side of the photo, not fully visible). Coupling caused increased axial tension and compression in the walls. (photo by Joe Maffei)

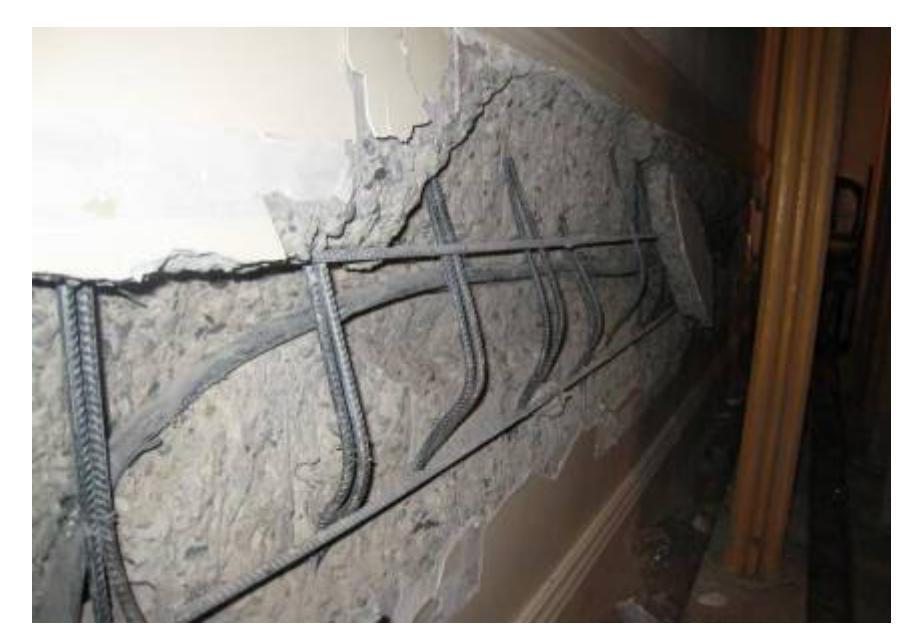
Vertical reinforcement in walls was observed to buckle, along with spalling of concrete cover over the buckled section of reinforcement. Bar buckling and concrete spalling occurred not only at the ends of walls, but also along much of the length of the wall (Fig. 5). Bar buckling is an undesirable behavior because it can lead to irreparable damage. When vertical bars buckle throughout a wall cross-section, the wall can shorten, putting floors out of level. Shortening of up to 40 cm occurred in some walls in the subject earthquake.

Buckling of a vertical reinforcement bar occurs when the bar has insufficient lateral restraint during a load cycle in which it is subjected to compressive strain. It is more likely to occur in bars where there are no cross-ties (transverse reinforcement perpendicular to the face of the wall) to restrain the bar from buckling, or where the diameter of the vertical bar is small compared to the vertical spacing of cross-ties, or when the cover concrete has spalled off. Bars are more susceptible to buckling if the compression demand follows previous cycles of plastic tension strain.

Fig. 5 – Buckling of vertical reinforcement in a concrete wall. (photo by Joe Maffei)

- Provide cross-ties at each vertical bar where plastic tensile strain is expected.
- Ties should be spaced vertically no further than six times the diameter of the vertical bar being restrained.
- The horizontal extent of ties should consider bar tensile strains throughout the cross-section, rather than just the compression neutral axis depth. This requires that in plastic hinge regions of walls, "buckling-restraint" cross-ties are provided over a greater horizontal extent than the length of "special boundary elements" (which provide confinement for compression). Outside of special boundary elements, buckling-restraint cross-ties are needed only to prevent vertical bars from buckling, so they do not necessarily need to meet the same spacing and area requirements as ties in the special boundary elements.

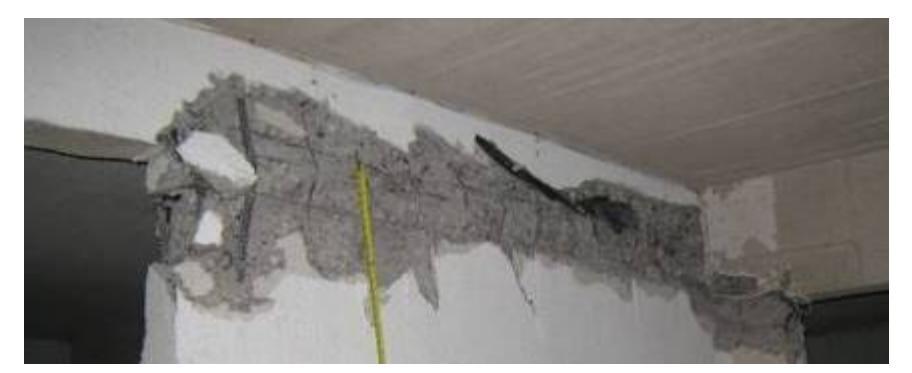
Bar buckling is also more likely to occur in walls whose configuration causes large strain demand. For example, for a given roof displacement demand, longer walls or coupled walls (Fig. 6) have greater vertical strain demand than walls that have smaller length-to-height ratio. Walls with L-shape or T-shape cross-section (Fig. 7) tend to have greater strain demand at the non-flanged end and along the length of the wall because the neutral axis is located closer to the flanged end [4] in comparison to a rectangular wall of the same length and axial stress demand.

Fig. 6 – Buckling of vertical reinforcement in a concrete wall. Coupling with another wall on the same line increases axial strain demand. (photo by Joe Maffei)

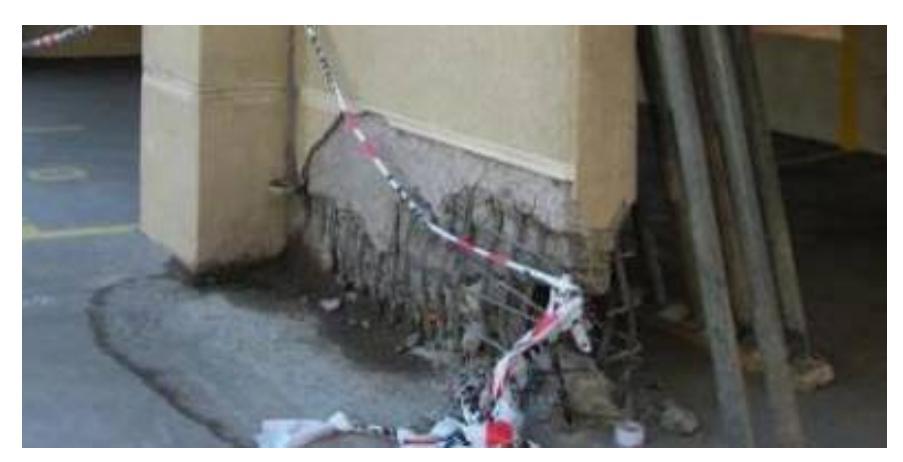
Fig. 7 – Buckling of reinforcement and crushing of concrete in a concrete wall. T-shaped cross-section increases strain demand at the non-flanged end and along the length of the wall. (photo by Joe Maffei)

Similar to bar buckling, concrete crushing is more likely to occur in walls with large strain demand, such as L-shaped and T-shaped walls and coupled walls, as described in the previous section. Concrete crushing in lightly confined or unconfined concrete is initiated when the compressive strain demand (from combined gravity and seismic actions) exceeds the strain at which concrete strength is maximum. Typically, this strain limit is first exceeded at an end of the wall. When strain demand exceeds this limit, the resistance of concrete at that location reduces, requiring load to be shed to the adjacent portion of the wall. The adjacent portion of the wall then also experiences excessive strain demand, and crushing damage propagates along the length of the wall. The resulting damage is localized in a short height of the wall; it is not distributed vertically as typically expected in a ductile flexural hinge.

The damage observed in the subject earthquake typically occurred in walls with essentially unconfined concrete (having few or no hoops or cross-ties), where special boundary elements would have been required according to ACI 318 [6]. In some cases, the area of vertical reinforcement was also relatively small, and the compression reinforcement would make only a modest contribution to compressive resistance, even if it had not buckled. Providing cross-ties to prevent bar buckling would have led to improved performance in some cases. Providing greater area of concrete (greater wall thickness) and/or hoops and cross-ties meeting the spacing and area requirements of "special boundary elements" would have further improved performance in cases with high compression demand.

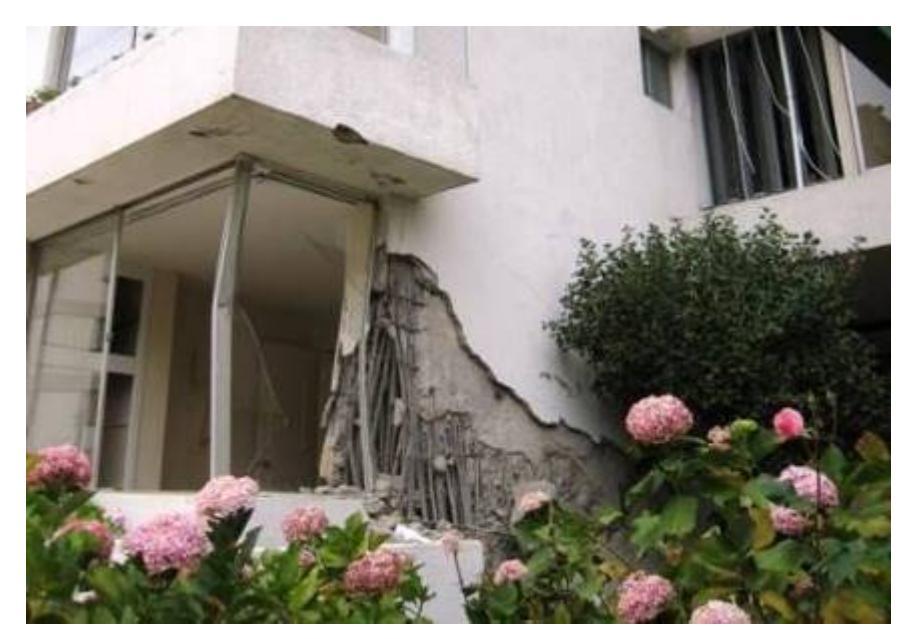
Fig. 8 – Crushing of concrete and buckling of reinforcement at the end of a wall. (photo by Joe Maffei)

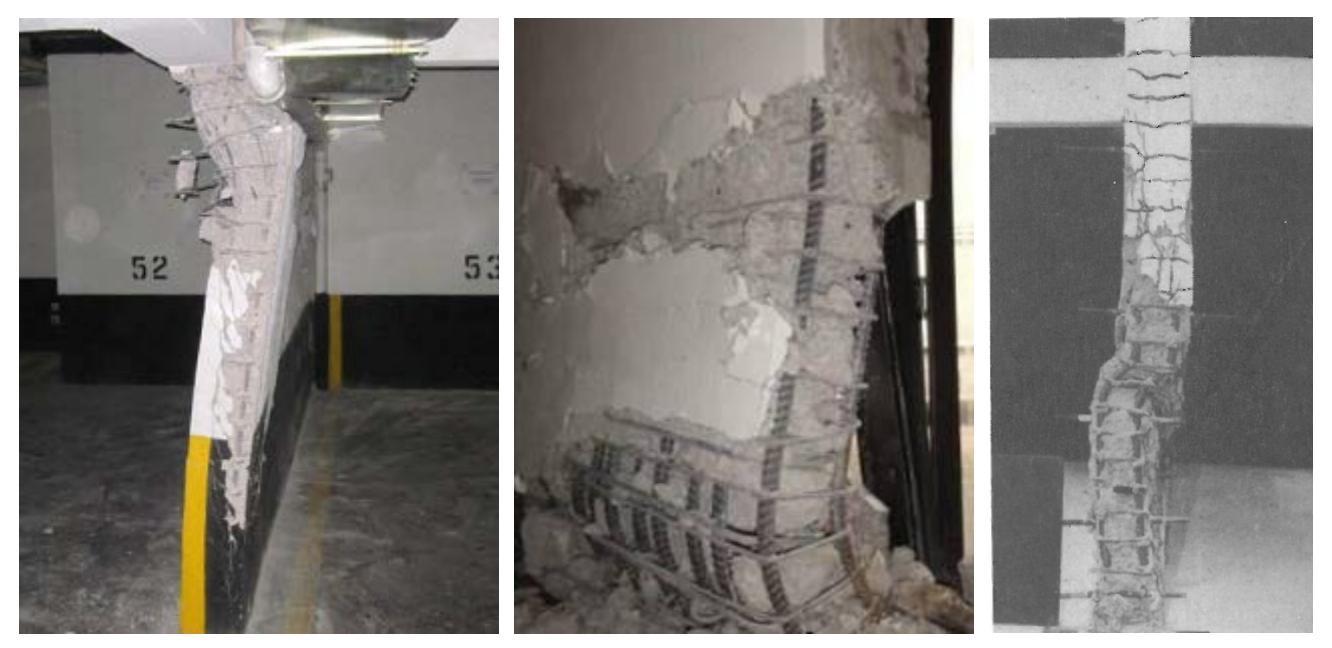
In some instances, concrete walls were observed to be buckled out-of-plane over a portion of the wall length and height (Fig. 9). Prior to the subject earthquake, this type of damage had been observed in experimental tests, but had not been reported in an earthquake. Instances of wall buckling were also reported in the 2011 Christchurch Earthquake. Like bar buckling, it is an undesirable behavior because it can lead to irreparable damage.

Like bar buckling, wall buckling is influenced by plastic tension strain, followed by compression. The slenderness of the wall (thickness compared to buckling height) can be related to the maximum tensile strain that the wall can undergo without buckling instability upon load reversal into compression.

While wall buckling was at first thought to be a more prevalent issue in Chile based on post-earthquake reconnaissance, studies of selected buildings suggest that other behaviors, such as bar buckling and concrete crushing, initiated much of the damage initially considered as wall buckling. This assessment is based on studies of several of the buildings in Chile where wall buckling was reported. For these buildings, the tensile strain expected to initiate wall buckling was found to be greater than the strain demand corresponding to the estimated roof drift in the earthquake, whereas compression demand exceeded that which would cause concrete crushing. Walls were found to be much more susceptible to buckling after concrete cover had spalled. Whether initiated by tensile strain or increased slenderness from concrete spalling, neither behavior mode of wall buckling is desirable compared to stable flexural yielding.

Fig. 9 – Out-of-plane wall buckling. (a) 2010 Chile Earthquake (photo by Jack Moehle). (b) 2011 Christchurch Earthquake [9]. (c) Experiment [10].

• In regions of potential plastic hinging, provide a lower-bound limit for wall thickness at the ends of walls, as a function of the unsupported wall height (between floors). The Uniform Building Code [7] required minimum wall thickness of 1/16 the unsupported wall height, and similar provisions have been added to ACI 318-14. The minimum wall thickness can be provided as a flange or a thickened section at the end of the wall. The thickness requirement could also depend on variables such as unbraced wall length, axial load, neutral axis depth, or expected strain demand. Provisions for alternative analysis methods, such as based on [8] could justify thinner walls in instances where this requirement may be overly restrictive.

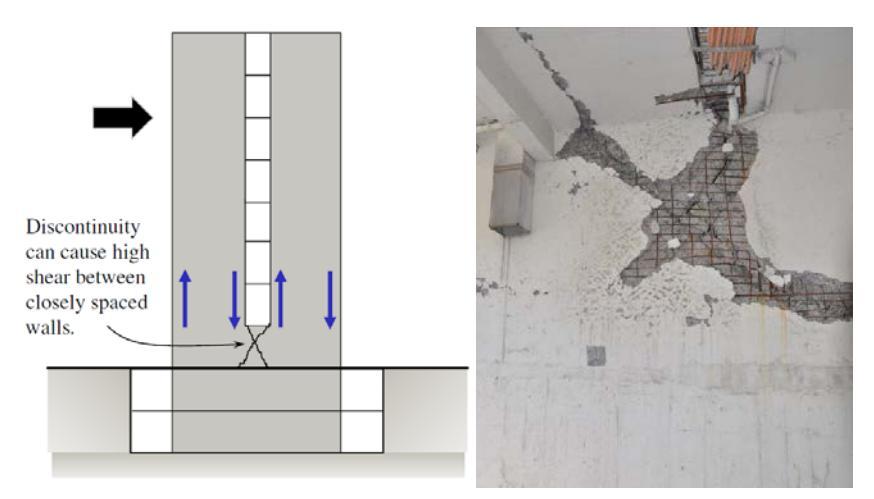
As shown in Fig. 10, when two wall piers land on a basement wall, lateral earthquake forces can cause a stress concentration at the basement wall because the tension end of one wall pier is close to the compression end of the other pier. The stress concentration is greater if the wall piers are close together, and it is less if the piers are further apart. Similar stress concentrations can occur if wall piers are joined at other levels by an element (such as a solid wall at the penthouse level) that is significantly stiffer than the floor slabs or coupling beams that join the wall piers at typical levels.

Fig. 10 – Damage from stress concentration at a solid wall below a series of vertically-aligned openings. (image by Karl Telleen, photo by EERI team)

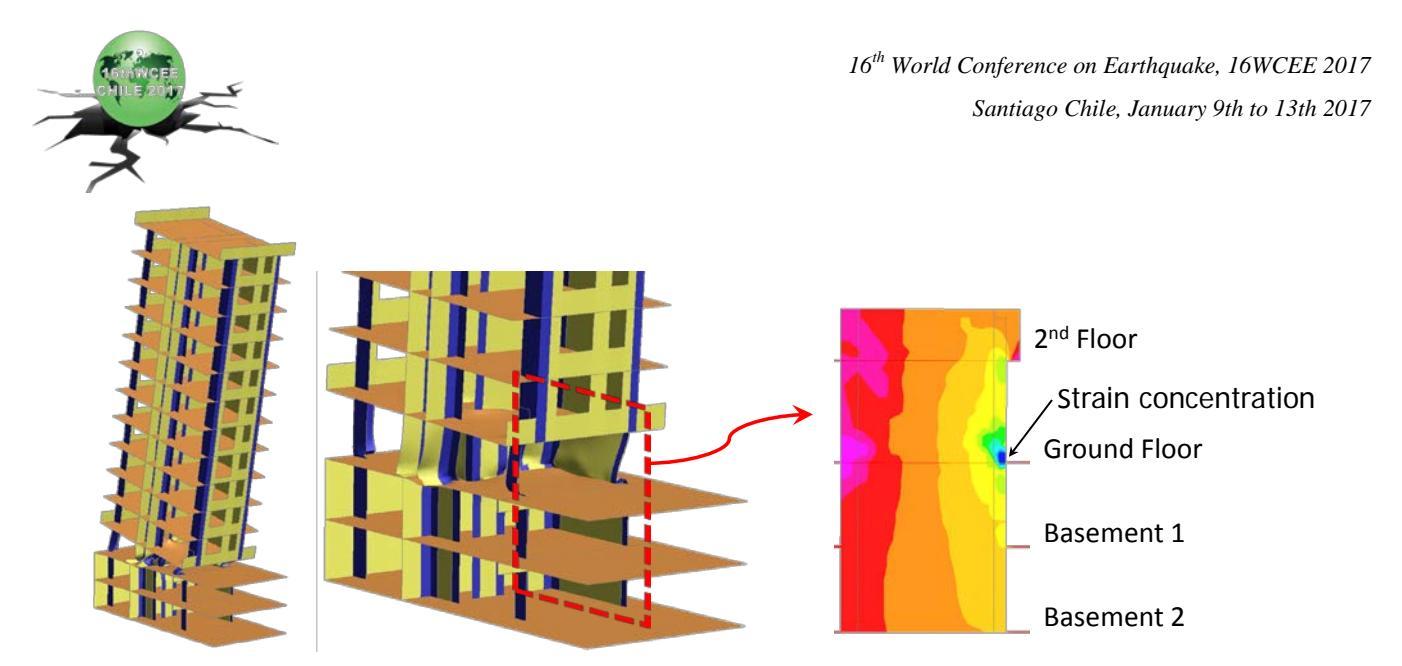
Fig. 11 – Nonlinear finite element analysis of a portion of a residential building that collapsed in the 2010 Chile Eartquake. (images by Michael Willford and Yuli Huang)

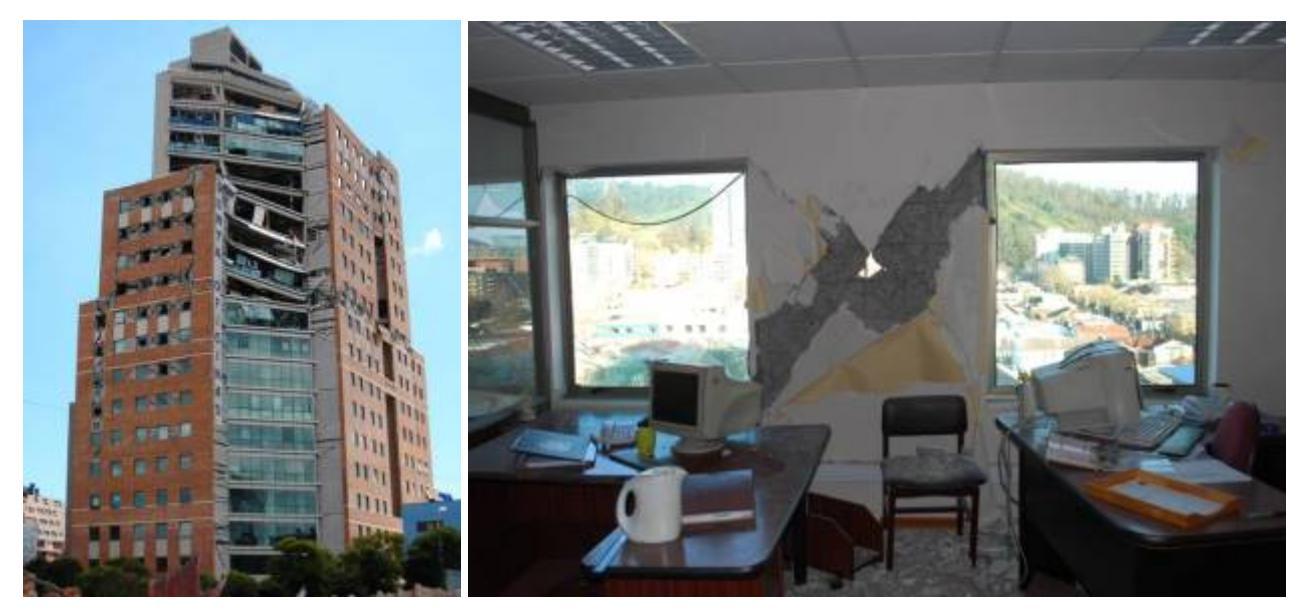
The office building shown in Fig. 12 experienced damage related to several structural discontinuities and plan irregularities. In addition, perimeter concrete walls with punched openings exhibited strong-spandrel weak-pier behavior that contributed to a partial story collapse. Current requirements of ACI 318 have provisions to encourage strong-column weak-beam behavior in moment frames, but similar requirements do not exist for pier-spandrel systems. Plastic mechanism analysis of a portion of the damaged building (Fig. 13) indicates that the observed behavior of the pier-spandrel system is predictable using hand calculations.

Fig. 12 – Office building with shear damage to wall piers, including partial story collapse. (a) photo by Joe Maffei, (b) photo by EERI team.

• Evaluate the strength hierarchy and expected behavior of pier-spandrel systems, and design to achieve strong-pier weak-spandrel behavior.

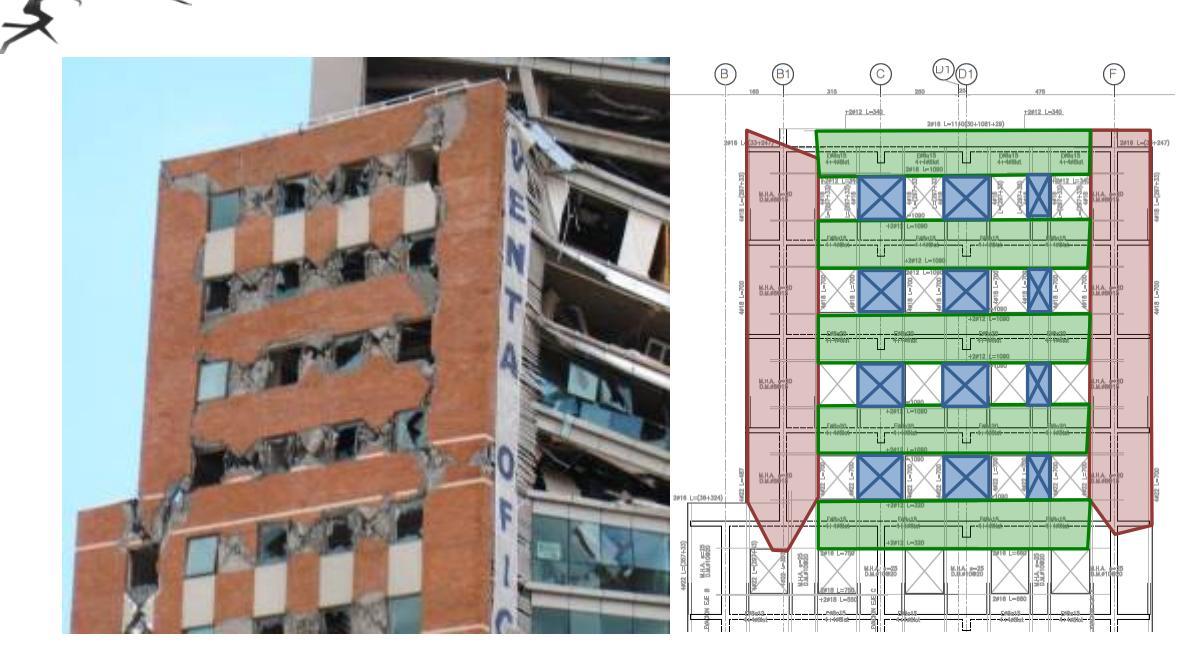
Fig. 13 – Plastic mechanism analysis of the pier-spandrel system indicates that the behavior observed in (a) is predicable using hand calculations to compare pier strength vs. spandrel strength as indicated in (b). (photo by Joe Maffei, image by Ady Aviram)
