# EFFECTIVE VISCOUS DAMPING IN REINFORCED CONCRETE BUILDINGS: ESTIMATION BASED ON MEASURED STRONG MOTION RESPONSE

P. Hesam<sup>(1)</sup>, A. Irfanoglu<sup>(2)</sup>, T. J. Hacker<sup>(3)</sup>

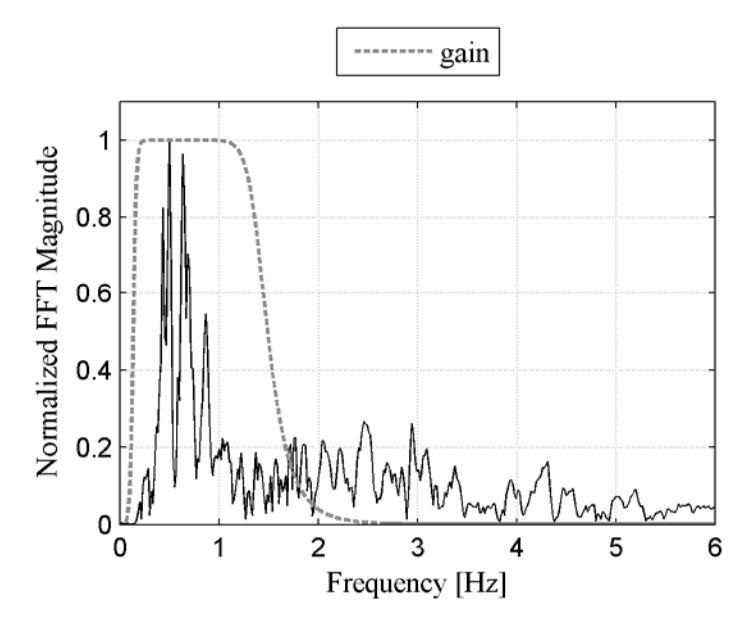
Figure 1 shows the Fourier spectral response of the acceleration measured at the roof level during 1994 Northridge earthquake as well as the band-pass filter applied to it. The frequency with the maximum Fourier amplitude represents the frequency of the dominant mode, i.e. first mode, of response. The inverse of the dominant frequency is called the "apparent period" of the structure by Cecen [8]. In this study, the apparent period is used to estimate the effective viscous damping of the structure.

Figure 1 – 7-story hotel (1994 Northridge GM) – North-South direction – Fast Fourier Transform

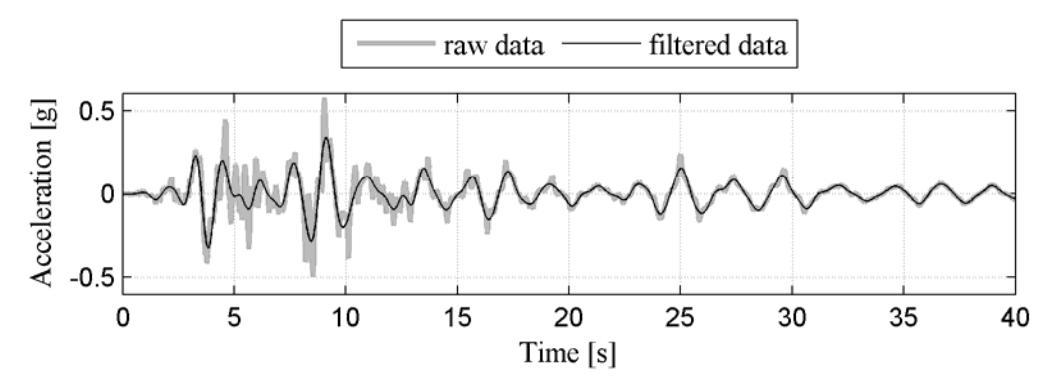
Figure 2 – 7-story hotel (1994 Northridge GM) – North-South direction – Ground acceleration

Figures 2 and 3 show the ground acceleration and the roof acceleration responses. Figure 4 shows the roof velocity response relative to ground. Figure 5 shows the roof displacement response relative to ground. Figure 6 shows the estimated mass-normalized damping ratio.

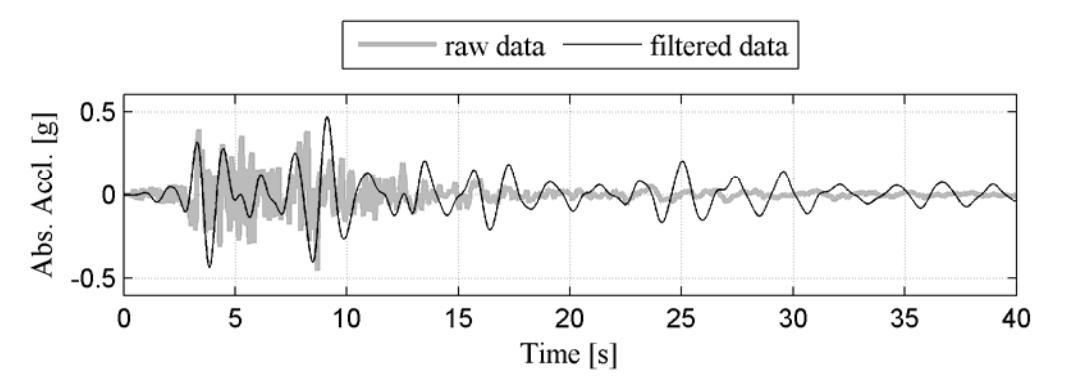
Figure 3 - 7-story hotel (1994 Northridge GM) - North-South direction - Roof acceleration

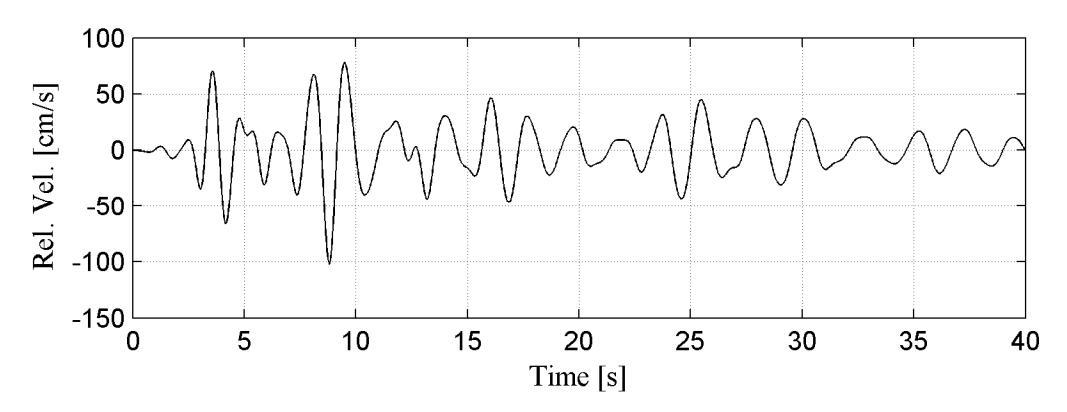
Figure 4 - 7-story hotel (1994 Northridge GM) - North-South direction - Roof velocity relative to ground

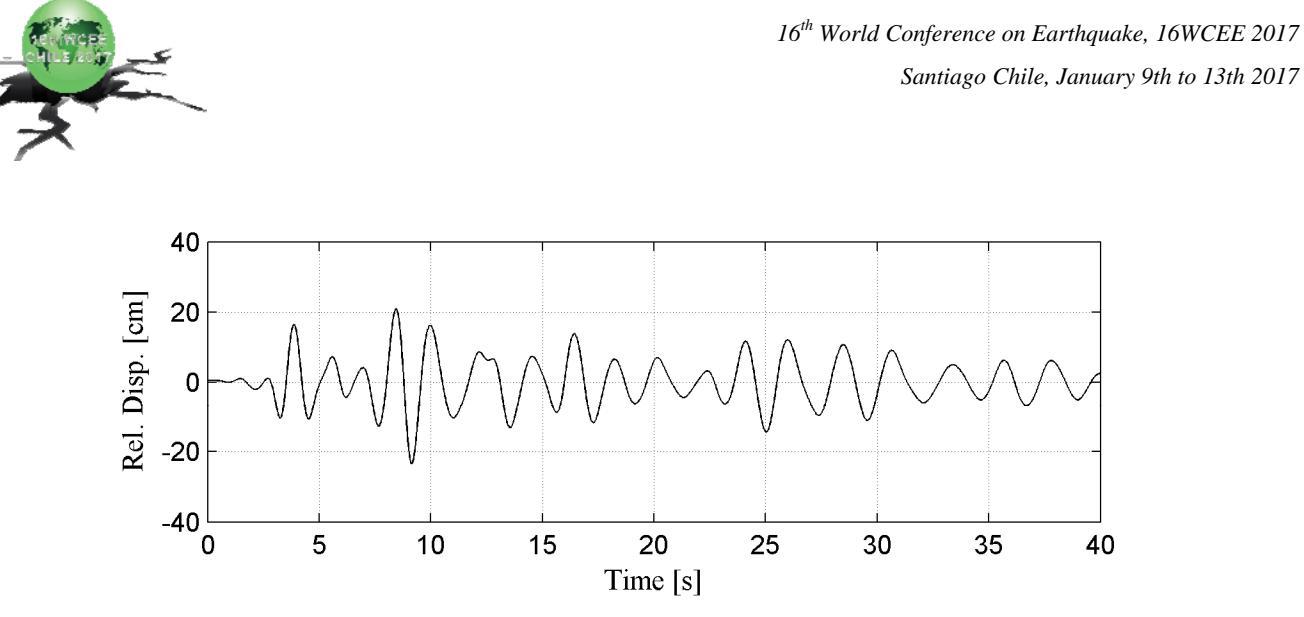
Figure 5 – 7-story hotel (1994 Northridge GM) – North-South direction – Roof displacement relative to ground

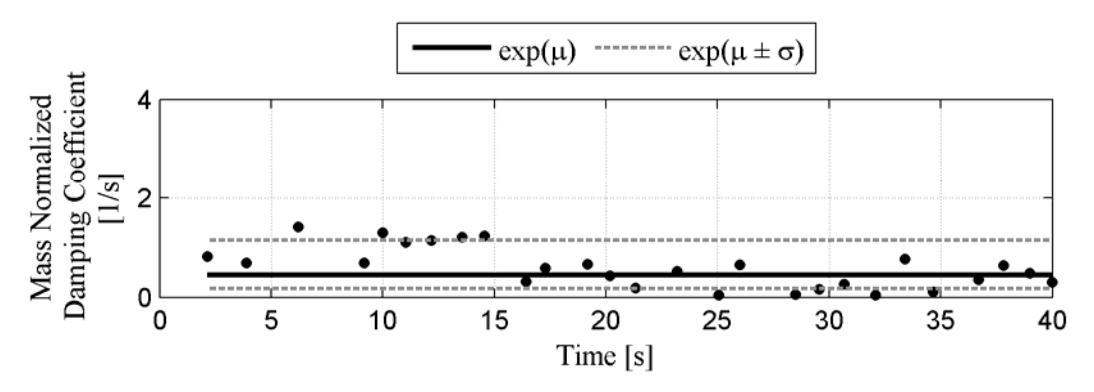
Figure 6 – 7-story hotel (1994 Northridge GM) – North-South direction – Mass-normalized damping coefficient. The log-normal mean as well as one standard-deviation range for the estimates are shown.

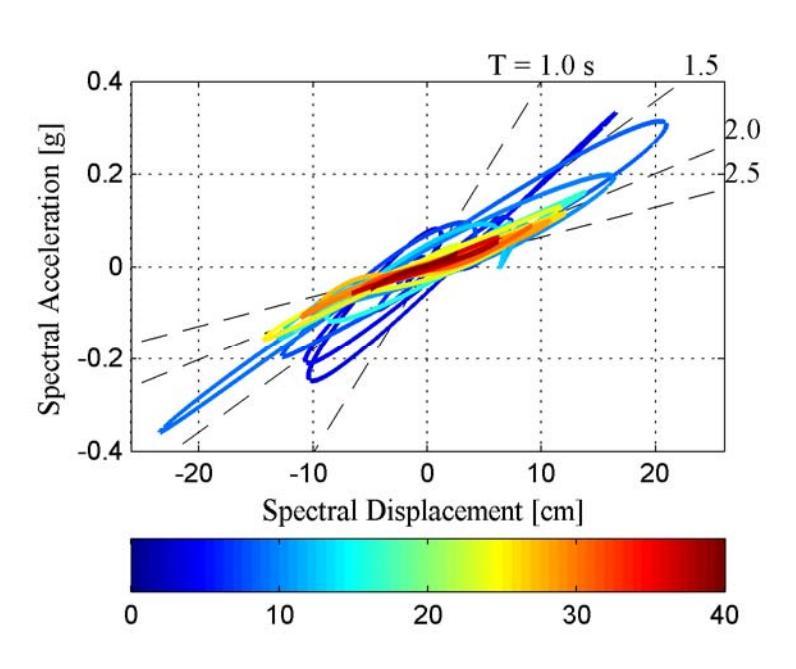
Figure 7 - 7-story hotel (1994 Northridge GM) - North-South direction - Hysteresis

Figure 7 shows the spectral displacement versus spectral acceleration of the roof. The mass participation factor is assumed to be 130%. Figure 8 shows the spectral displacement versus spectral acceleration of the roof, regardless of the direction of motion. The color bars in Figures 7 and 8 indicate, in seconds, the time of the response from the start of the motion.

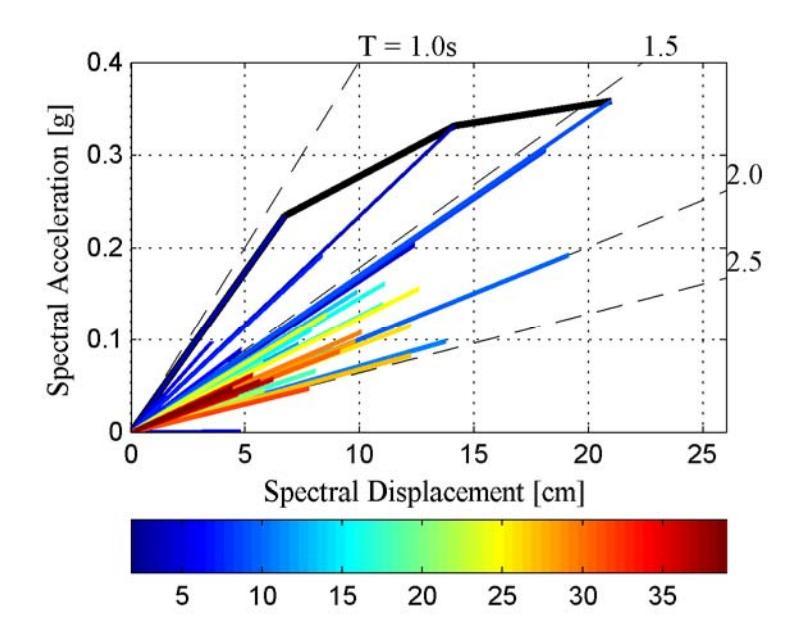
Figure 8 – 7-story hotel (1994 Northridge GM) – North-South direction – Force-displacement curve (capacity curve) envelops local peak responses, shown in spectral acceleration-spectral displacement.
