Paper N° 2792

EARTHQUAKE DAMAGE RESULTING FROM SLAB-ON-GROUND TRENCHING

16th World Conference on Earthquake Engineering, 16WCEE 2017 Santiago Chile, January 9th to 13th 2017

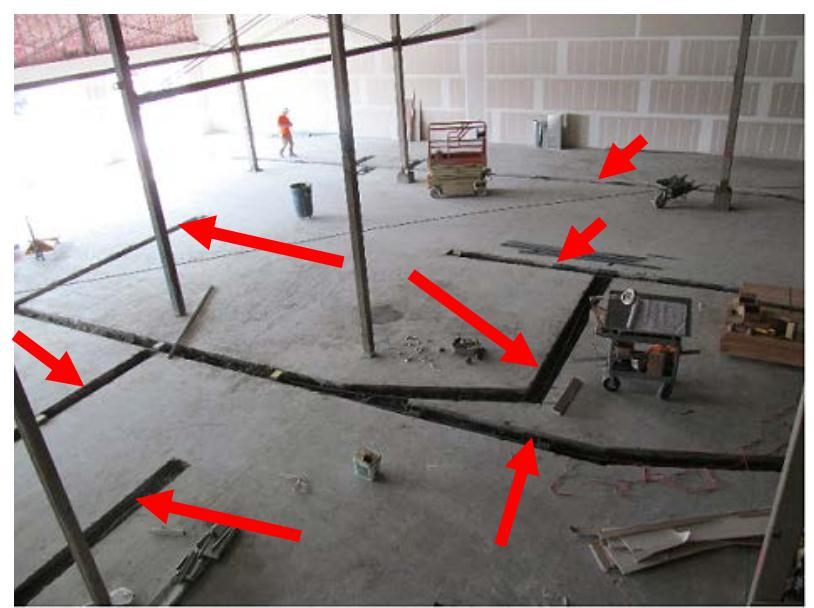
Fig. 1 - Trenching through existing slab-on-ground

Trenching through concrete slabs-on-ground is a common practice performed to place mechanical or electrical utility lines underneath existing slabs-on-ground. A typical trenching procedure is to full-depth sawcut the concrete slab-on-ground, including any embedded reinforcing, and remove the concrete from the area between sawcuts. The trenching can result in long strips of slab removal that can run from one end of a building to another; often the trenches intersect and branch out, creating a patchwork of slab removal (Fig. 1). After slab removal, the subbase and subgrade is removed and the pipes or conduits are placed. The trench is then backfilled with soil and new concrete is cast.

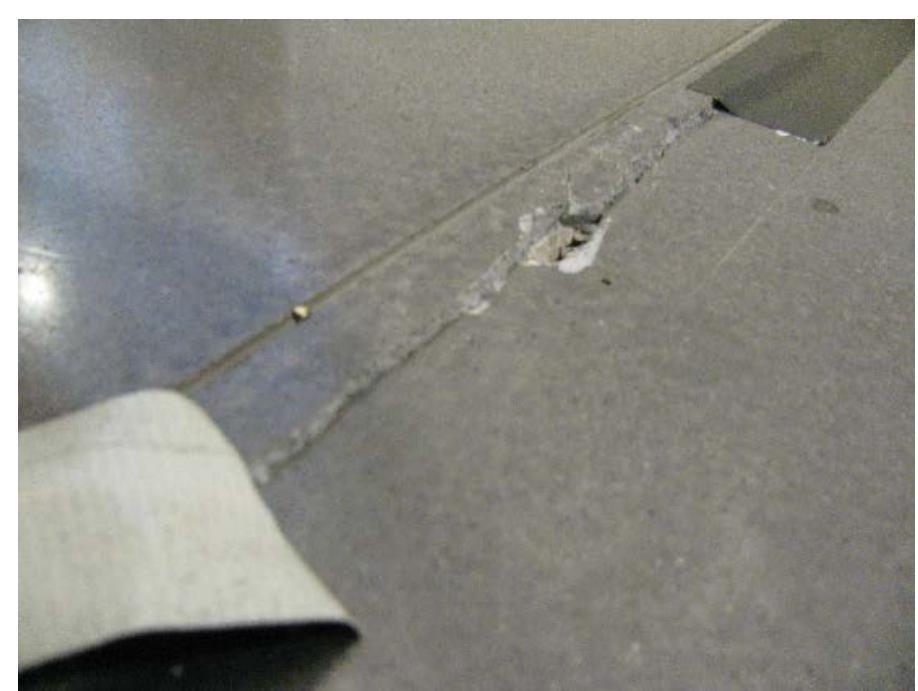
Fig. 2 - Vertical offsetting at a slab-on-ground joint due to earthquake-induced settlement

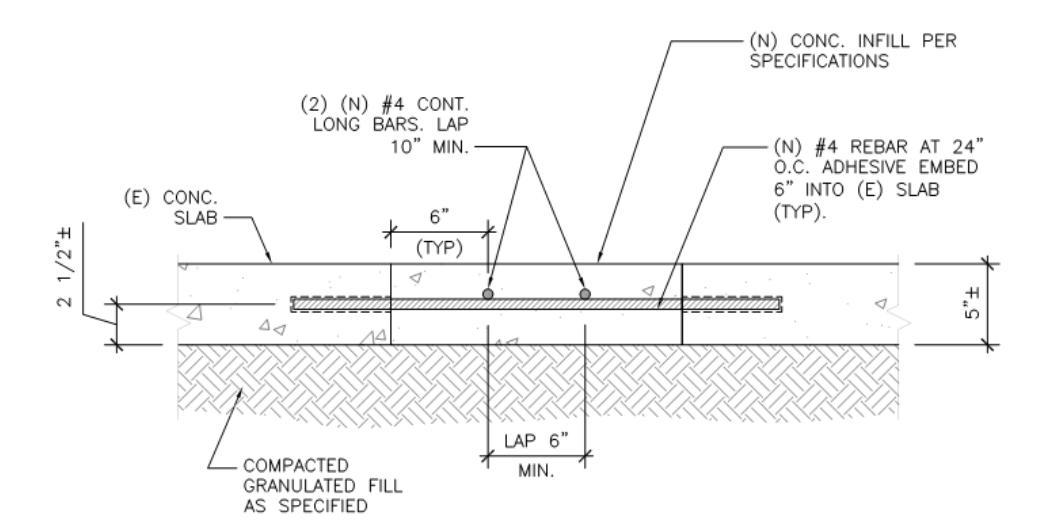
Fig. 3 – First example structural slab-on-ground trenching patch detail

The detail in Fig. 3 provides information on the patch reinforcing and how it is attached to the existing slab-on-grade. Proper attachment of the new reinforcement to the existing slab with epoxy dowels ensures that forces are transferred across the sawcut joint. However, this detail does little to address the existing subbase/subgrade conditions and does not make any efforts to match the newly placed material with existing. While there are numerous elements of this detail that are intended to address force transfer at the sawcut joint, this could be improved by requiring the joint to be roughened prior to new concrete placement. Furthermore, the strength and type of the concrete infill is not stated, however, this can have a significant effect on the performance of the patch.

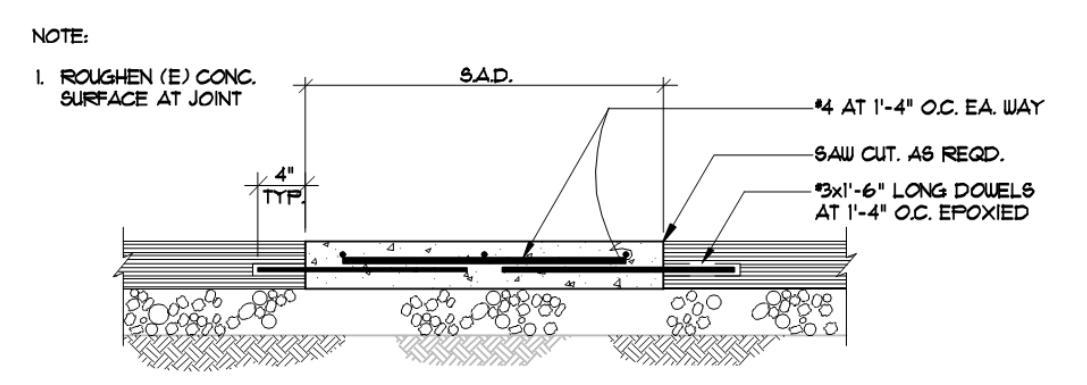
Fig. 2 – Second example structural slab-on-ground trenching patch detail

The detail in Fig. 4 provides information for new dowels to be placed and attached to the existing slab-ongrade, which will provide the transfer of forces across the sawcut joint. Information is also provided for the reinforcing of the patch itself. A note is included in this detail that indicated to roughen the surface of the concrete which will aid in the existing concrete and patch behaving more integrally. In this detail, the steel that is placed across the sawcut joint is a dowel, which may imply a smooth bar. A smooth bar does not have the same ability to impart loads into the concrete when in tension and therefore the joint is inherently weaker in tension and bending moment than if a deformed bar were used. In a fully supported condition, shear transfer through the joint would be the primary concern, however, in areas of liquefaction or differential settlement the slab may be required to span a void, thus needing to have a moment capacity. The detail shows the subbase/subgrade and shows that it is the same in the area under the patch as the adjacent, however, does not explicitly indicate what it is.

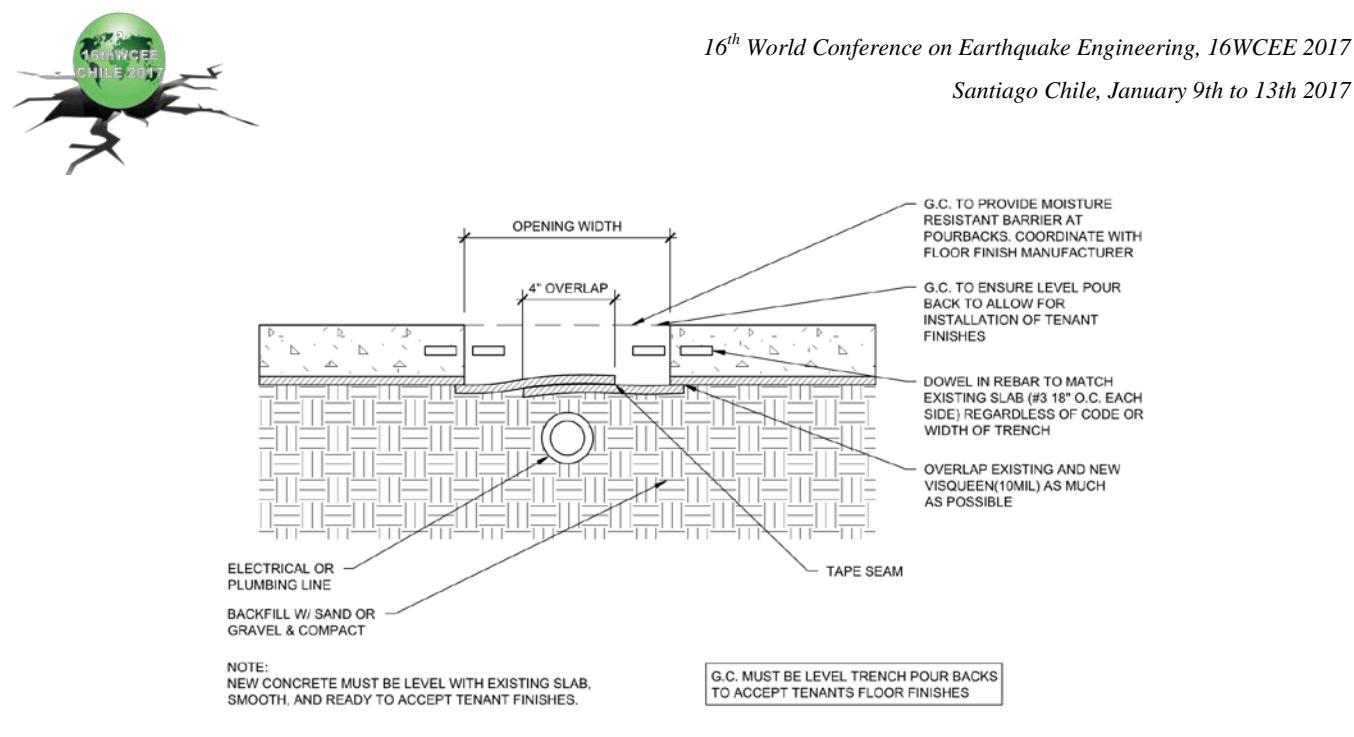
Fig. 5 – Third example structural slab-on-ground trenching patch detail

This detail addresses the continuity and patch of the under-slab moisture barrier, something that previous details did not. The backfill in this detail is indicated as compacted sand or gravel which may or may not match the existing soil profile. The detail also appears to show that the bottom of the patch is inset, therefore making it thinner, and inherently weaker, than the surrounding areas. Surprisingly, this detail also provides no longitudinal reinforcement in the direction of the trench; this is even with a width of the trench that sets no maximum.

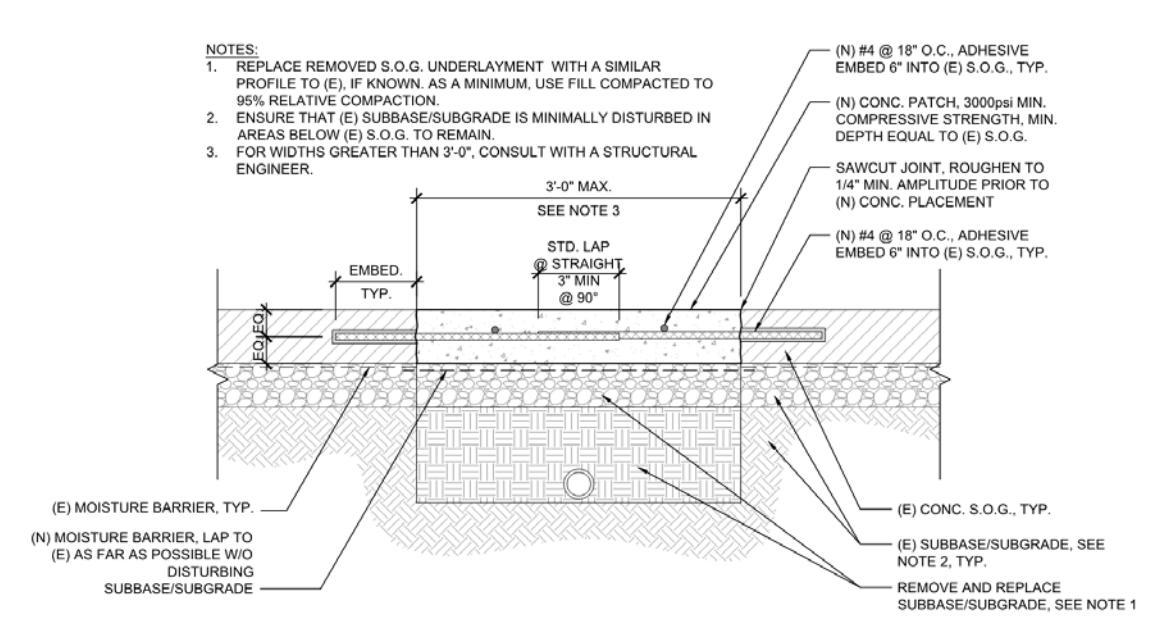
Fig. 3 – Suggested slab-on-ground trenching patch detail

Considering all the details studied, the detail in Fig. 6 below is a suggestion of a standard generalized detail that could be used in various projects, including in high seismic zones with liquefaction and differential settlement risk. The detail presents the subbase/subgrade in general terms, however, requires that replacement of the existing system in kind, if it is known. If the existing system is not known, the detail gives a minimum guideline. The moisture barrier, if exists, is shown to be patched prior to placement of the concrete. A note is included indicating that the depth of the concrete patch must be at least the same depth as the existing concrete to ensure that a weak point is not created. Furthermore, a minimum concrete strength is indicated to ensure that the quality is acceptable. Embedded deformed bars and a significantly roughened surface of the sawcut ensures that there is a good bond and force transfer through the joint. A maximum width is established for the trench and a note is added indicating that a structural engineer should be retained for larger trenches. This ensures that the patch is designed for project specific conditions if it is large.
