CYLIC TESTING OF REINFORCED CONCRETE STRUCTUAL WALLS WITH ORDINARY BOUNDARY ELEMENT DETAILING

C. Motter⁽¹⁾, J. Wallace⁽²⁾

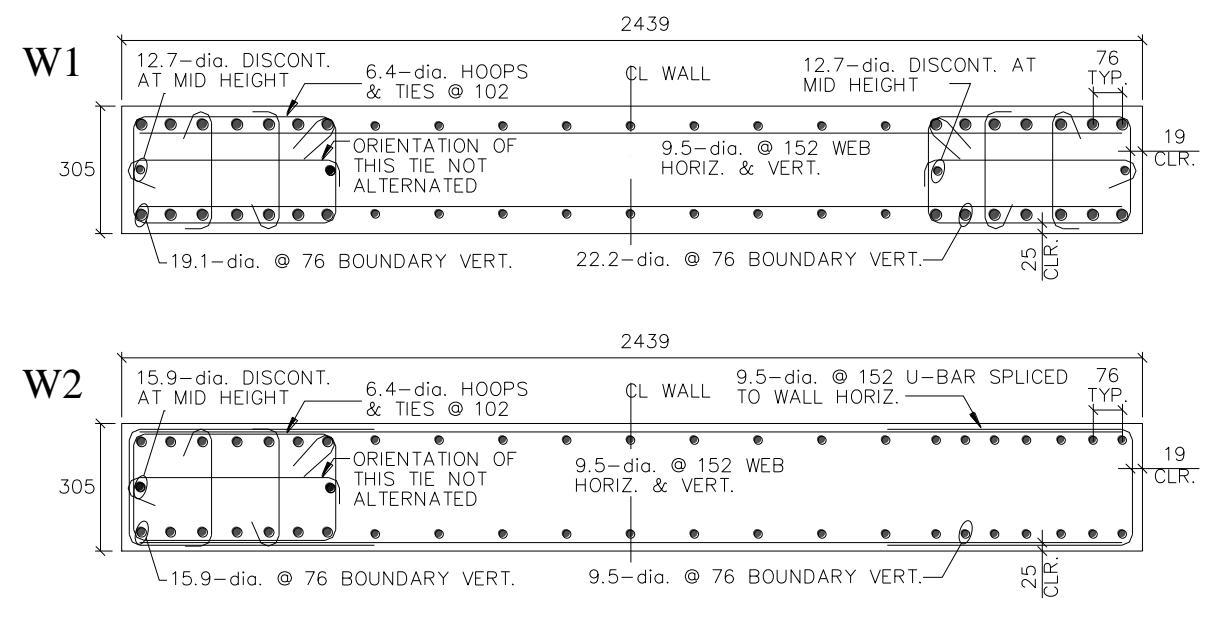
Fig. 1 - Wall Cross-Sections (Dimensions in millimeters)

Two specimens, referred to as W1 and W2, were designed and tested in the UCLA Structural Earthquake Engineering Laboratory. The test specimens were designed to be roughly one-half-scale based on an assumed prototype. The cross-sections for both walls were rectangular with an asymmetric layout of reinforcement at the boundaries (Figure 1). The primary test variables were the quantity of wall boundary longitudinal and transverse reinforcement, which led to variation in the longitudinal and transverse reinforcement ratios and the s/d_b ratio, which is the ratio of the vertical spacing of boundary transverse reinforcement, s, to the bar diameter of the boundary longitudinal reinforcement. The s/d_b ratio indicates an increased likelihood for buckling of boundary longitudinal reinforcement. The s/d_b ratios at each end of the wall were 5.3 and 4.6 for W1 and 6.4 and 16.0 for W2; therefore, the likelihood of bar buckling is significantly increased at one boundary of W2 relative to the other wall boundaries.

At both wall boundaries of W1 and at one boundary of W2, reinforcement was provided to satisfy provisions for an intermediate level of wall boundary transverse reinforcement (i.e., for an OBE), which requires 203-mm maximum vertical spacing of this reinforcement. Assuming 13-mm diameter hoops and ties at 203-mm spacing for the prototype led to 6.4-mm diameter hoops and ties at 102-mm spacing for the test specimens. At one boundary of W2, light boundary reinforcement excluding hoops and ties was provided. In regions of the United States expected to be subjected to strong ground shaking, the upper-level stories in a typical high-rise wall are often lightly-reinforced, sometimes without boundary hoops and ties. Per ACI 318-11 Section 21.9.6.5(a), minimum wall boundary transverse reinforcement is permitted when the ratio of longitudinal reinforcement at the wall boundary is less than or equal to $400/f_y$ (f_y in ksi) or $2.76/f_y$ (f_y in MPa. This led to the use of 14 - 9.5mm Grade 60 ($f_y = 60$ -ksi = 414-MPa) longitudinal bars at the W2 wall boundary ($\rho = 0.0061$) with minimum

boundary transverse reinforcement. Per ACI 318-11 Section 21.9.6.5(b), this minimum reinforcement consisted of 9.5-mm U-bars engaging wall boundary longitudinal reinforcement and spliced to the 9.5-mm web transverse reinforcement at both ends of the wall. For W1, the horizontal web bars were embedded (without hooks) into the cores of the ordinary boundary elements. It is noted that for both W1 and W2, longitudinal and transverse wall web bars were selected to meet the code minimum reinforcement ratio, which is $\rho_l = \rho_t = 0.0025$ per ACI 318-11 Section 21.9.2.1.

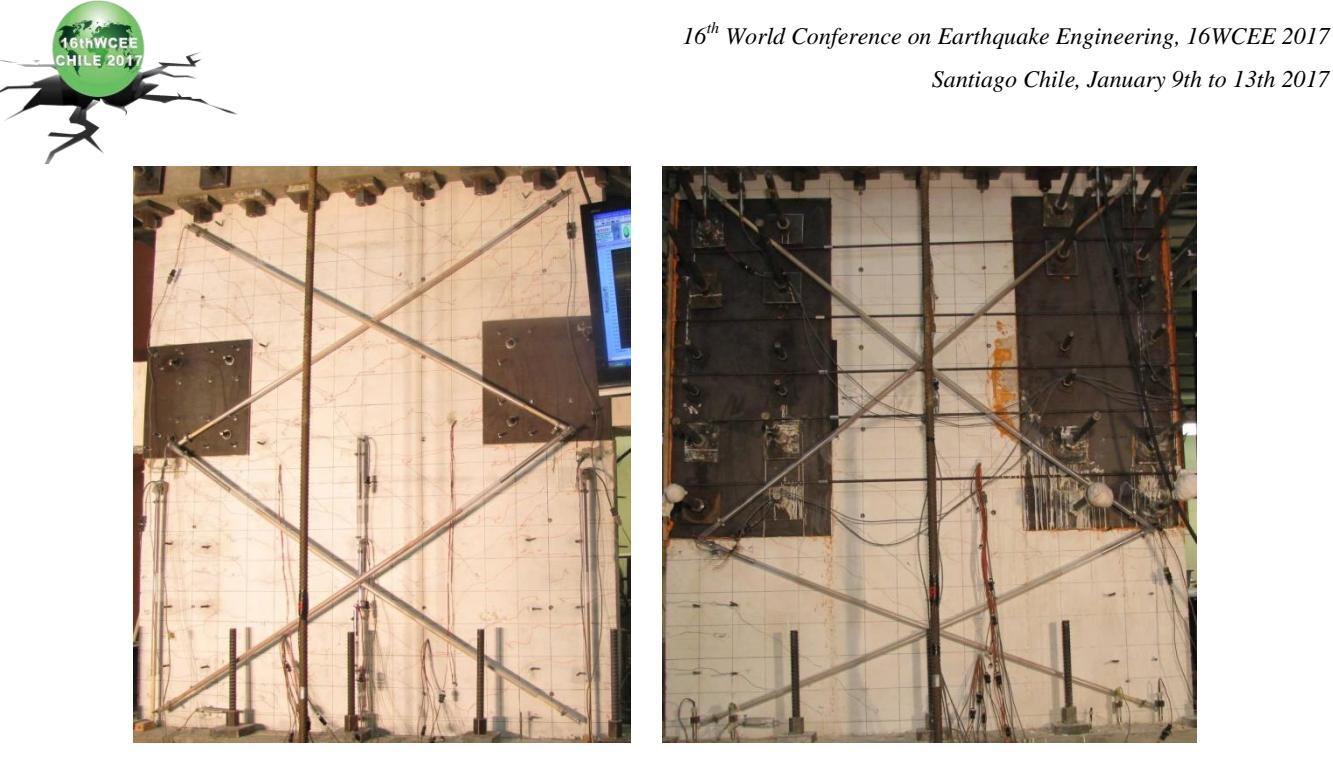
Fig. 2 – Photo of Repairs to Walls Prior to Testing (Dimensions in millimeters)

Both of the walls tested in this study were used previously for testing of steel reinforced concrete (SRC) coupling beams [7]. This resulted in damage at the beam-to-wall connections, which were located slightly above mid-height of the walls at each end. This damage was repaired prior to testing of the walls, as shown in the photos in Figure 2. The repairs at this region included removal of the embedded steel beams for W2, removal of damaged concrete, grouting of damage regions, and the use of steel plates and post-tensioned threaded rods to provide confinement and prevent spalling of concrete. Because the coupling beam centerlines were located 1676-mm above the base of the 2438-mm long walls, a successful repair was not expected to improve the post-yield performance of the specimens, as damage for the flexure-controlled walls was expected to concentrate at the base of the walls. During prior testing of the SRC coupling beams, demands at the base of the wall produced flexural cracking, but generally did not cause yielding of wall boundary longitudinal reinforcement.

Prior to testing W1 and W2, high-strength (~69.0-MPa = 10-ksi) hydro-stone grout was used to repair wall damage that occurred during coupling beam testing (Motter et al, 2014). Each test specimen included a construction joint that was located 1905-mm above the base of the wall, i.e., at the top of the coupling beams that were tested by Motter et al (2014). Based on average values from tests on 152-mm x 305-mm concrete cylinders, the tested concrete strength, $f'_{c,test}$, for the $f'_c = 31.0$ -MPa mix was 50.1-MPa and 47.7-MPa for concrete below and above the construction joint, respectively, for W1 and 40.7-MPa and 39.7-MPa for concrete below and above the construction joint, respectively, for W2.

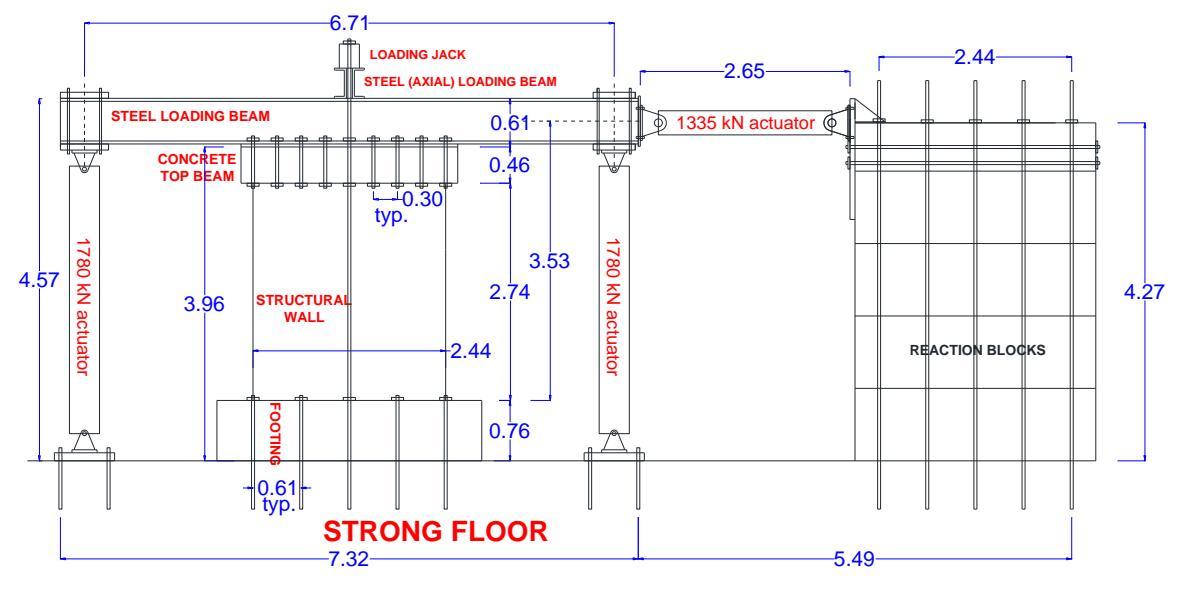
Fig. 3 – Test Set-Up (Dimensions in millimeters)

Using the test set-up shown in Figure 3, both specimens were tested at the University of California, Los Angeles Structural/Earthquake Engineering Testing Laboratory. The specimens were subjected to a constant axial (gravity) load of 1220-kN ($0.053A_gf'_c$, corresponding to $0.032A_gf'_{c,test}$ for W1 and $0.040A_gf'_{c,test}$ for W2) and quasi-static, reversed-cyclic lateral loading and overturning moment applied at the top of the wall. Two 1780-

kN (max.) actuators with +/- 457-mm stroke were used to apply wall overturning moment. The wall lateral shear force (and additional moment) was applied by a 1335-kN (max.) actuator with +/- 305-mm stroke and was reacted by the reaction blocks. The reaction blocks were stacked, grouted at the interfaces, and post-tensioned to the laboratory strong-floor with 32-mm diameter high-strength post-tensioning rod. The "concrete top beam" refers to a thickened portion at the top of the shear wall that was poured continuously with the upper wall. The concrete top beam facilitated anchorage to the steel loading beam that was positioned across the top of the specimen. The concrete top beam was post-tensioned to the steel loading beam, and the footing was post-tensioned to the laboratory strong floor. To prevent out-of-plane displacement or torsion of the specimen during testing, a steel brace (not shown) was attached to the steel loading beam. Loading jacks at the top of the steel loading beam were used to apply axial compressive load to the top of the wall. Additional axial load was applied by the two vertical actuators.

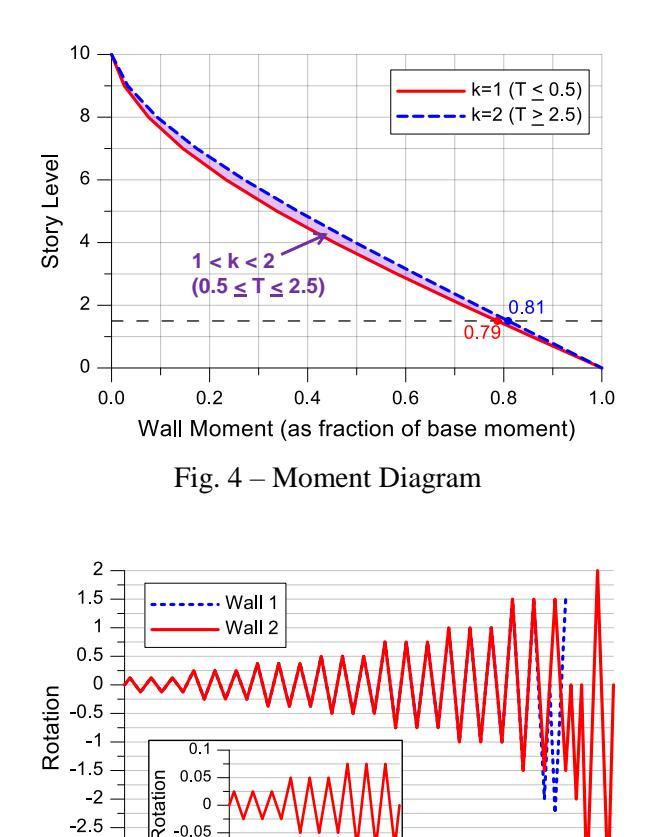
Fig. 5 – Loading Protocol

Both tests were displacement-controlled using the plastic hinge rotation measured by a pair of LVDTs, located near opposite ends of the wall, spanning from the footing to the assumed plastic hinge length. The assumed plastic hinge length was taken as $l_w/2=1219$ -mm (where l_w is the wall length) for the first specimen. For the second specimen, this length was taken to the base of the steel plates used for repair, as the presence of the steel plates was expected to prevent the spread of plasticity into the repaired region. The bottom of each steel plate was located $3l_w/8=914$ -mm above the base of the wall. The loading protocols for both tests are shown in Figure 5. Relative to W1, additional low-level cycles were carried out for W2, as yielding was expected to occur at a smaller rotation due to the lower yielding moment associated with the reduced quantity of wall boundary longitudinal reinforcement. The loading protocols were identical between 0.125% and 1.5% rotation, except for the inadvertent loading from -0.25% rotation to -1.15% rotation (at a rate of roughly 0.07% rotation per second) during the first loading cycle at 0.25% rotation for W2. Three cycles were carried out at all loading increments

through 1.5% rotation. Beyond 1.5% rotation the testing protocol was based on the observed damage and response of the test specimens. Failure initially occurred at one wall boundary for both specimens. In an effort to reduce the likelihood of fracture of the longitudinal bars at this boundary, asymmetric loading was then used in order to limit the level of compression applied to the boundary that had failed. This was done in an effort to generate failure at the other boundary of the specimen, noting that fractured bars would reduce the compression demand on the boundary that had not failed and reduce the likelihood that this failure could be achieved.

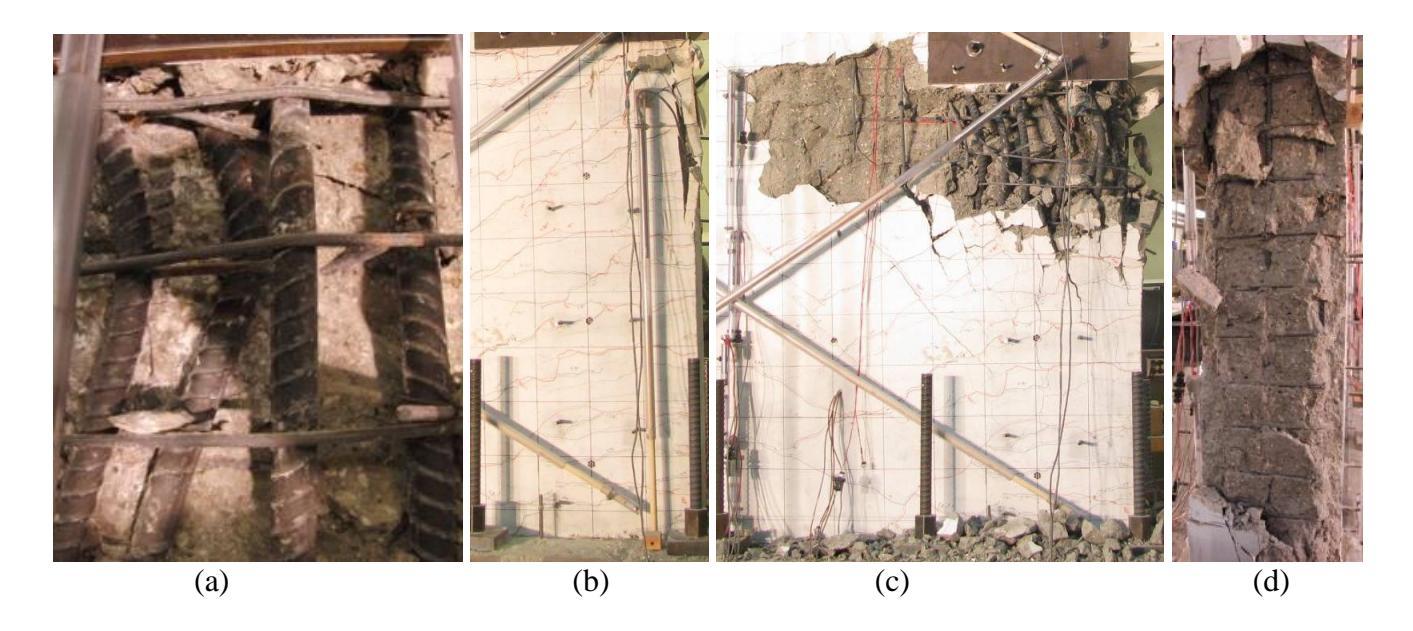
Fig. 6 – Damage photos for W1 at: Boundary with $s/d_b = 5.3$ at: a) +1.5% rotation, 1st cycle (north face); b) +1.5% rotation, 1st cycle (south face); c) +1.5% rotation, 3rd cycle. Boundary with s/db = 4.6 at: d) -2.25% rotation

For both walls, damage concentrated beneath the repaired region of the wall (Figure 6 and Figure 7) rather than at the base. This was due to pre-existing damage, noting that the applied wall demands were largest at the base. For W1, damage concentrated at the wall boundary with a lower s/d_b ratio (i.e., at the wall boundary with 22-mm diameter longitudinal reinforcement), which was likely the result of pre-existing damage, noting that this wall boundary was damaged more heavily during previous testing (Motter et al, 2014). For W2, damage predominantly occurred at the wall boundary with a higher s/d_b ratio (i.e., with 9.5-mm diameter longitudinal reinforcement). With reference to the loading protocol shown in Figure 5, positive loading put the damaged wall boundary into compression for both W1 and W2.

For W1, damage at the wall boundary with the lower s/d_b ratio was observed to occur at one face prior to the other, likely due to pre-existing damage. At one face of this boundary, minor damage was evident at 0.375% rotation with longitudinal bar bucking initiating during the first loading cycle at 1.0% rotation. Bar buckling at this face had become extensive after the positive excursion of the first loading cycle at 1.5% rotation (Figure 6a) but was not observed at the other face of this boundary element (Figure 6b). After the 3rd cyclic excursion to 1.5% rotation in the positive direction, significant bar buckling and spalling and crushing of some core concrete was observed (Figure 6c). At the other wall boundary, damage was much less extensive. Large splitting tensile cracks (~5-10-mm crack widths) and some spalling of cover concrete was observed after the first loading cycle

at 1.5% rotation. After the completion of the negative excursion to 2.25% rotation, significant spalling of cover concrete was observed but bar buckling was not evident (Figure 6d). Bar buckling at this boundary was eventually observed during a final negative excursion to 4.5% full-height rotation. During this final excursion, the corresponding plastic hinge rotation was unknown and not indicated on the plot in Figure 5, as some sensors were removed to avoid damage from spalling concrete.
