POST-SEISMIC CAPACITY OF DAMAGED AND REPAIRED REINFORCED CONCRETE PLASTIC HINGES EXTRACTED FROM A REAL BUILDING

Abstract

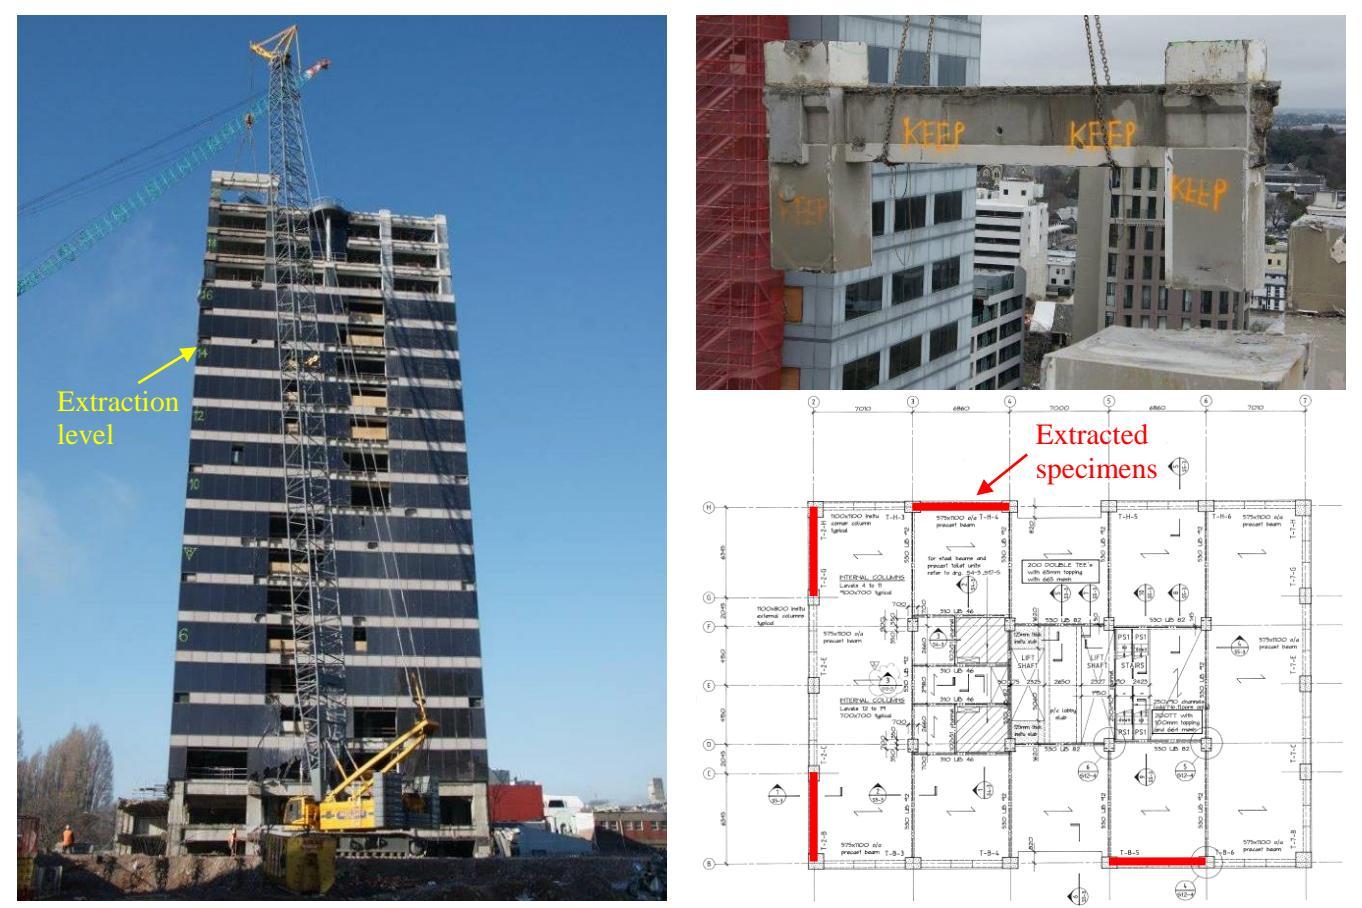
Figure 1 – Elevation of the PWC building during the deconstruction process (left); extraction of one of the "H frames" (upper-right); typical floor plan view at the upper levels (lower-right), red lines indicate locations where the specimens were taken out of the 16th floor level.

The PWC building (see Figure 1) was a 22-storey structure located on Armagh Street in the Christchurch's Central Business (CBD) area. The lateral system comprised precast perimeter reinforced concrete (RC) frames with wet joints (typical of emulation of cast-in-place approach) in the beams at mid-span. The gravity system comprised precast double-tees with a reinforced concrete topping, supported on steel beams and concrete columns. The foundation system consisted of raft foundations. It was designed following capacity design principles and built in the 1980s. The perimeter frames had a hoop detail in the beam-ends intended to relocate the plastic hinge 500mm away from the column face, so to avoid excessive demand and damage at the beam-column joint.

the EW direction, consistent with the direction of the strongest components recorded in the surrounding area. Maximum observed residual cracks varied between 0.8mm and 20mm wide in the EW direction, and between 0.4mm and 8mm in the NS direction. Interestingly enough, most of the observed cracks were within, instead of outside, the plastic hinge relocation detail (see Figure 2) which thus apparently did not work as intended per the original design. Residual drifts and tilting (due to liquefaction and lateral spreading) were also observed. More detailed information on the observed damage can be obtained in [2] [3]. The building was considered uneconomical to be repaired and consequently demolished in 2012. Four "H frames" were extracted from the 16th floor level during the demolition process for experimental purposes (see Figure 1).

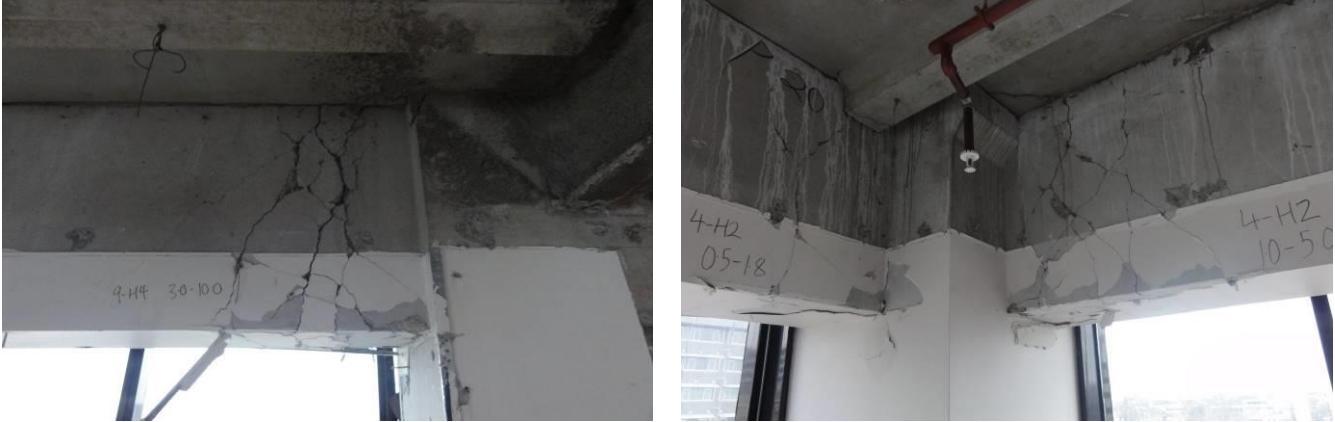
Figure 2 – Typical damage observed in the superstructure of the PWC building, level 9 interior unit H4 (left) and level 4 corner unit H2 (right) [3].

During the CES, the building appeared to behave as expected, with the beams developing plastic hinges at both ends along the full height of the structure, with a general trend of diminishing level of damage along the elevation. The columns or joints did not show any signs of damage. The building experienced more damaged in

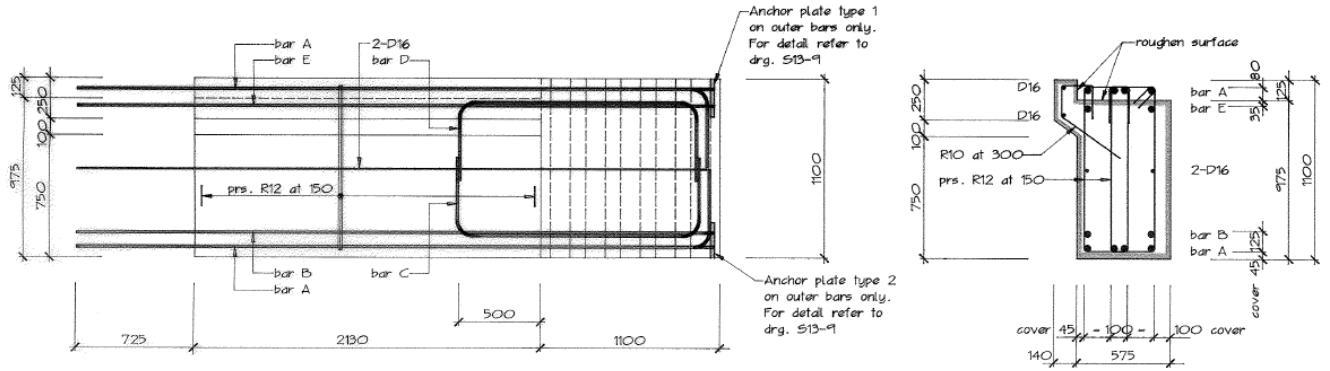
Figure 3 – Typical section and elevation view of beams tested [4].

The "H frames" extracted during the deconstruction process were later cut in two "T-shape" specimens due to laboratory crane capacity limitations. Each of the "T-shape" specimens tested weighs between 10.5ton and 13ton. The beams are 2550mm long (measured from the column face to the point of load application), 575mm wide by 1100mm high. The (main) longitudinal reinforcement consists of top and bottom 4 D-28 straight bars and 2 additional D28 hooked bars (within the plastic hinge relocation detail); the transverse reinforcement consists of 2 R-12 stirrups (one interior, one exterior) spaced at 150mm crs. There is also secondary reinforcement detailed such that it provides vertical support to the flooring system (see Figure 3). The columns are 2700mm long, either 1100mm square (at the building's corners) or 1100mm by 800mm (at the building's interior columns). The nominal steel yield strength and concrete compressive strengths, as specified in the drawings, are 300MPa and 30MPa, respectively.

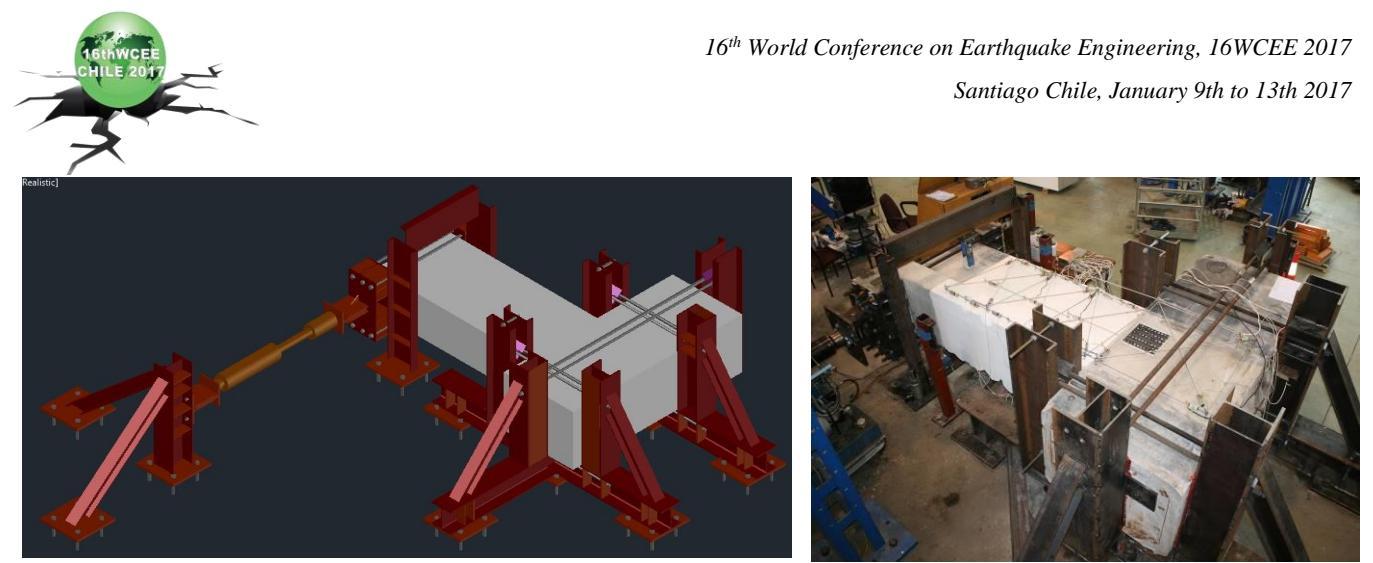
Figure 4 – 3D CAD view of the reaction frame (left); specimen 1 during the tests (right).

As shown in Figure 4, the reaction frame used for the tests consisted of steel braced frames anchored to the RC strong floor. The beam-column joint was placed horizontally on top of steel beams and clamped to the braced frames with steel channels and post-tensioned Macalloy bars. The beam-end was vertically supported on Teflon pads. A steel frame with a roller prevented the beam-end to uplift due to any accidental eccentricity that might occur at the actuator-to-beam connection. No axial and gravity loads were applied at the column (in addition to the resultant force from the post-tensioned bars) and beam, respectively.

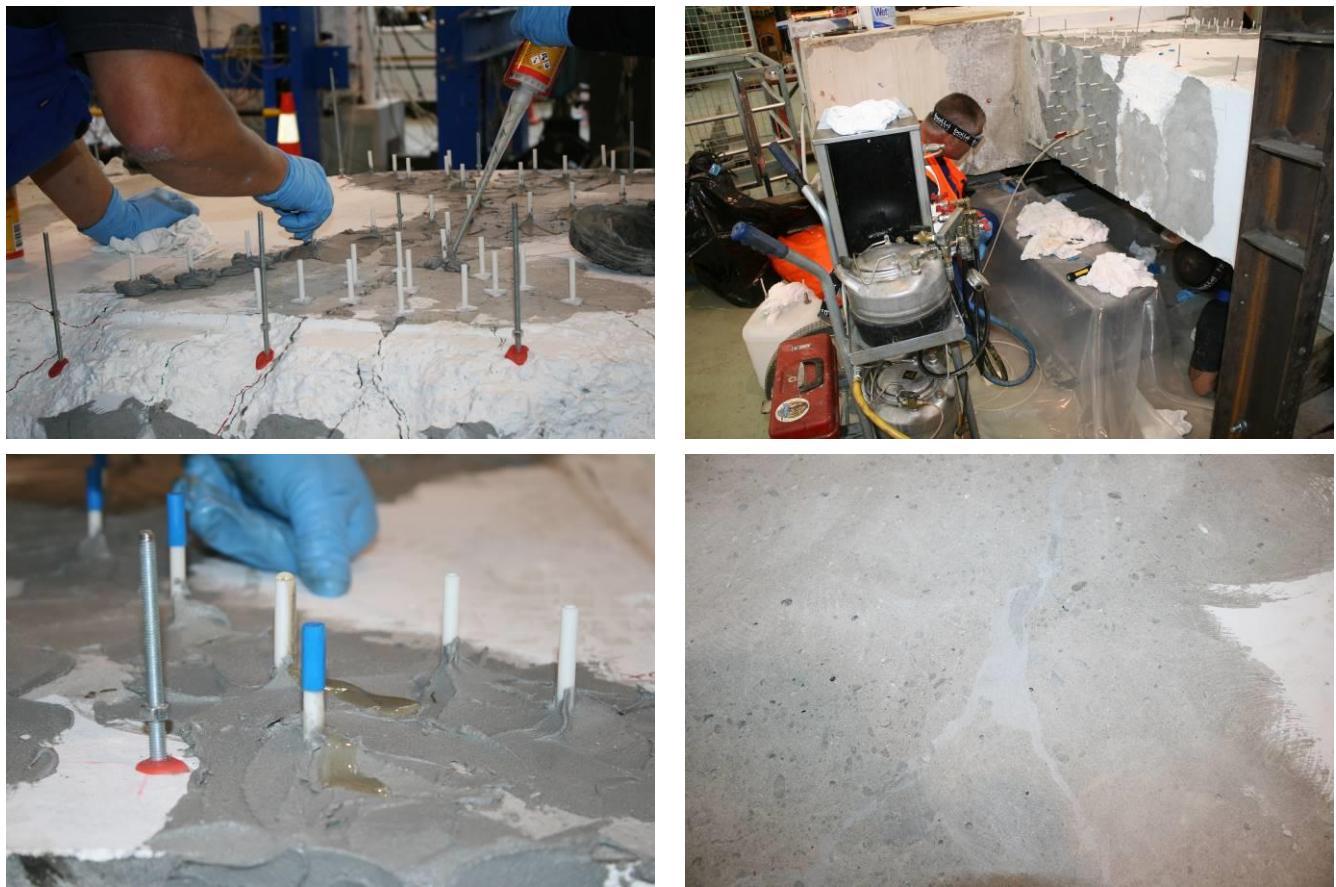
Figure 5 – Epoxy repairs in specimen 3. Sealing process with epoxy mortar and installation of injection ports (upper-left); resin injection with an air-operated pump (upper-right); epoxy resin leaking from and sealing of the injection ports (lower-left); finish once the epoxy mortar has been removed (lower-right).

The repair works were conducted by BBR CONTECH, concrete specialists with broad experience on epoxy injection repairs in Christchurch following the CES, with the technical support from the product manufacturer. As shown in Figure 5, the damaged specimens were repaired in the same horizontal position as they were tested. The repair process started with grinding the surface along the crack lines to seal them with a well bonded epoxy mortar. It was necessary to seal both sides of the crack to prevent leakage. Injection ports were simultaneously installed at 100-200mm crs. (sometimes closer depending on the cracking pattern). The epoxy material was mixed and the resin was injected under pressure via the injection ports through an air-operated pressure pump. The injection port was sequentially interchanged to allow the resin to travel and fill the interior cracks. The ports were sealed as the resin started leaking through them. Once the injection process was finished, the surface was cleaned off by removing the hardened epoxy mortar, leaving the surface flush. A total 4.8L and 10.9L of resin injected at 34.5MPa (5psi) were required to repair the specimens 2 and 3, respectively.

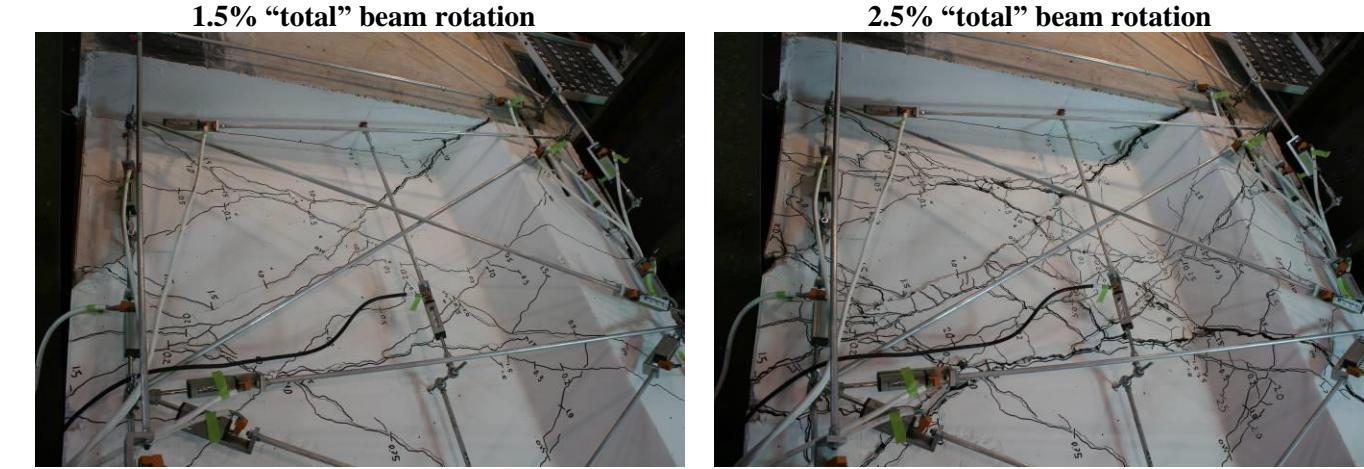
Figure 6 - Residual racking pattern observed during Test 1, at 1.5% and 2.5% "total" beam rotation.

<u>*Test 1:*</u> Cracks of 0.1mm in width opened up at 0.2% "total" beam rotation. These cracks might be pre-existing ones (earthquake induced) that closed due to the low level of inelastic action. At 1.5% total rotation most of the deformation was concentrated at a single diagonal crack 4-12mm wide (see Figure 6), and shear distortions became more evident. The reason of these diagonal cracks could be excessive principal tensile stresses as a result of the diagonal compression strut induced by the hooked bars within the plastic hinge relocation detail. It was not possible to test the specimen up to failure due to the excessive and unexpected shear deformation (and sliding shear mechanism) of the specimen. The reaction frame was later modified in order to accommodate such displacement.

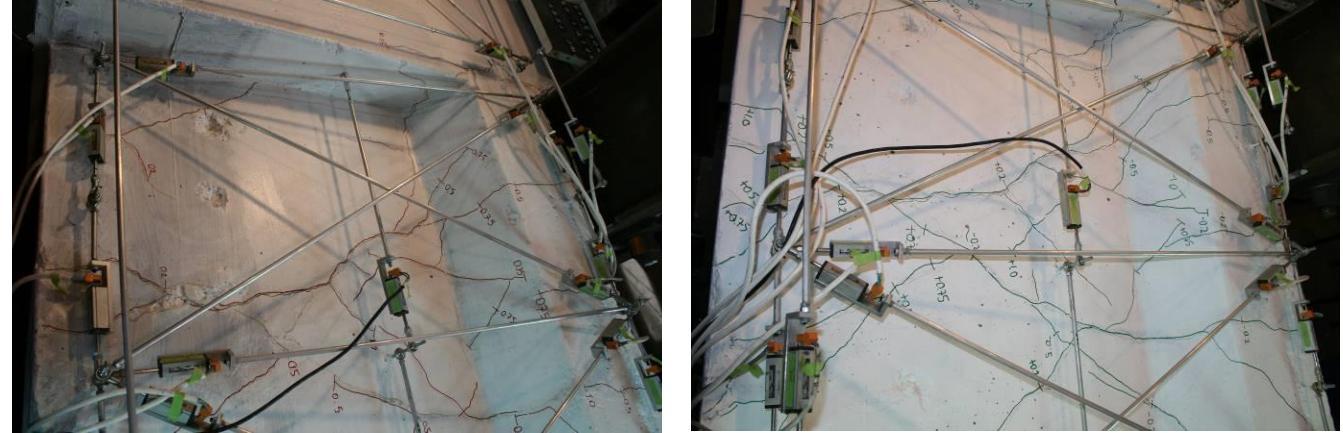
Figure 7 – Residual cracking pattern observed during Test 2 at 1.0% "total" beam rotation.

<u>*Test 2.1:*</u> Cracks 0.1mm wide were also observed at 0.2% "total" beam rotation. Maximum cracks of 3mm in width were observed at 1% "total" beam rotation (see Figure 7). By comparing the cracking pattern before and after the test, it is believed that most of the (earthquake) pre-existing cracks were activated at this beam rotation level. Residual (static) cracks between 0.1mm and 2.0mm in width were observed at the end of the test.

<u>Test 2.2</u>: Cracks of 0.1-0.2mm in width started developing at 0.1% "total" beam rotation. A new crack extended from the column face towards the interior of the joint, and did not follow the injected crack path. At 0.75% "total" beam rotation, 0.1mm-hairline cracks started developing outside the plastic hinge relocation detail. At beam rotations of 1.5%, residual (static) cracks started becoming comparable to the maximum observed (70-90% of the maximum crack width). Maximum cracks of 9-18mm in width were observed at 2.5% "total" beam rotation. As shown in Figure 7, most of the repaired cracks re-opened up during the Test 2.2.

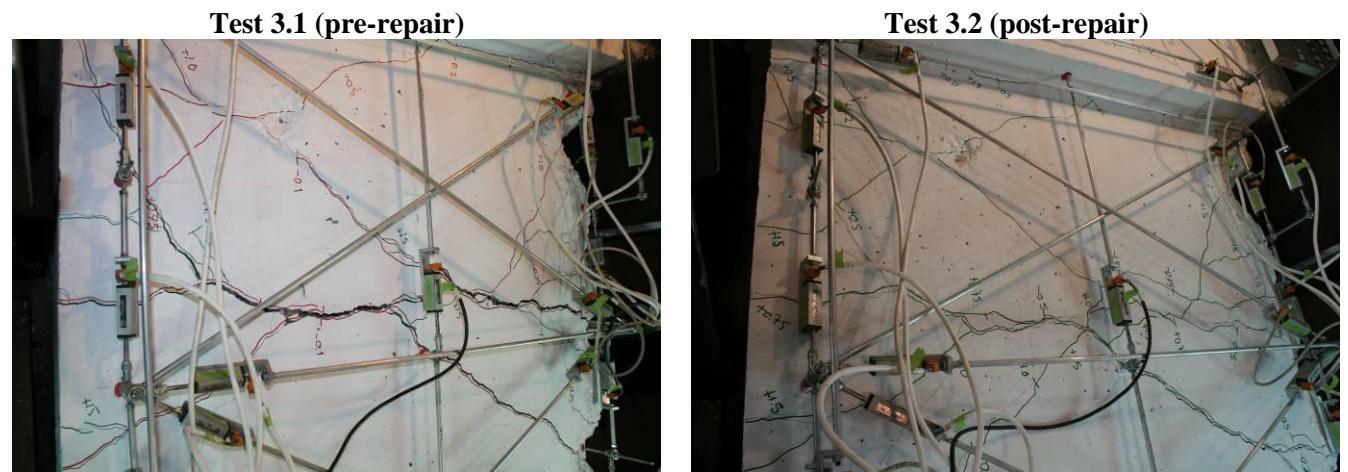
Figure 8 – Residual cracking pattern observed during Test 3 at 1.5% "total" beam rotation.

<u>Test 3.2</u>: Cracks 0.1mm wide were observed at 0.1% "total" beam rotation. Sliding and diagonal cracking was observed at the cold joint, even at such low rotation level. New flexural cracks were observed outside the plastic hinge relocation detail. As in the Test 3.1, residual (diagonal) cracks started becoming comparable to the maximum observed at 1.5% "total" beam rotation level. Maximum cracks of 10mm in width were observed at 2.5% beam rotation. As shown in Figure 8, most of the repaired cracks opened up during the Test 3.2.

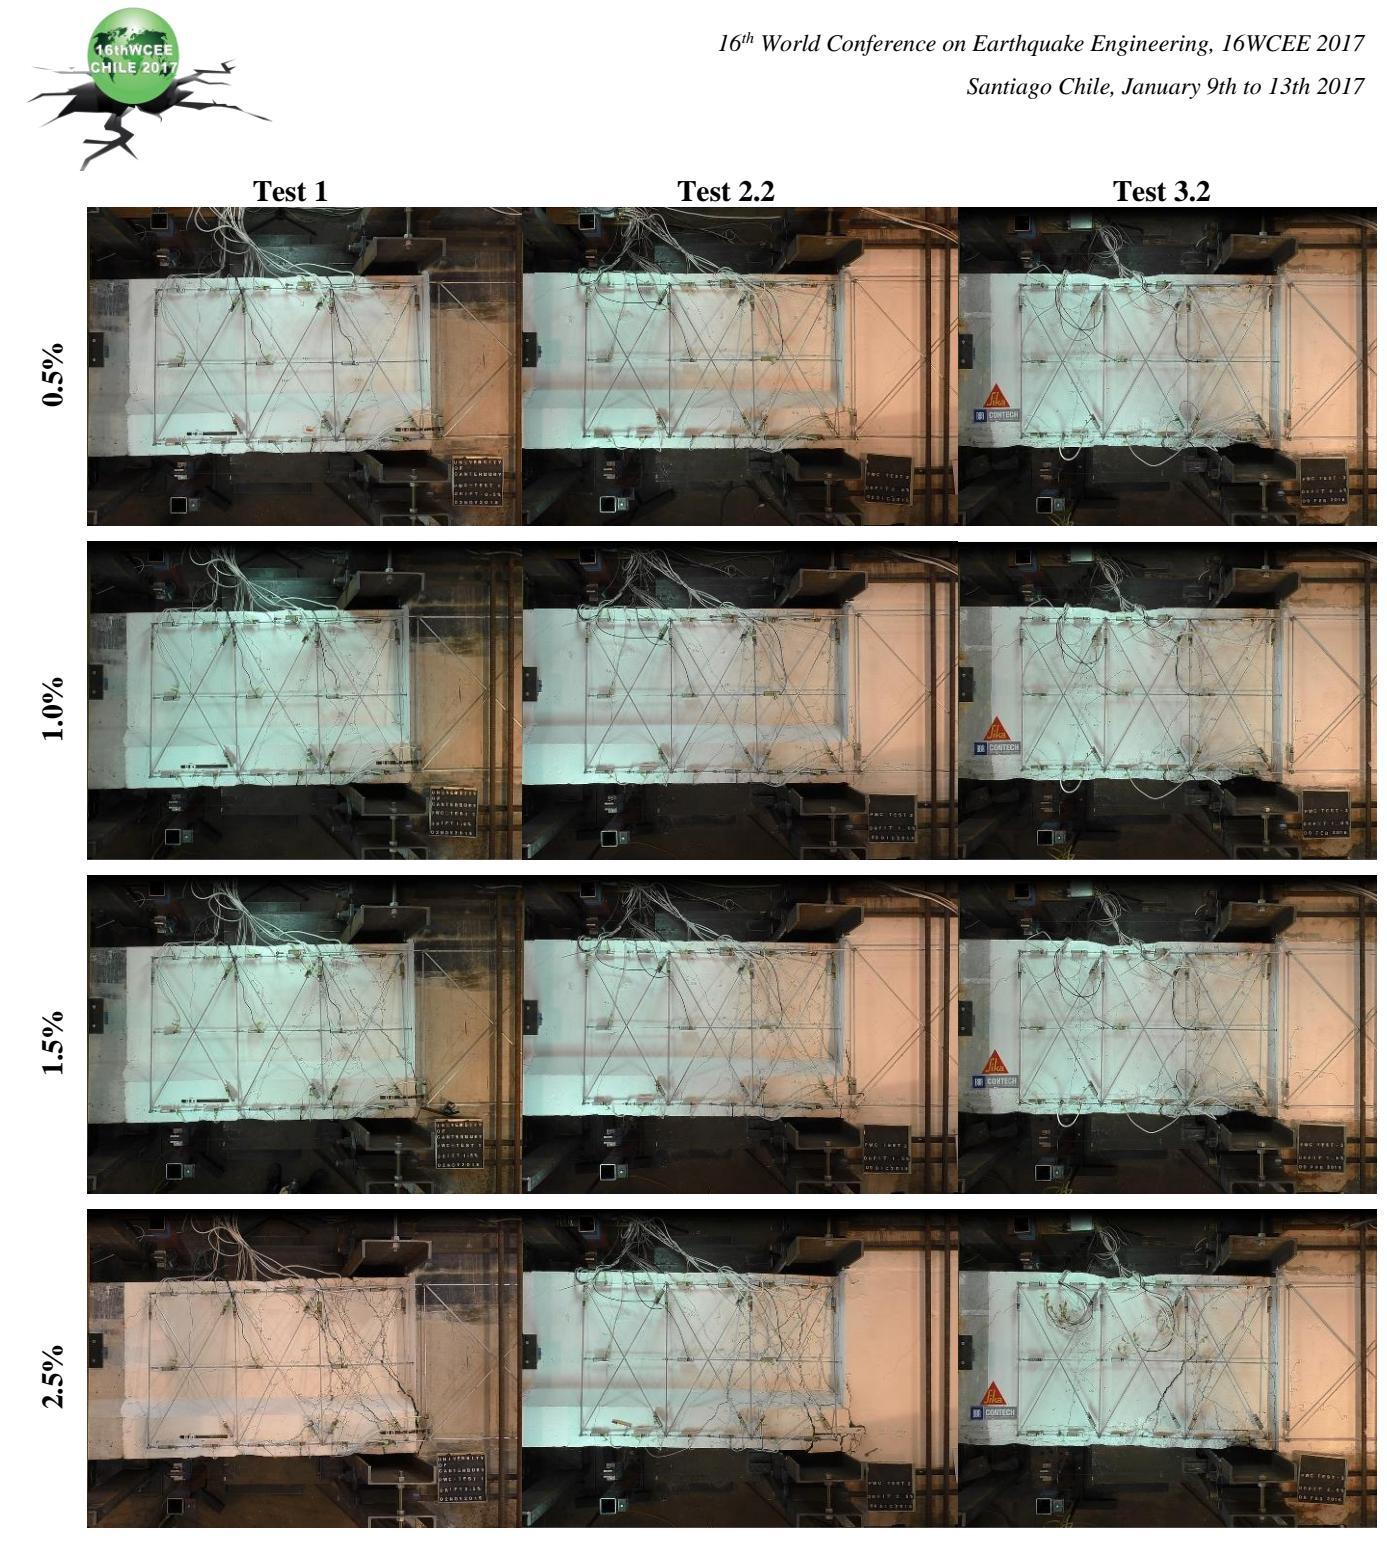
Figure 9 – Observed damaged at different beam rotations (in "total" displacement units).

Figure 9 shows cracking patterns in Tests 1, 2.2 and 3.2, at different levels of "total" beam rotation. It is evident that the damage in Test 2.1 is more severe at lower (below 1.5%) rotation levels. Test 1 experienced the most severe damage at 2.5%, while Test 3.2 experienced the less damage at all rotation levels, with some of the damage in the form of flexural cracks outside the plastic hinge relocation detail.

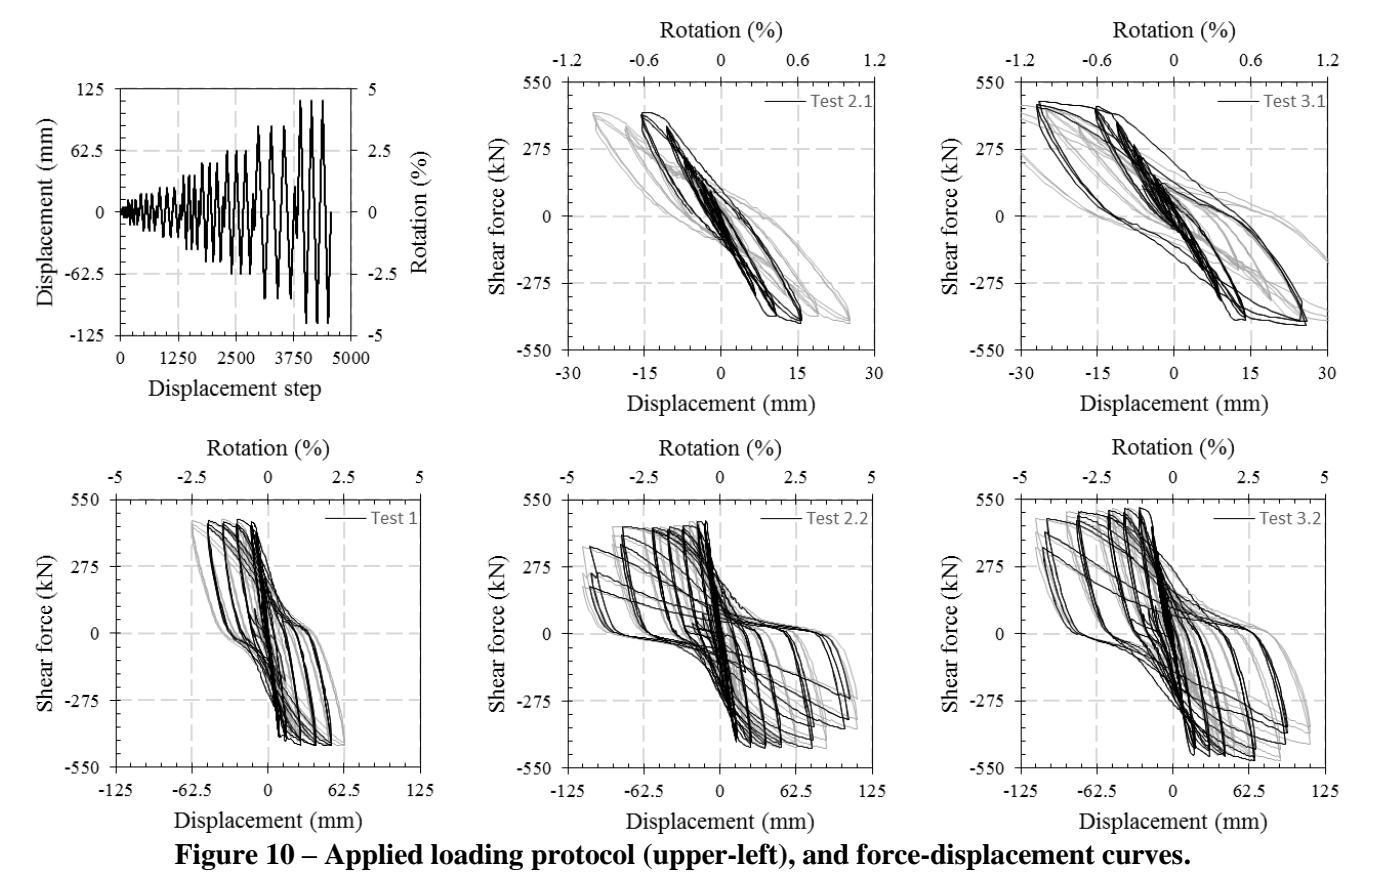
In Figure 10, solid grey lines represent force-displacement curves measured in "total" displacement units, whereas solid black lines are in "effective" displacement units (i.e., the "total" applied displacement minus the equivalent lateral displacement at the beam end due to rigid body translation and rotation). The onset of nonlinearity occurs at about 0.5% "effective" beam rotation. Rotation ductility demands of around 1.20 and 2.10 were achieved at the end of Tests 2.1 and 3.1, respectively.

All the tests show a relatively stable hysteretic behaviour at early stages, with however a sudden drop in strength during the last 3 cycles in both repaired configurations (Tests 2.2 and 3.2). Higher pinching behaviour, due to cracks opening and closing and more likely due to bond-slip degradation, was observed in the repaired configurations, in particular for Test 2.2.

When considering Test 3.2, the relocation of cracks outside the plastic hinge relocation detail led to higher shear forces for the same displacement demand and a more stable hysteresis loop with less pinching. Overall, the effective displacement (capacity) achieved in the test was lower than in other tests.

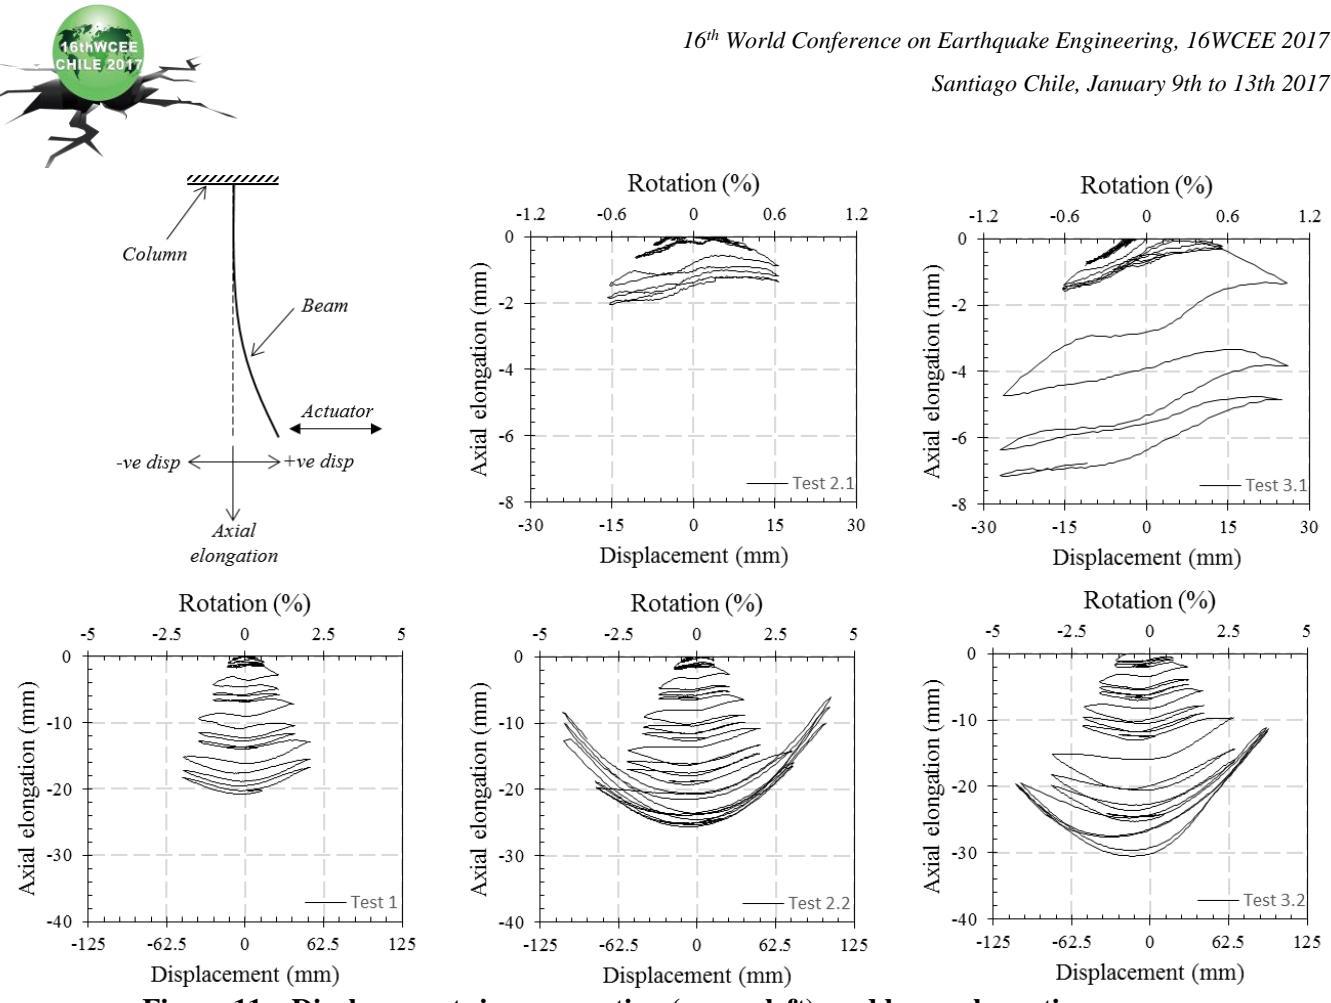
Figure 11 – Displacement sign convention (upper-left), and beam elongation curves.

Figure 11 shows the axial beam elongation for all the tests. It can be noted that the beam elongation is permanent and cumulative. Maximum elongations in Tests 2.1 and 2.2 were 2mm and 7.2mm, respectively, equivalent to 0.08% and 0.29% increase in beam length. These beam elongations were consistent with the maximum cracks widths observed at the end of the tests. Maximum elongations in Tests 1, 2.2 and 3.2 were 21mm, 26mm, and 30mm, equivalent to 0.85%, 1.05%, and 1.20% increase in beam length, respectively. It is worth noting that the testing apparatus allowed for free beam elongation without any restraint action from the floor diaphragm as in fact would occur in the real building. Therefore, while the results are important to develop a better understanding of the behaviour of a "free" subassemblies, the beam elongation results are not fully representative of what we would have observed following the earthquakes.

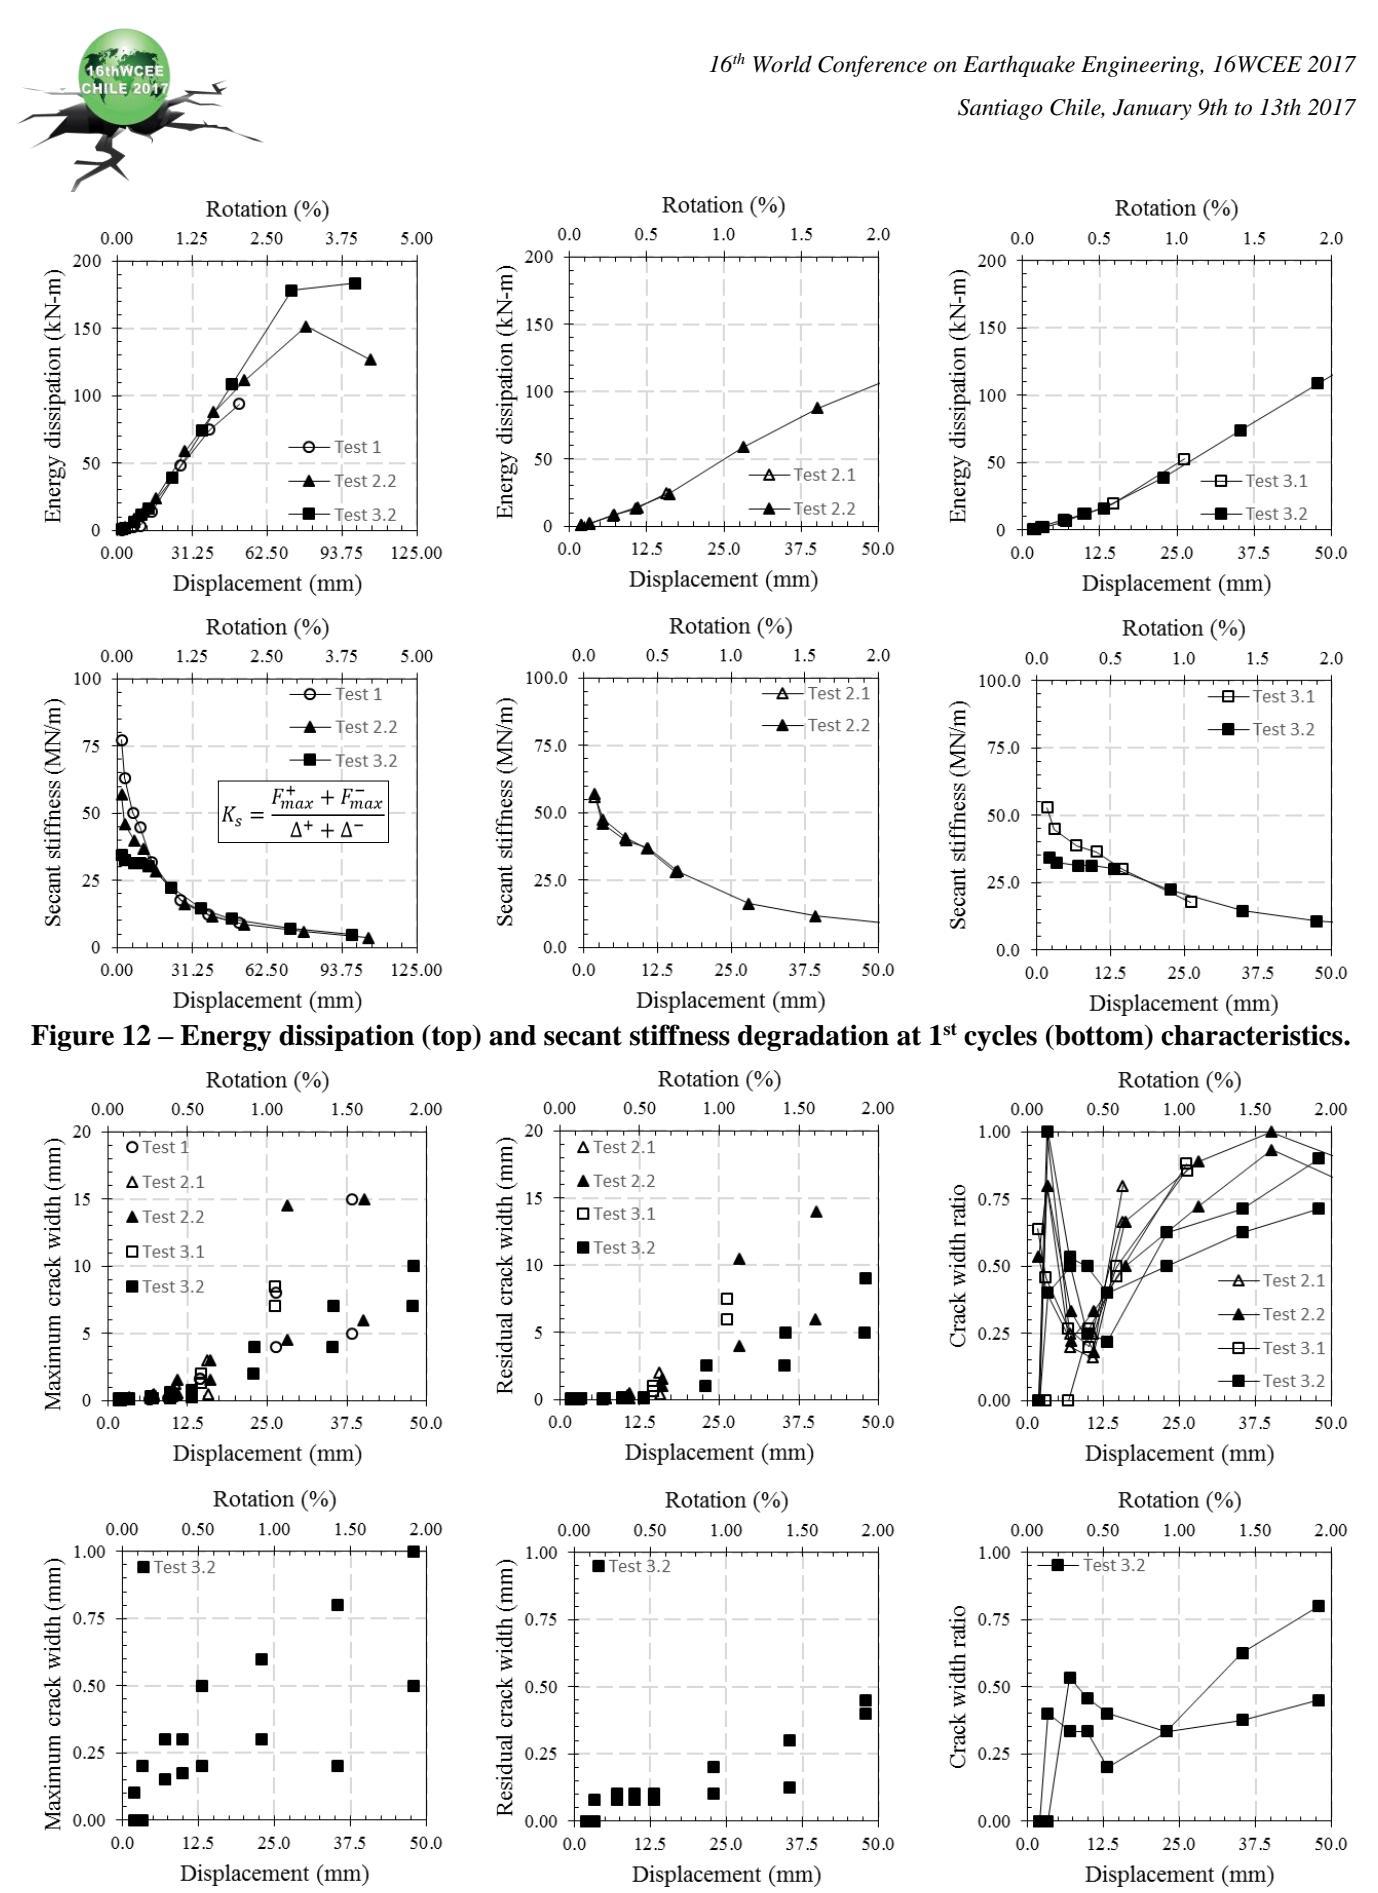
Figure 13 – Maximum and residual cracks, and crack width ratios within (top) and outside (bottom) the plastic hinge relocation detail.

Figure 13 shows maximum and (static) residual crack widths measured during the tests. The top figures correspond to the most critical crack(s) observed within the plastic hinge relocation detail (i.e., shear-flexural cracks); the bottom ones correspond to flexural cracks observed outside the plastic hinge relocation detail during the Test 3.2. The maximum crack widths are measured at peak force, whilst the residual crack widths at zero force. Worth reminding that these residual cracks are "static" ones. The dynamics effects during the earthquake, as well as any axial load contribution, i.e. slab engagement effect resisting to the beam elongation, would further reduce them, thus increasing the maximum/residual ratio [6] [7].

Crack width ratios computed as the residual crack width upon the maximum residual rack width are also shown in the figure. It is evident how the crack width ratios are rotation (i.e. drift) dependant, showing a change of slope from negative to positive at rotations near or at the onset of nonlinearity. The negative slopes below the onset of nonlinearity are due to the fact that at low rotation levels the residual cracks are very small and almost constant (hairline-to-0.1mm in width), regardless of the increase of the maximum crack widths as the rotation level increases. This is in line with recent post-earthquake observations [8] [9] where hairline-minor residual crack width could in fact hide non-negligible, if not significant, damage, including tensile fracture of the bars, especially in lightly reinforced shear walls.
