# RESPONSE OF A R/C BUILDING IN CEPHALONIA (GR) TO EARTHQUAKE EXCITATIONS DURING THE 26/01-03/02/2014 SEISMIC SEQUENCE

The seismic sequence in the island of Cephalonia, Greece, in the beginning of 2014, which included two chronically close strong motions, raised the problem of determining the structural response due to the two consecutive strong seismic events. Due to the fact that the modern seismic codes do not include specifications dealing with such series of events, the majority of structures are analysed considering one design seismic event corresponding to an assumed specific occurrence probability during their structural life. The current study investigates the response of an existent r/c building in the region of Lixouri, in the island of Cephalonia, designed on the basis of the old Greek seismic code, applying the specific consecutive seismic events. By means of the results obtained, an attempt is made to test the potential ability of the finite element model for the approximation and justification of the real observed damage and, additionally, to explain the observed damage state after the second strong seismic event. For this purpose, non-linear time response analyses

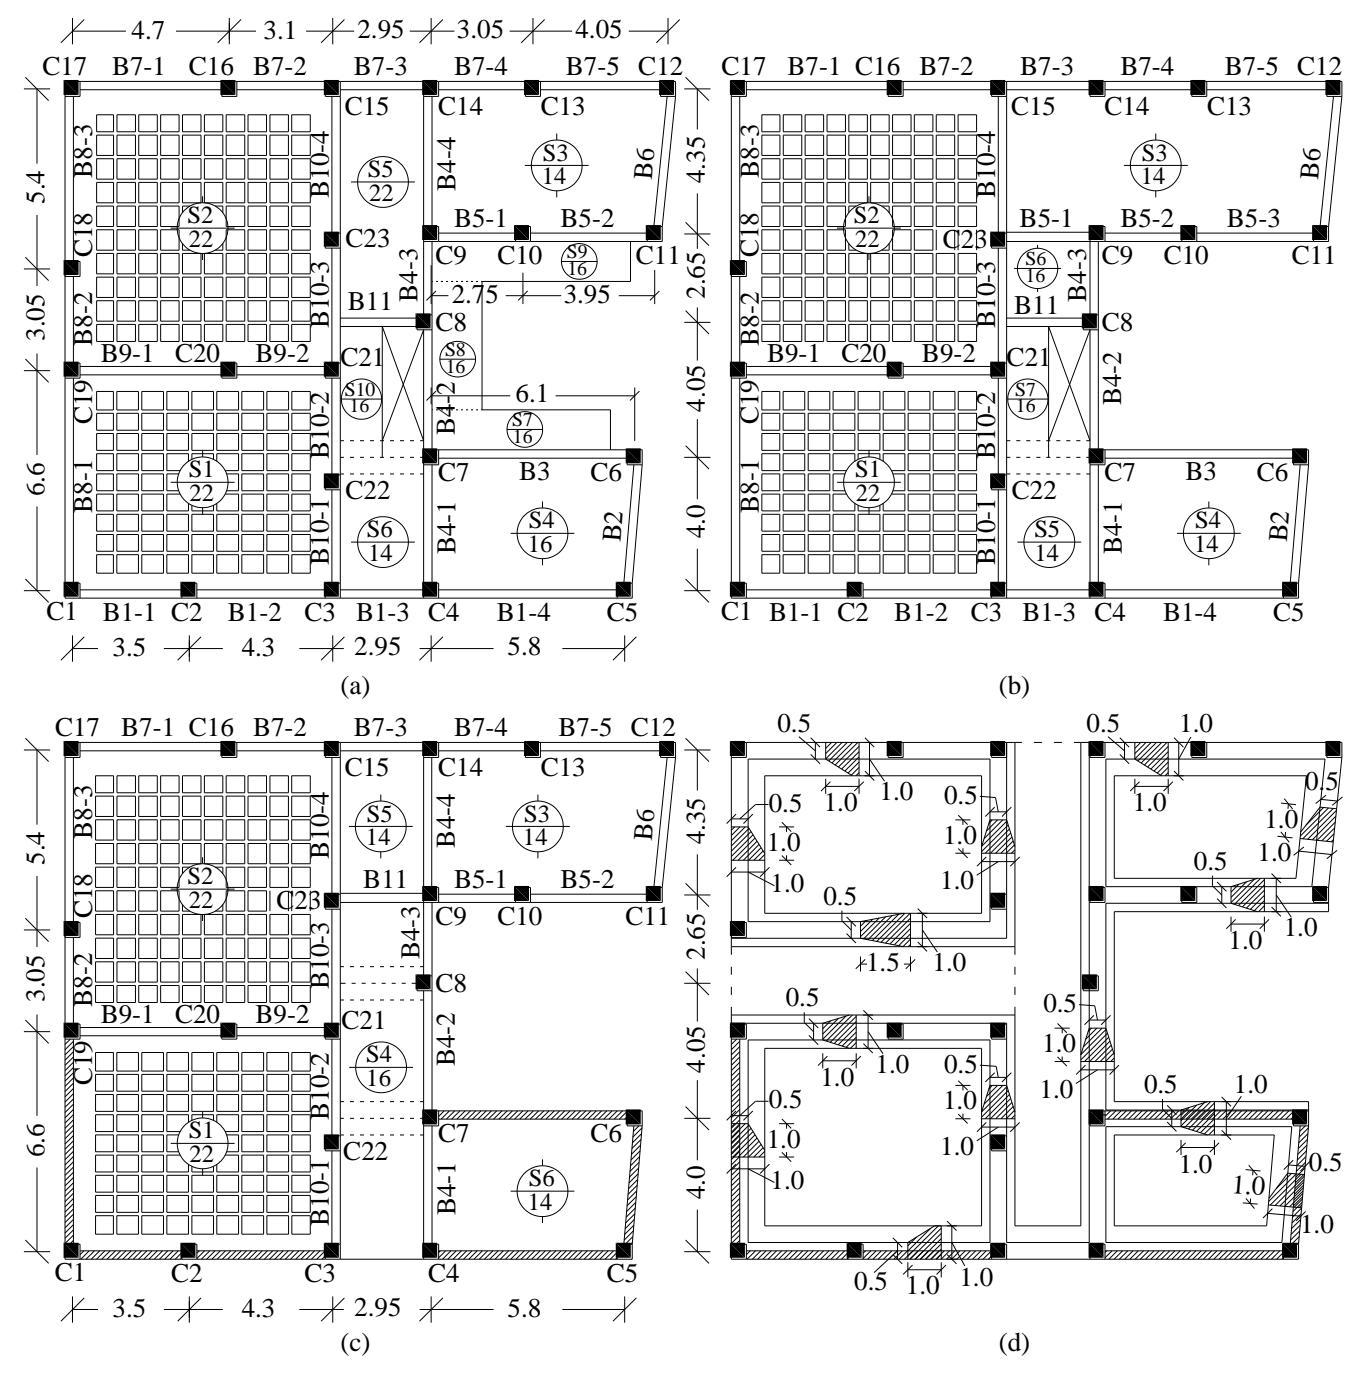
The r/c building analysed is located in the town of Lixouri in the island of Cephalonia, Greece and was constructed in 1985 under the Greek codes applying at that time. It is a two-storey building with basement and a loft (Fig. 1). The materials employed for the construction of the bearing system were concrete grade B225 and steel grade StIIIa, according to the categorization permitted within the framework of the corresponding codes. The height of both the ground floor and the first floor is 3.0m, while the height of the basement is 1.95m. As for the loft, which is covered by a tiled roof, the maximum height is 4.0m and the minimum 1.0m. The loft and the tiled roof, which constituted a storey addition, were constructed in 1993. The loft was made of lightweight materials and it was thus considered that it could only be introduced in the model as a permanent vertical load. In a part of the perimeter of the basement, r/c walls were constructed (Fig. 1d).

The structural type of the building is "frame system" (system of spatial r/c frames without r/c walls). The floor plans at all levels are non-regular (Fig. 1a-d) according to EN19981-1 criteria. The columns are located mainly at the perimeter of the building (Fig. 1a-d), and they have a quadrangular cross-section (with dimensions 0.45mx0.45m in all levels). The longitudinal reinforcement of columns consists of 12 bars of 20mm in the basement and the ground floor and 8 bars of 20mm in the first floor. The transverse reinforcement of columns consists of stirrups of 8mm placed every 15cm. All beams have a cross-section of 0.25/0.60m at all levels (except for beams B11 (Fig. 1a-c), which bear the staircase, with a cross-section of 0.25/1.00m). The longitudinal and transverse reinforcement of beams are shown in the constructional drawings, which were available to the authors. The slabs of the building are of two types: there are solid slabs and ribbed slabs (zoellner slabs), as shown in Fig.1a-c. The foundation of the building consists of r/c foundation beams which

have trapezoidal cross-sections (with a height of 1.0m and width of 1.0m at the base and 0.5m at the top, Fig. 1d). The building has strong masonry infill walls in the perimetrical frames and lightweight ones in the interior.

Fig. 1 – Structural design drawings of (a) the roof of the 1<sup>st</sup> floor, (b) of the roof of the ground floor, (c) of the roof of the basement and (d) of the foundation

• The structural elements of the foundation (foundation beams (Fig. 1d)) were modelled using linear beam elements, assuming the absence of plastic deformations.

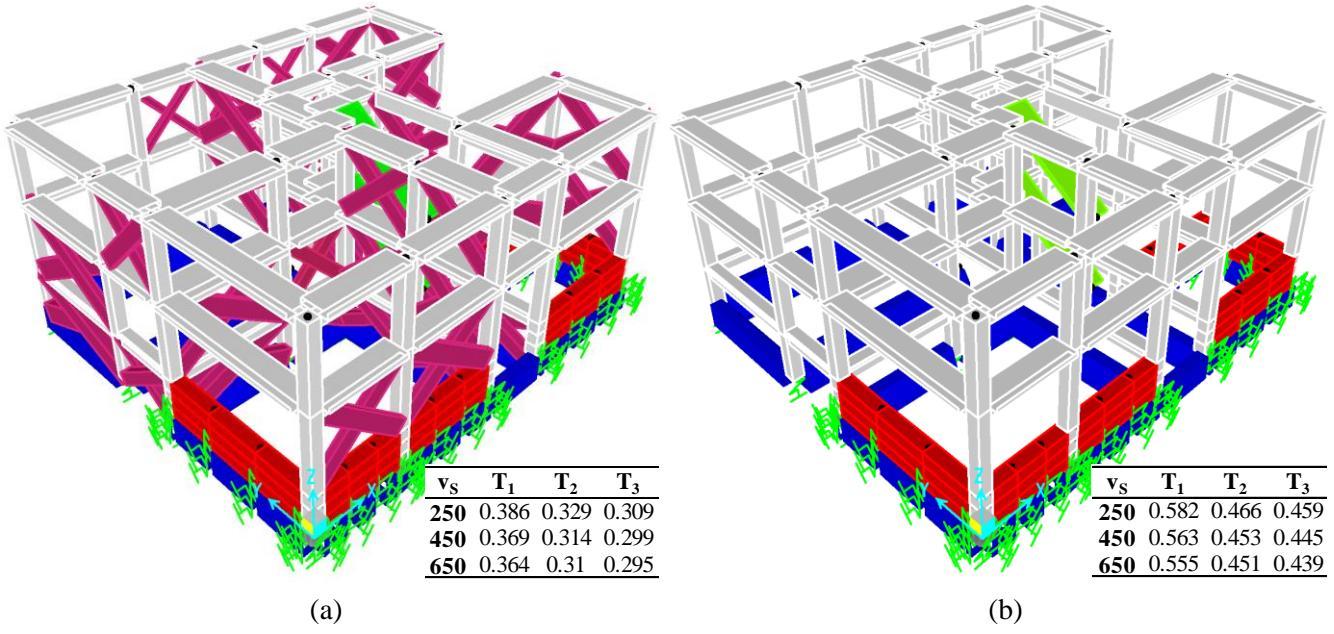
- For the modelling of masonry infill walls, two approaches were made. In the first approach, masonry fills were considered only as permanent vertical loads. In the second approach, they were taken into account both as vertical loads as well as members with capacity of horizontal resistance to seismic loads. In this case, diagonal non-linear springs (e.g. [6]) were employed for their modelling assuming a bilinear stress-strain model, as described in Appendix C of EN1998-3 [3]. Finally, it must be noted that masonry infill walls were modelled as elements bearing seismic loads only in those bays where there were no wall openings of a considerable area (Fig. 2a).

Fig. 2 – The FE model and the first three natural periods of the building (a) with and (b) without the influence of masonry infill walls

The models employed with and without considering of the masonry infill walls are presented in Fig. 2. In the same figure the first three natural periods of the building are also presented.

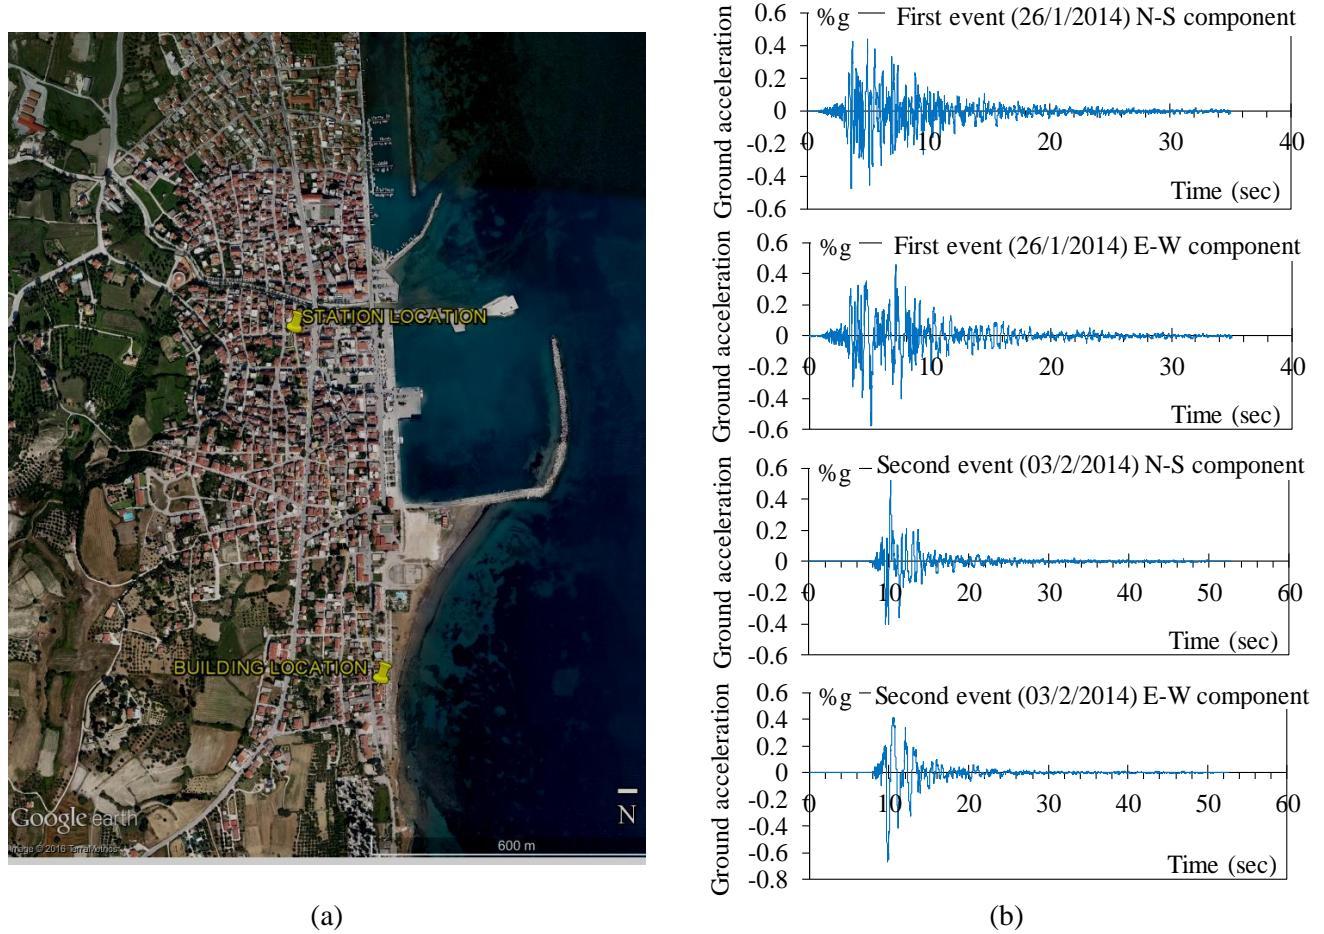
The seismic sequence in the island of Cephalonia, in the beginning of 2014, consisted of a large number of seismic excitations of various magnitudes. However, the main characteristic of this sequence was the two mainshocks on 26/01/2014 ( $M_w=6.1$ ) and on 03/02/2014 ( $M_w=6.0$ ). As a result, in a timespan of one week, the buildings and the infrastructures in the island suffered two strong seismic events which in many cases caused heavy damages [1]. The sequence was monitored and recorded by both the permanent and temporary accelerograph network of EPPO-TSAK, as well as the one of the NOA [1]. The accelerograms which were used in the present paper (Fig. 3b) were recorded by a station of the NOA (first main event) and by a station of EPPO-ITSAK (second event). Both stations were installed in the Lixouri Town Hall located in a 700m distance from the analysed building (Fig. 3a) [1].

Fig. 3 – The location of the analysed building and the recording instruments [source: Google Earth] (a) and the recorded accelerograms (b)

In order to achieve the goals of the present paper, non-linear time response analyses (NTRA) were utilized. The accelerograms which are presented in fig. 3 were used as seismic inputs. The two horizontal components of seismic excitations in the N-S and E-W direction were considered to be parallel to the constructional axes of the building X and Y respectively (Fig. 5). As regards the analyses for the seismic sequence, new accelerograms were created. These accelerograms consist of the accelerograms of the first and the second mainshocks separated by a time gap equal to 100sec, according to suggestions which are given in the literature (e.g. [8]).

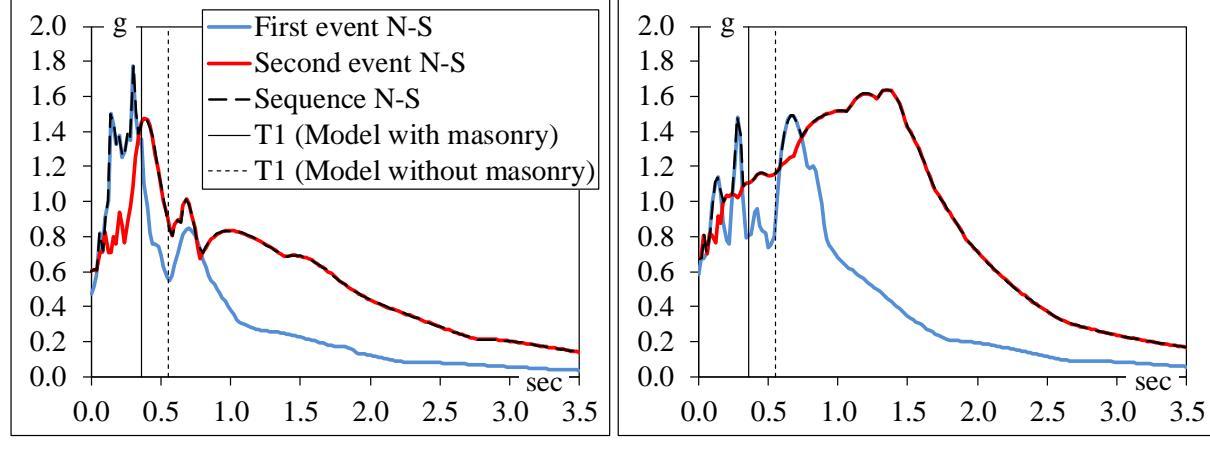
Fig. 4 illustrates the elastic response spectra (structural damping ratio 5%) and the fundamental period  $T_1$  of the building, as well as the values of characteristic seismic parameters for the first and the second mainshocks.

Fig. 4 – The elastic response spectra (a) and the values of seismic parameters of the two strong events (b)

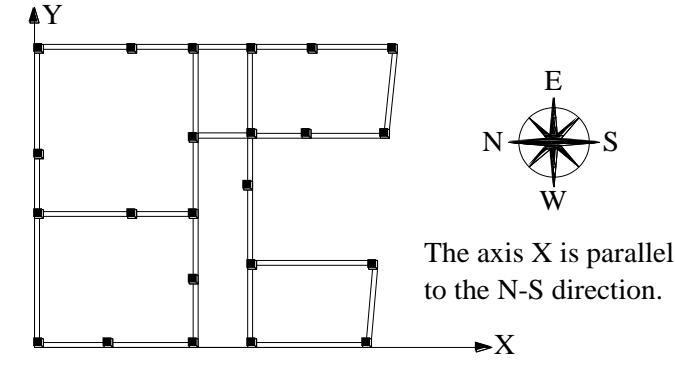
In Fig. 5, the orientation of the two horizontal components of the mainshocks' records (in the N-S and the E-W direction) was illustrated with respect to to the constructional axes of the analysed building.

Fig. 5 – The orientation of the horizontal components of the two mainshock records and of the constructional axes of the analysed building

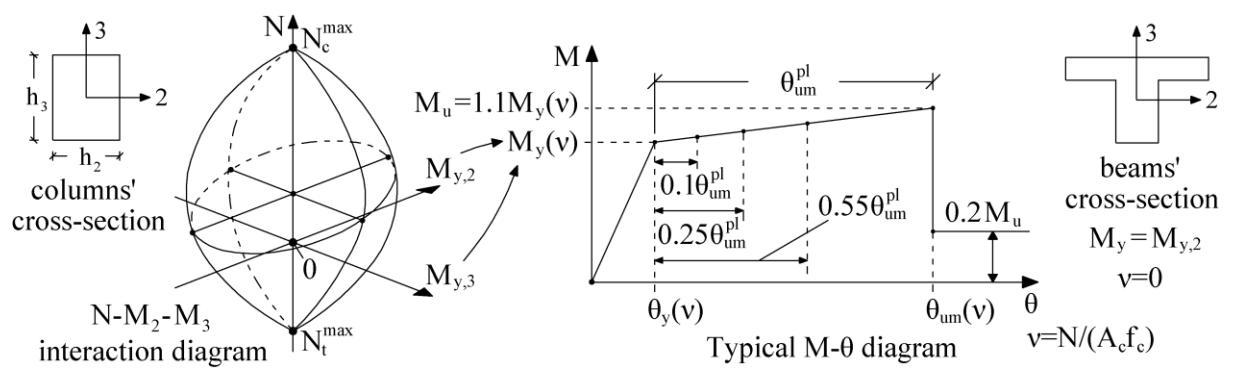
Figure 7 illustrates the distribution of critical zones (ends) of beams and columns respectively according to the values of chord rotations as they were calculated from the NTRA. In order to model the non-linear behaviour of the r/c members, as well as to estimate the characteristic values of chord rotation  $\theta$  (on the basis of the equations of appendix A of EN1998-3), the assumptions which are presented in Fig. 6 were made.

Fig. 6 - Basic assumptions for the definition of the damage state of r/c members

From Fig. 7, it can be observed that the estimation of the damage level of r/c members is accomplished through the comparison of the calculated values of chord rotation at the critical zones with characteristic values of chord rotation which correspond to the predefined damage levels. When  $\theta < \theta_y$ , no damage occurs. When  $\theta_y < \theta < 0.1\theta_{um}^{pl}$ , almost invisible damage occurs, which does not need any consideration (slight damage). When  $0.1\theta_{um}^{pl} < \theta < 0.25\theta_{um}^{pl}$ , damage is repairable and is not characterized as serious (moderate damage). When  $0.25\theta_{um}^{pl} < \theta < 0.55\theta_{um}^{pl}$ , damage is considered serious and needs special and costly techniques in order to be repaired (heavy damage). Finally, when  $\theta > 0.55\theta_{um}^{pl}$ , damage is characterized as not repairable.

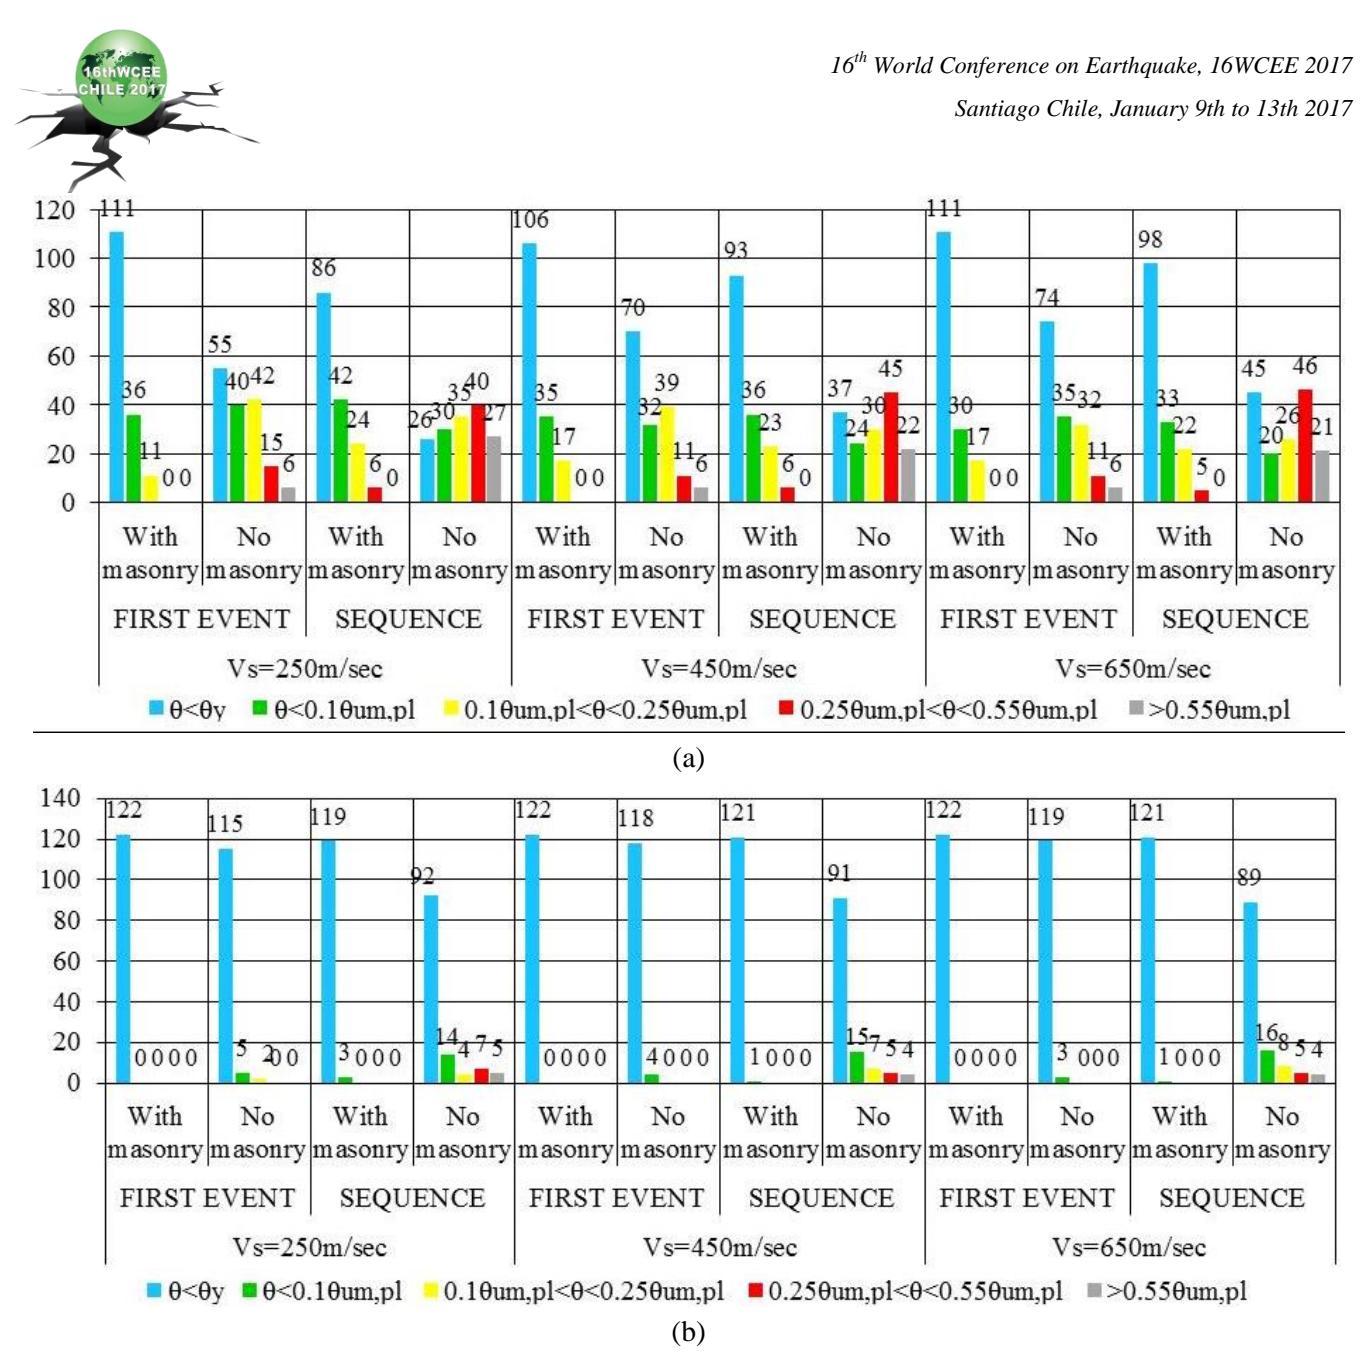
Fig. 7 – Distribution of the critical zones of beams (a) and columns (b) in the predefined damage levels

On the basis of the previously described criteria for the damage classification, it can been seen from Fig. 7a that for all examined cases, the influence of the second mainshock in the increase of the damage in beams is very significant. For example, it can be mentioned that from the total of 158 locations of potential formation of plastic hinges in the critical zones of beams, in the case of foundation soil with  $v_s=250$ m/sec, the number of critical zones in which moderate or heavy damage occurs  $(0.1\theta_{um}^{pl} < \theta < 0.55\theta_{um}^{pl})$  increases from 11(=11 critical zones with moderate damage and none with heavy) to 30 (=24 critical zones with moderate damage and 6 with heavy). This conclusion is drawn from the analysis in which the model with the influence of the masonry infills is used (Fig. 2a). Moreover, during the second mainshock, critical zones with heavy damage occurred as well  $(0.25\theta_{um}^{pl} < \theta < 0.55\theta_{um}^{pl})$ . Corresponding results were also obtained from the analyses in which the two other soil categories were considered.

was considered. In this case, when the masonry infill walls are imported to the FE model, the number of the critical zones where the damage is heavy ( $\theta$ >0.55 $\theta_{um}^{pl}$ ) after the second mainshock, is 6 (Fig. 7a). The corresponding number when the masonry infill walls are ignored is 67 (=45+22). In other words, by ignoring the masonry infill walls in the analyses, we obtain an unrealistic damage state which was not observed during the insitu inspection after the second mainshock. Corresponding results are also produced from the analyses in which the two other soil categories are considered.

The conclusions which turn out from Fig. 7a (which refers to the damage levels of beams) are generally identical with the corresponding conclusions for the columns' damage which are presented in Fig. 7b (in buildings' columns, there are 122 critical zones, i.e. potential locations of plastic hinges formation, in total). However, in the case of columns, the damage level is significantly lower than the aforementioned damage levels of beams. For this reason, these conclusions are not clearly observable from Fig. 7b. In any case, the conclusion according to which the influence of the masonry infill walls possesses the basic role in the observed low damage state still holds. It must be noted here, that the significantly low damage level of columns is also due to the fact that the dimensions of their cross-section, as well as their reinforcement (see paragraph 2.1), correspond to columns in close distances, especially in the perimeter of the building, which leads to an optimal distribution of vertical and horizontal seismic loads.

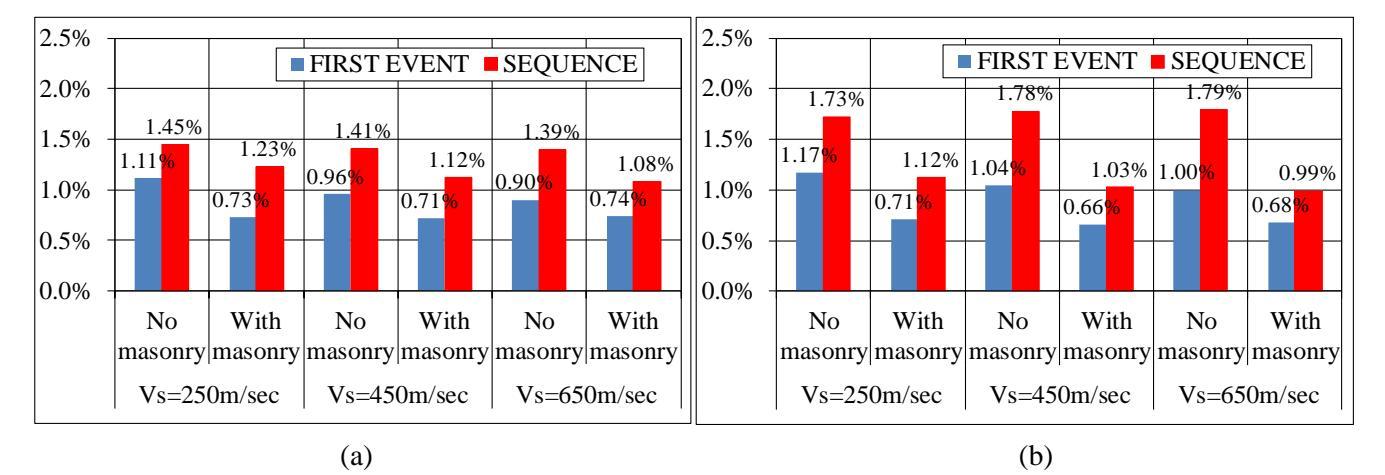
Figures 8 and 9 illustrate the Maximum Interstorey Drift Ratios (MIDRs) of the ground floor and the 1<sup>st</sup> floor in the directions of the constructional axes X and Y for all analyzed cases. From these figures, it can be deduced that the maximum relative displacements of storeys are increased in all cases after the second mainshock. This conclusion is obviously due to the fact that the building suffers damage (even if extremely minor) mainly occurred in masonry infill walls after the first mainshock, as well as due to the fact that the second mainshock has a magnitude of the same order as the first. Therefore, the building responded to the second mainshock having lost a small amount of its structural members and masonry infill walls stiffness. In particular, with regards to the masonry infill walls, the following remarks can be made:

(a) When the masonry infill walls are taken into consideration in the FE model as members which receive horizontal seismic loads, the MIDRs take values between 0.50% and 0.75%. These values can explain the low damage level after the first mainshock (e.g. [9]).

(b) The favorable influence of the masonry infill walls is more significant during the seismic sequence. More specifically, the combined study of Figs. 8 and 9 leads to the conclusion that when the masonry infill walls are

ignored in the FE model, all MIDRs take values greater than 1.0% (in most cases greater than 1.5%, while in some cases even greater than 2%). These values can lead to the misleading conclusion that the building was suffered heavy damage, something that was not confirmed from the in-situ inspection after the second mainshock.

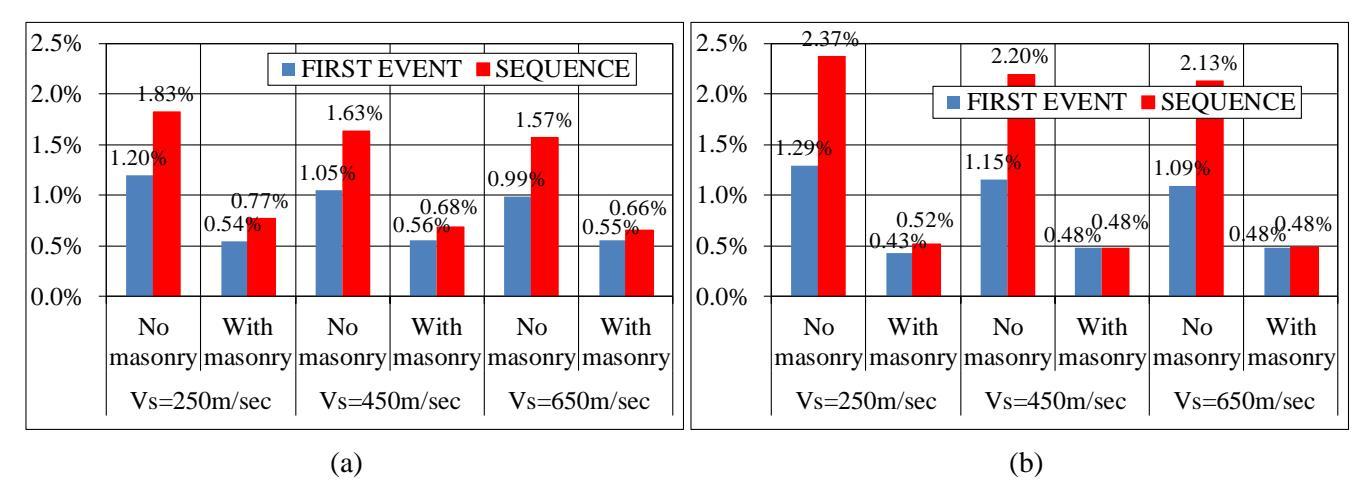
Fig. 9 – MIDRs of (a) the ground floor and (b) the 1<sup>st</sup> floor along the constructional axis Y of the building

The conclusions about the influence of the foundation soil category on the damage state when the MIDR was used as the damage level criterion are similar to those extracted when the damage level was assessed using the chord rotation in the critical zones of structural members. More specifically, the soil foundation category does not affect significantly the damage state of the building after the first or the second mainshock. To illustrate more precisely, it can be noted that the comparison of the results obtained from the analyses in which soils with  $v_s=450m/sec$  and  $v_s=650m/sec$  were respectively used led to the conclusion that these results are almost similar, especially in the case in which the masonry infill walls are considered.

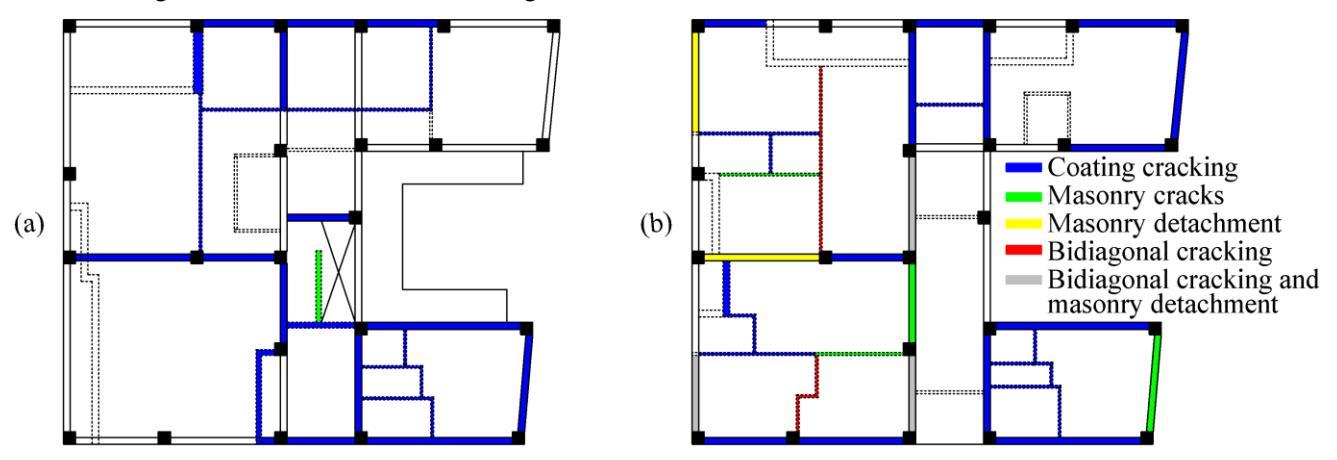
Figure 10 illustrates the results of the in-situ damage inspection after the second mainshock. Due to the fact that the time span between the two mainshocks was only eight days, damage inspection was made only after the second mainshock. Therefore, the comparisons between the analytically calculated and the actual damage state concern the sequence of the two mainshocks. It must be noted that no damage in structural r/c members was detected, except for some surface cracks in the concrete. As presented Fig. 10, various types of damages were detected in masonry infill walls. The importance of these damages ranges from simple coating cracking to bidiagonal cracking and/or masonry detachments. Fig. 10 also yields the conclusion that the masonry damages were detected are more in number and more serious in the ground floor. This figure also shows that the more serious damages occur in the masonries along the structural axis Y.

Fig. 10 –The results of the in-situ damage inspection of the examined building after the second mainshock for the 1<sup>st</sup> floor (a) and for the ground floor (b).

The conclusions reached from Fig. 10 can be generally evidenced by the results of the analyses which are made in the framework of the present paper. As regards the conclusion that more masonry damages appear in the ground floor than in the 1<sup>st</sup> floor, it must be reminded that Figs. 8 and 9 show that, in general, the MIDRs which result from the seismic sequence (from the FE model in which the influence of the masonry infill walls is taken into consideration) are greater in the ground floor. Another conclusion which is drawn from the study of Figs. 8, 9 and 10 is that the MIDR values which better validate the observed damage state result from the FE model in which a soil with  $v_s=650$ m/sec is considered. This FE model leads to a maximum MIDR value of 1.08% in the ground floor, whereas the FE model in which a soil with  $v_s=250$ m/sec is considered leads to a maximum MIDR value of 1.23%. Obviously, the observed masonry damage better match the MIDR value of 1.08% than the value of 1.23% at the ground floor.
