## Revision of Guideline for Post-Earthquake Damage Evaluation of Reinforced Concrete Buildings in Japan

In Japan, the Guideline for Post-Earthquake Damage Evaluation and Rehabilitation, originally developed in 1991 and revised in 2001, was revised in 2015 based on the lessons from damaging earthquakes such as the 2011 East Japan Earthquake. The authors have developed a method to evaluate residual seismic capacity of reinforced concrete structures based on *R*-index, which was employed in the Damage Evaluation Guideline. The *R*-index is defined as the ratio of residual seismic capacity to the original capacity, and is calculated from residual seismic capacity in structural members. In this paper, firstly, the general concept of the Guideline for reinforced concrete buildings is presented. Secondly, the main points in the revision in 2015 are introduced.

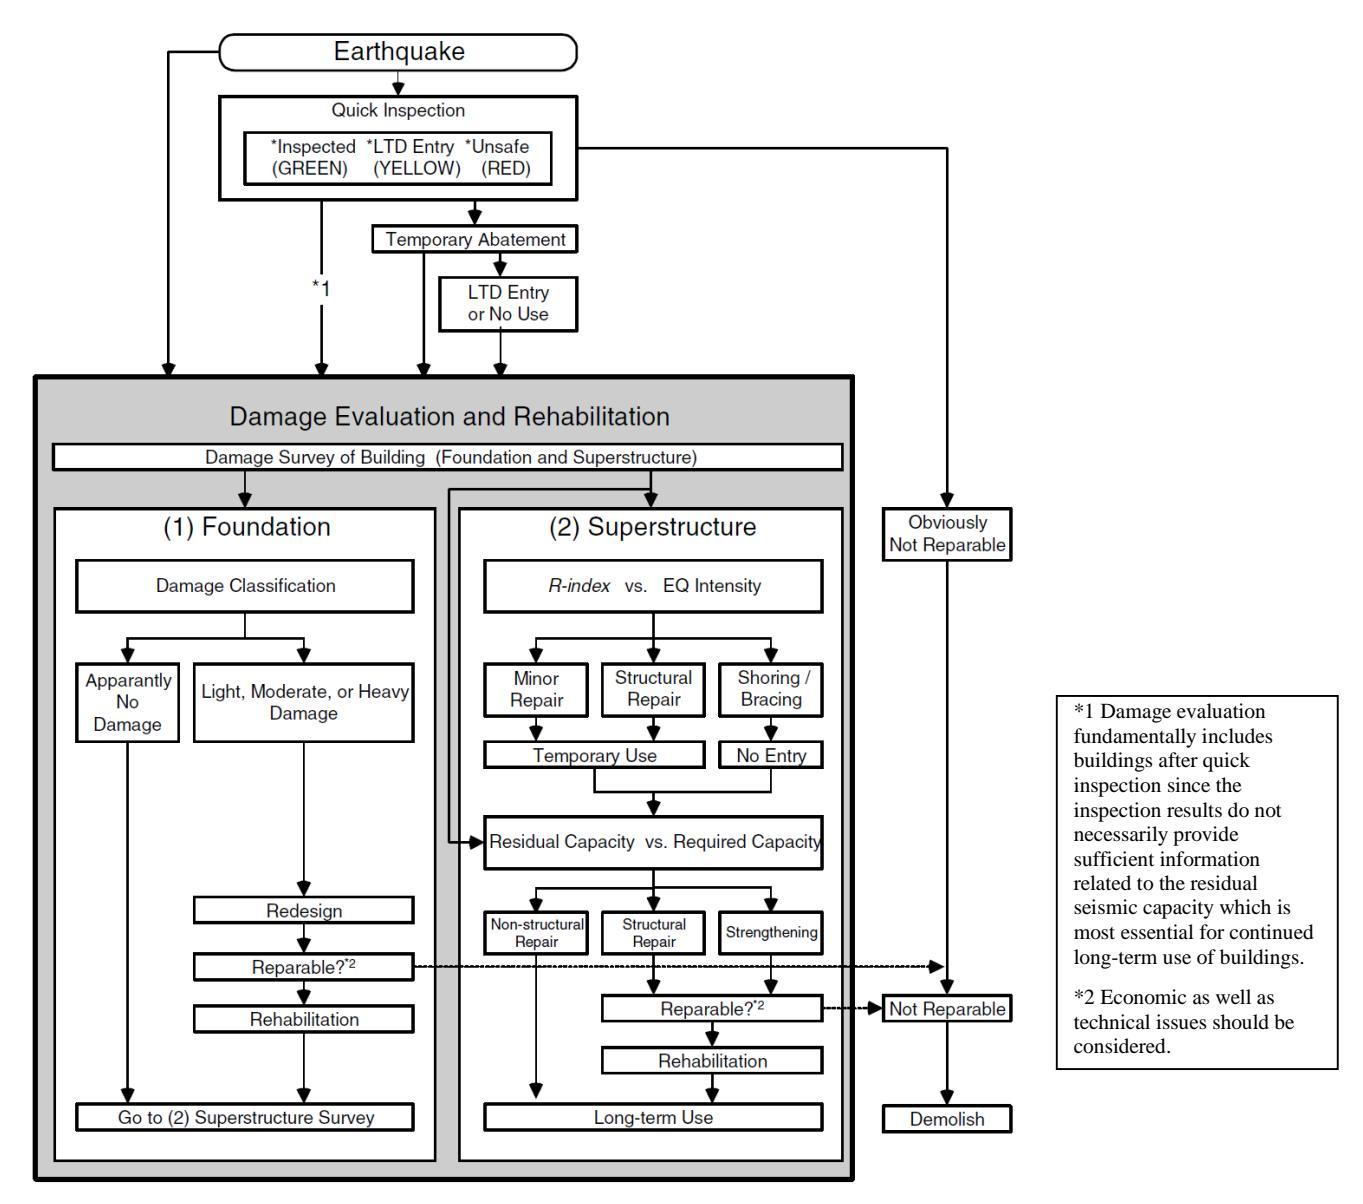
Fig.1 – General Flow of Damage Evaluation and Rehabilitation in the Guideline [3]

Damage evaluation of a building is performed on the foundation system and superstructure system, respectively, and the damage rating of each building is made in a combination form for each system such as "no damage in foundation and moderate damage in superstructure". Rehabilitation actions necessary for the building are then determined considering identified damage. Fig. 1 shows the general flow of damage evaluation and subsequent rehabilitation.

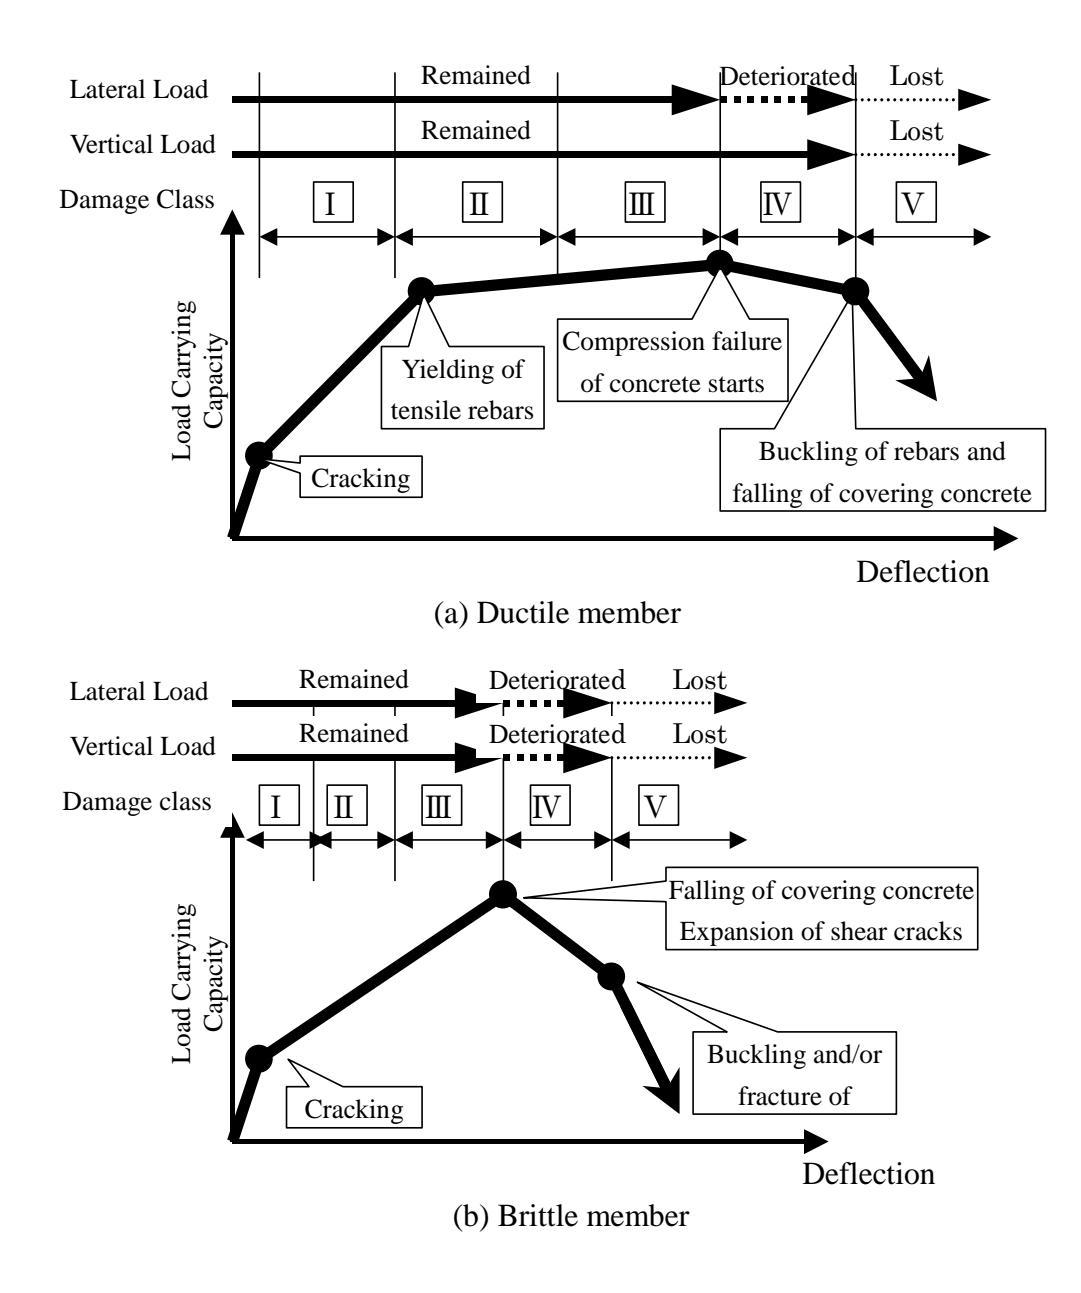
Fig. 2 - Idealized lateral force-displacement relationships and damage class [2]

In the Damage Evaluation Guideline [1], the state of damage of each structural member is first classified into one of the five classes listed in Table 1. The relationship between each damage class given in Table 1 and the lateral force-displacement curve is approximated as shown in Fig. 2. Examples of damage class for columns and walls are shown in Photo 1.

In Fig. 2(a), a ductile member deforms up to a maximum lateral strength level after yielding. Furthermore, after reaching the maximum strength, the reduction of strength is relatively small. If the maximum deformation during an earthquake does not reach deformation at yielding point, extensive damage would not occur. This state corresponds to damage class I, between the cracking and yield points. If the maximum deformation does not exceed the maximum strength, damage to cover concrete is limited and most of the lateral and vertical strengths remains in the flexural member. This state corresponds to damage class II and damage class III. If the maximum response exceeds the maximum lateral strength point, deterioration in lateral strengths with spalling of cover concrete would be observed. The vertical strength may remain if the buckling and/or fracture of reinforcing bars and crush of core concrete, etc., do not occur. This state corresponds to damage class IV. If buckling and/or fracture of reinforcing bars and crush of core concrete, etc. No not occur. This state corresponds to damage class IV.

The degree of damage in a brittle member, as shown in Fig. 2(b), is similar to that of a ductile member up to the maximum strength, although diagonal or X-shape cracks may also be visible (damage classes I, II and III). After the maximum strength is reached, a significant reduction in both lateral and vertical strength may occur (damage class IV). Finally, X-shape shear cracks widen and both lateral and vertical load carrying capacity will be lost suddenly (damage class V).

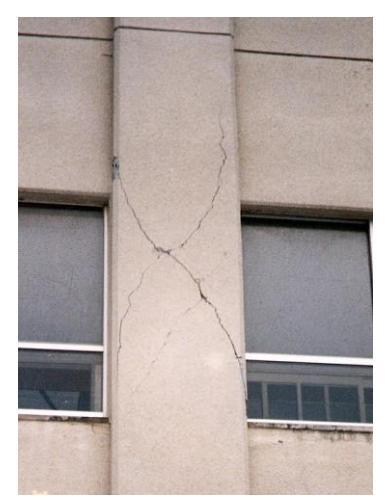
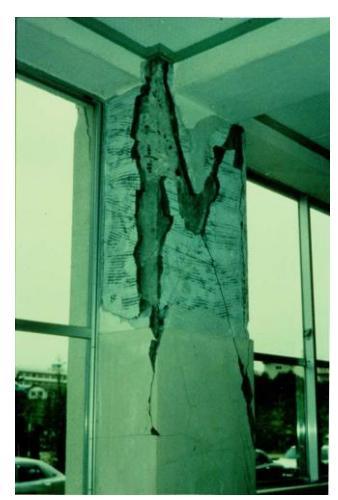
Damage class III: (left) Cracks with a width of about 2mm on structural concrete

(right) Spalling concrete cover and slightly exposed rebars

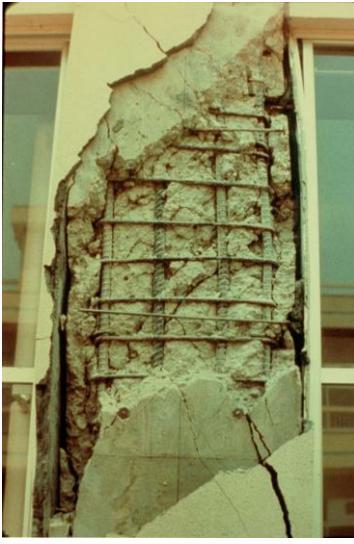
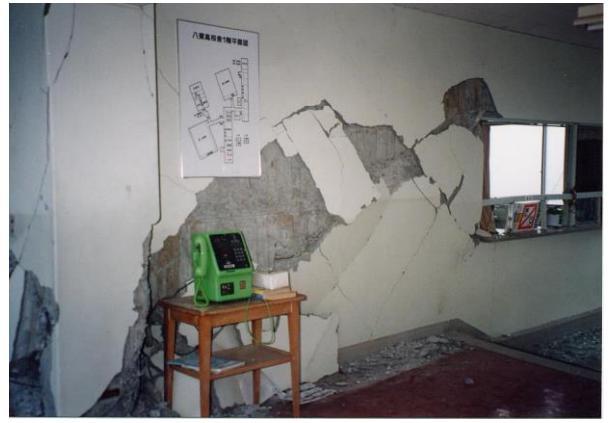
Damage class IV: Exposed rebars without buckling or fracture

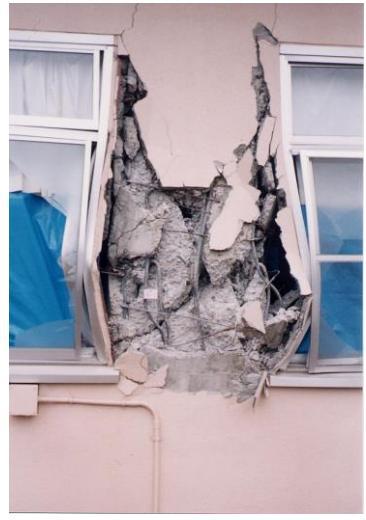
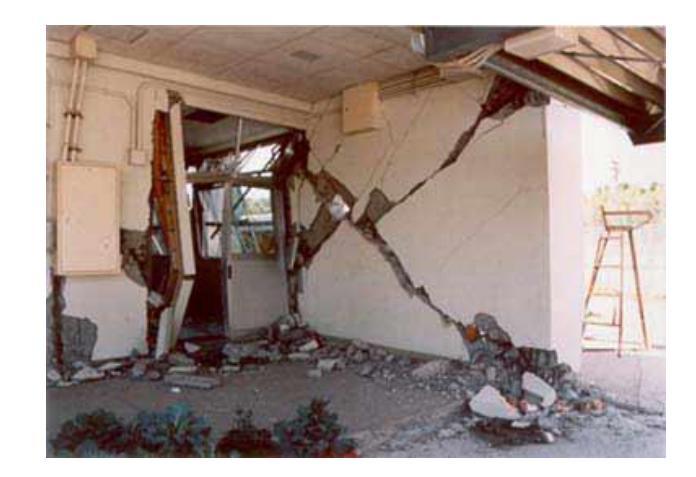
Damage class V:

Photo 1 – Damage class examples

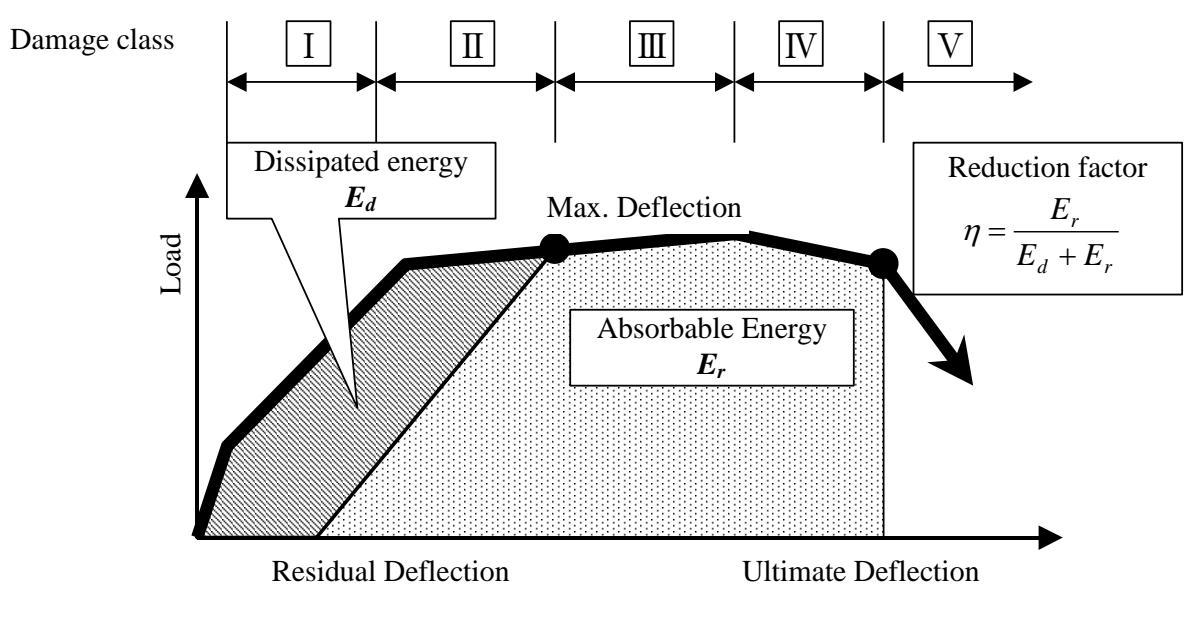
Fig. 3 – Seismic capacity reduction factor  $\eta$

In the Seismic Evaluation Standard [2], the most fundamental component for the *Is* index is the  $E_0$  index, which is calculated from the product of the strength index (*C* index) and the ductility index (*F* index) (see Appendix). Accordingly, the  $E_0$  index corresponds to the energy dissipation capacity in a structural member. Fig. 3 shows a conceptual diagram illustrating the lateral force-displacement curve and a definition of the  $\eta$  factors. When the maximum response reaches point A during an earthquake and residual displacement (point B) occurs, the area of  $E_d$  and  $E_r$  is assumed to be the dissipated energy during the earthquake and the residual energy dissipation capacity after the earthquake, respectively. The  $\eta$  factor is defined as the ratio of residual energy dissipation capacity,  $E_r$ , to original energy dissipation capacity,  $E_t (= E_d + E_r)$ , and can be calculated by Eq. (2).

$$\eta = \frac{E_r}{E_t} \tag{2}$$

where,  $E_d$ : dissipated energy,  $E_r$ : residual energy dissipation capacity,  $E_t$ : original energy dissipation capacity ( $E_t = E_d + E_r$ ).

The seismic capacity reduction factors, *i.e.*,  $\eta$  factors for structural members corresponding to the damage classes, are listed in Table 2. The values for  $\eta$  factors are determined from the residual crack width and the overall damage state of RC columns observed in the first author's laboratory experiments [4] and analytical studies [5], [6]. The post-earthquake seismic capacity, *DIs* index, of the overall building after earthquake damage can be calculated based on the  $E_0$  index reduced by the  $\eta$  factor corresponding to the observed damage class of each structural member.

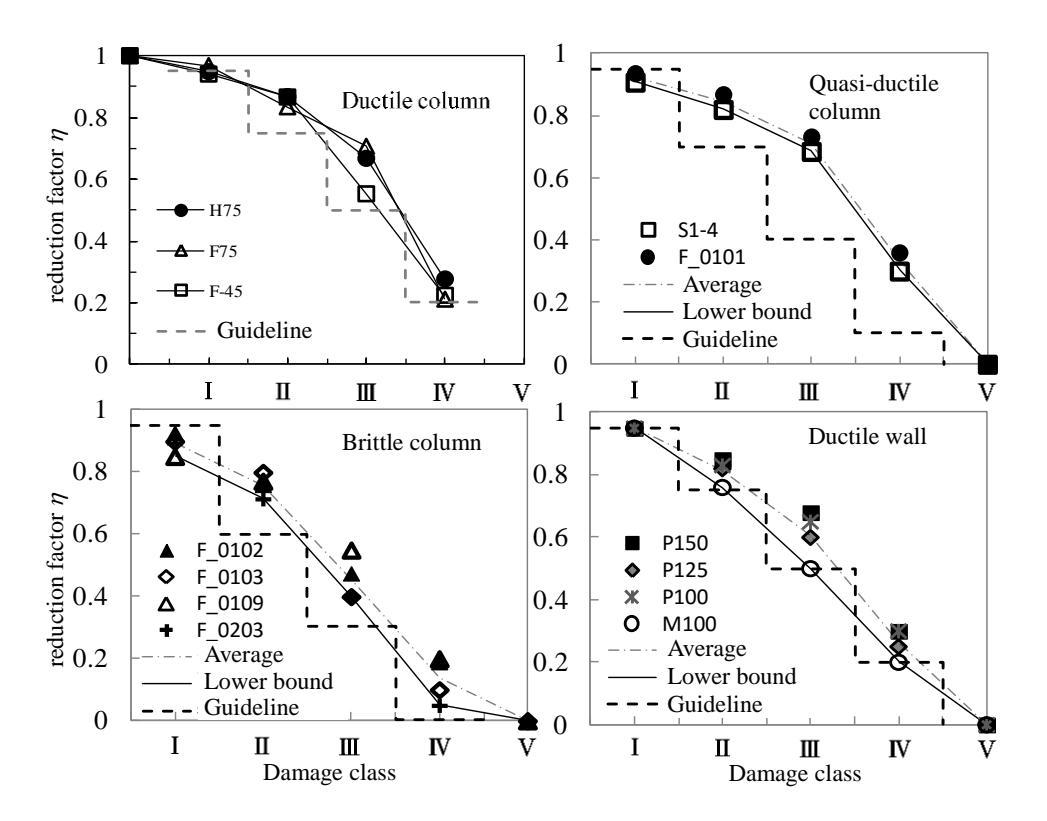
Fig. 4 – Experimental data of Seismic capacity reduction factor  $\eta$

The values of  $\eta$  factors for brittle columns were applied to shear walls in the previous Guideline [1], and no recommendation for beams as shown in Table 2, because experimental data focused on residual seismic capacity was quite limited at the 2001 revision. In the 2015 revision, the values of  $\eta$  factors were enhanced through examination of experimental data [7,8]. A new category of "Quasi-ductile columns" was introduced in addition to ductile and brittle columns in the previous Guideline. The values of  $\eta$  factors were re-evaluated based on conservative estimation of experimental data are shown in Fig. 4. Moreover,  $\eta$  factors for beams and walls were given independently as shown in Table 3.

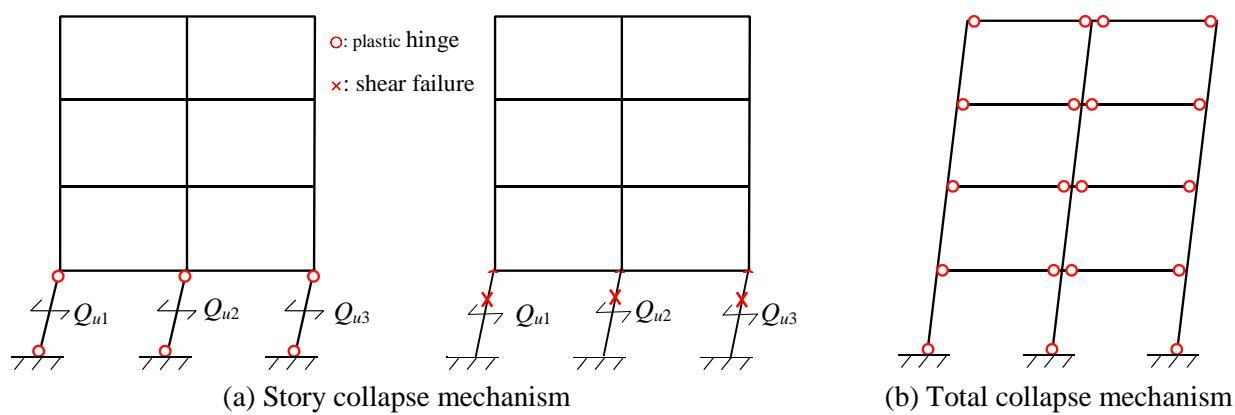
Fig. 5 – typical collapse mechanism of frame structures

Fig. 5 shows typical collapse mechanism of frame structures. As was revealed in past damaging earthquakes in Japan, typical life-threatening damage is generally found in vertical members, and story collapse mechanism, as shown in Fig. 5(a) and Photo 2, is formed. Therefore, the current Guideline is essentially designed to identify and classify damage in columns and walls rather than in beams, and residual seismic capacity, R-index, can be evaluated based on story shear by Eq. (3) assuming ductility index (F index) is uniform in all the vertical elements in the story. When damage is found in beams, the damage classification needs to be performed considering their deficiency in vertical load carrying capacity as well as lateral resisting of columns adjacent to damaged beams.

Although story collapse is the most popular failure mechanism, other relatively ductile failure patterns, total collapse mechanism, were observed in reinforced concrete buildings damage by recent earthquakes such as the 2011 East Japan Earthquake. Beam yielding total collapse mechanism (Fig. 5(b)), which is recommended in the current seismic code and guidelines, was found in some relatively new middle or high rise buildings designed according to current seismic codes. Therefore, the evaluation method for total collapse mechanism, proposed by the first author et al. [9], is introduced into the Guideline and the scope of application was widened. *R*-index for total collapse mechanism is evaluated by Eq. (4). Eq. (4) gives a ratio of internal work at all the plastic hinges in virtual work method before and after an earthquake.

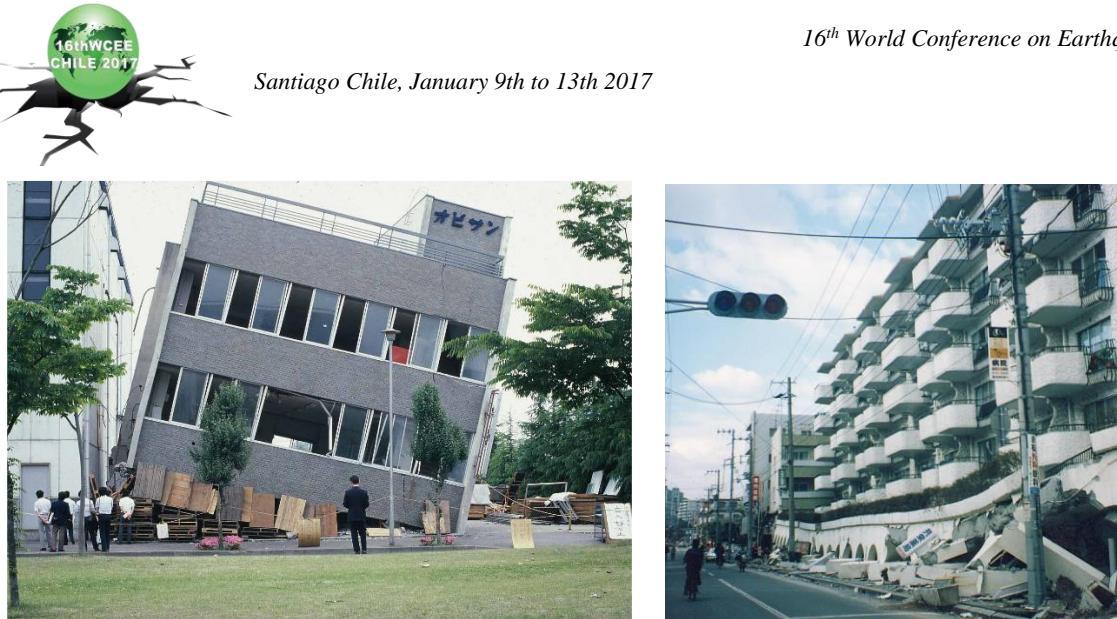
(a) 1978 Miyagi-ken-oki Earthquake

(b) 1995 Kobe Earthquake

Photo 2 – Story collapse of reinforced concrete buildings due to past earthquakes

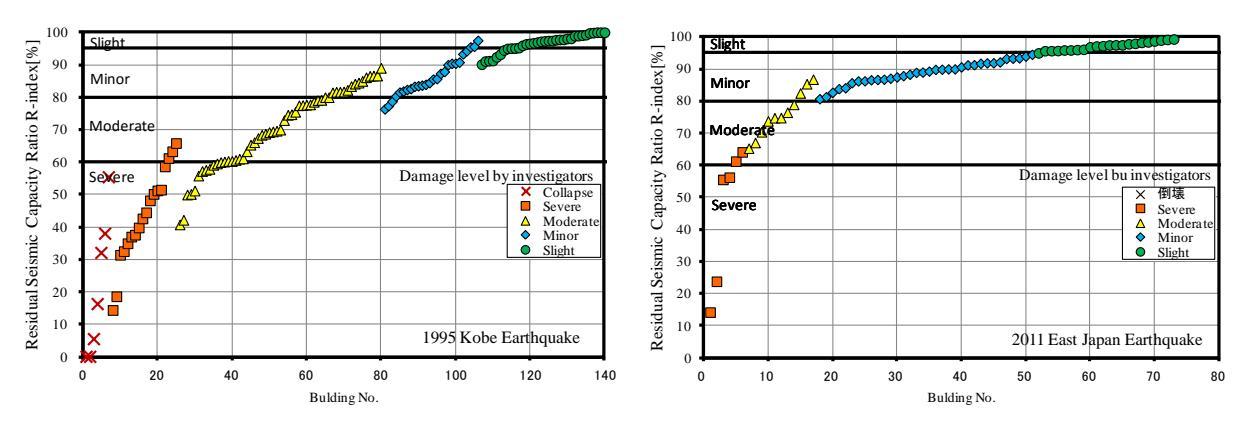
Fig. 6 – Residual seismic capacity index *R* and observed damage levels due to the 1995 Kobe Earthquake and 2011 East Japan Earthquake

The proposed damage evaluation method was applied to reinforced concrete buildings damaged due to the 1995 Hyogo-Ken-Nambu (Kobe) Earthquake and the 2011 East Japan Earthquake. The residual seismic capacity ratio, R index, of about 140 reinforced concrete buildings damaged due to the Kobe Earthquake and about 70 buildings due to the East Japan Earthquake are shown in Fig. 6 together with the observed damage levels from field surveys by experts such as professors. The horizontal lines in Fig. 6 are the boundaries between damage levels employed in the Damage Evaluation Guideline in 2001.

The boundary lines between damage levels were examined in the 2001 Guideline revision for the buildings in Fig. 6(a), of which failure mechanism is story collapse. The boundary line between slight and minor damage was set to R = 95% to harmonize "slight damage" to the serviceability limit state in which the building is functional without repair. Almost all severely damaged buildings and approximately 1/3 of moderately damaged buildings were demolished and rebuilt after the earthquake according to a report of the Hyogo Prefectural Government (1998). If the boundary between moderate and severe damage was set to R = 60%, "moderate damage" may correspond to the repairability limit state.

As shown in Fig. 6(b), the damage levels based on the R index generally agree with those classified by investigators for the buildings suffered from the 2011 East Japan Earthquake, which include buildings with total collapse mechanism. Photo 3 shows overall view and damages to a residential buildings suffered from the 2011 East Japan Earthquake. The building was a 11-storied steel reinforced concrete structure constructed in 1979. Structural drawing of an outside frame was shown in Fig.7 together with crack maps. Damage to non-structural walls are severe, in particular, in lower stories and shear failure was found as shown in photo 4(b) and (c). On the other hand, damage to structural frame was limited. The frame formed total collapse mechanism with plastic hinges at beam ends by flexural yielding (Photo 4 (d)). Major damage class of beams were III for lower stories and I or II for middle and higher stories. Assuming story collapse mechanism, R-index is evaluated story by story ranging from 69% in the 2<sup>nd</sup> story to 95% in 8<sup>th</sup> story and as a result damage level is classified as "moderate". However, calculation method for total collapse mechanism gives one R-index of 87% in the sense of an average of whole

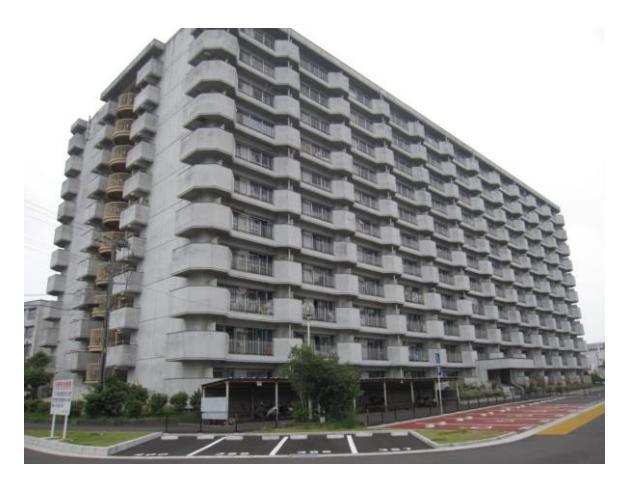
(a) Overall view

Photo 3 – Damage to a residential building with total collapse mechanism of beam yielding type

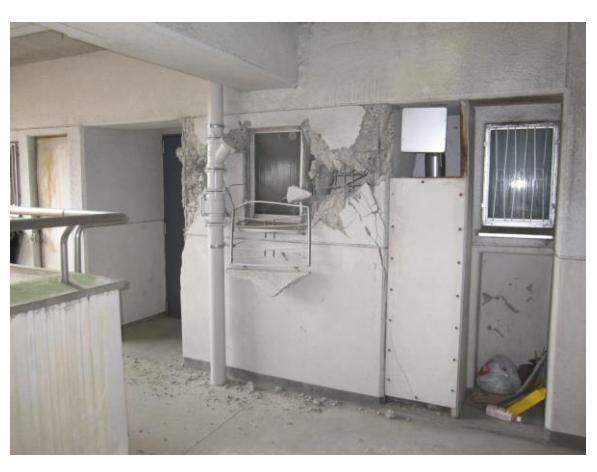
(b) Shear failure of non-structural wall

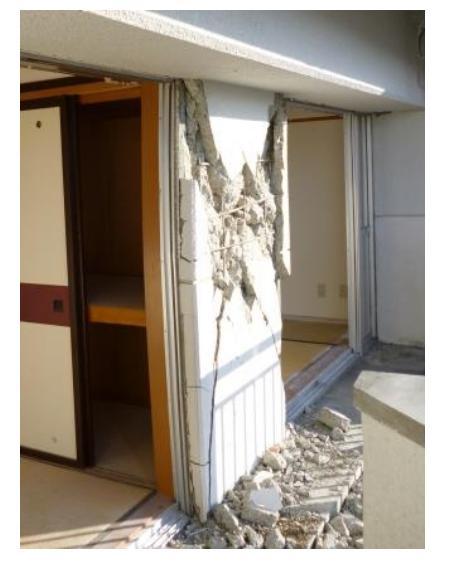
(c) Shear failure of non-structural wall

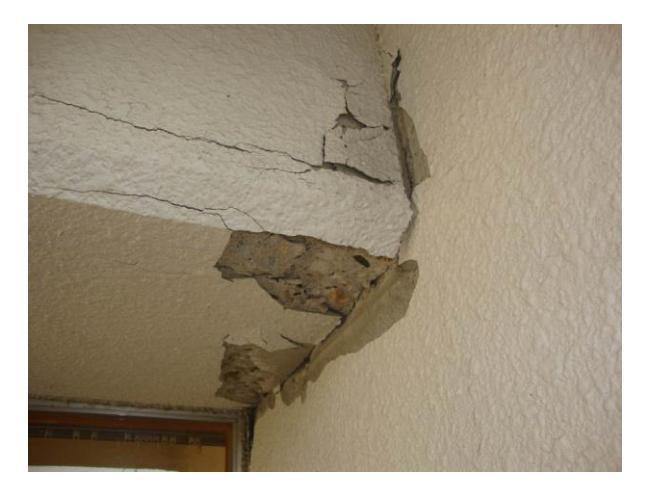
(d) Crush of concrete at plastic hinge region of a beam end

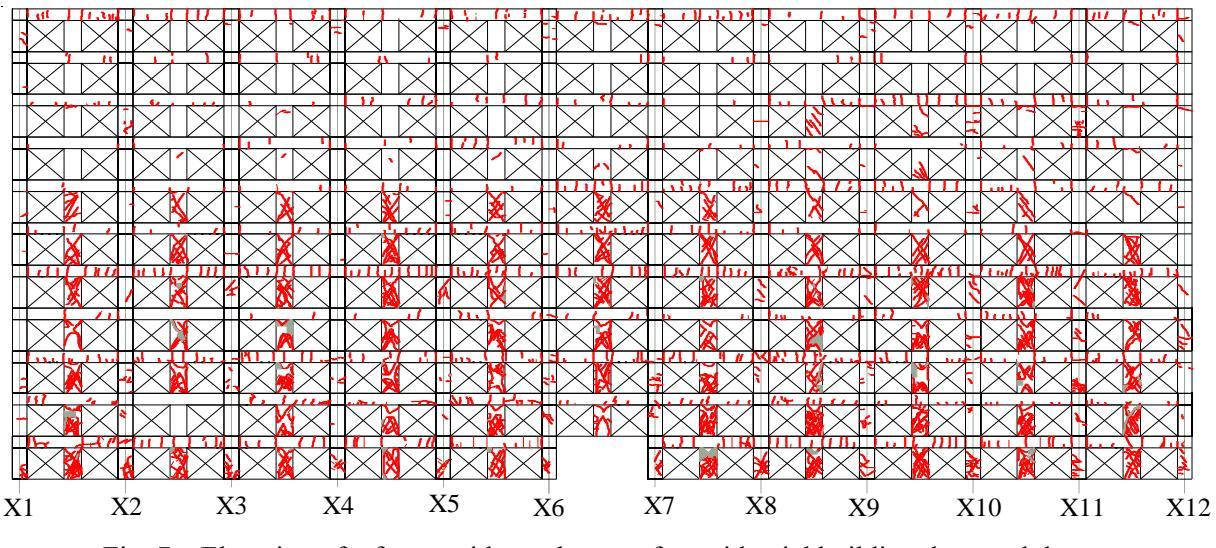
Fig. 7 – Elevation of a frame with crack map of a residential building damaged due to the 2011 East Japan Earthquake
