## POST-EARTHQUAKE RESIDUAL CAPACITY OF DAMAGED REINFORCED CONCRETE BUILDINGS

K.J. Marder<sup>(1)</sup>, K.J. Elwood<sup>(2)</sup>, G.C. Clifton<sup>(3)</sup>

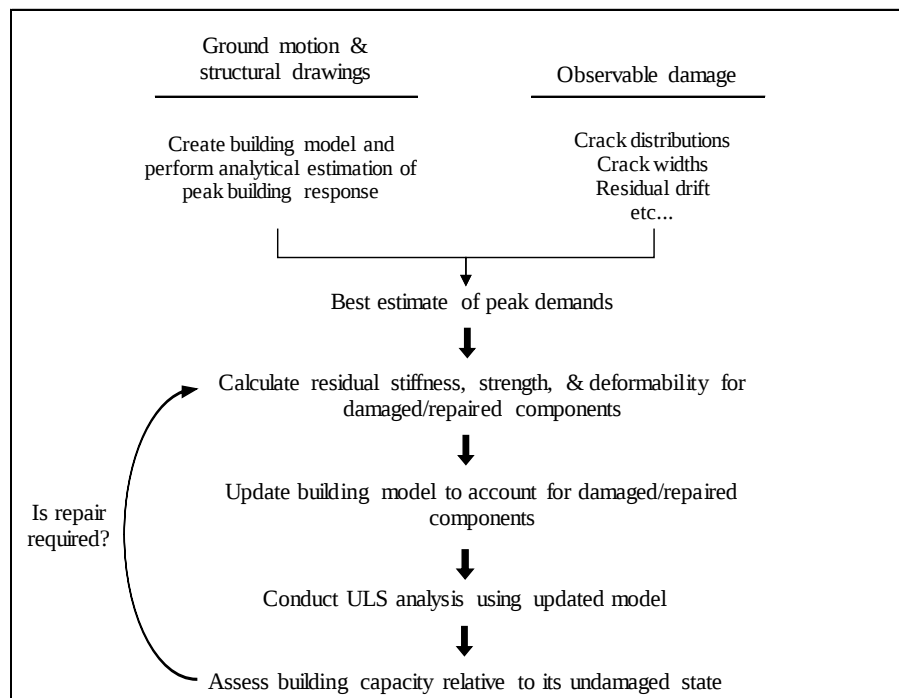
Fig.1 – Flowchart of proposed post-earthquake assessment methodology

Due to these limitations, a modified assessment methodology is proposed in this study. A flowchart showing this proposed framework is shown in Fig.1. The principal difference is the focus on estimating the peak demands incurred during the damaging earthquake, and using these peak demands as a basis for assessing residual capacity. The visual damage is used to refine the estimates of peak demands rather than as the basis for the entire assessment. At the global level, the overall distribution of damage in the structure can be compared against that predicted using an analytical model. Differences should be investigated and attempted to be reconciled. At the local level, detailed information on the in-situ damage can be used to better estimate the peak demands that a particular component experienced.

Once the best estimate of the demands on an individual component in the damaging earthquake have been established, models are required that can predict the residual stiffness, strength, and deformability of that component as a function of its peak demand. If it is determined that repair is needed to restore the component to a satisfactory performance level, models that can predict the post-repair behavior are also required. Modern hysteretic models for RC components that incorporate stiffness and strength degradation require complete information on the prior component response in order to define the level of degradation, such as the energy dissipation parameters used in the popular Ibarra model [9]. In a post-earthquake situation, only incomplete estimates of prior response are available, and residual capacity models must reflect this.

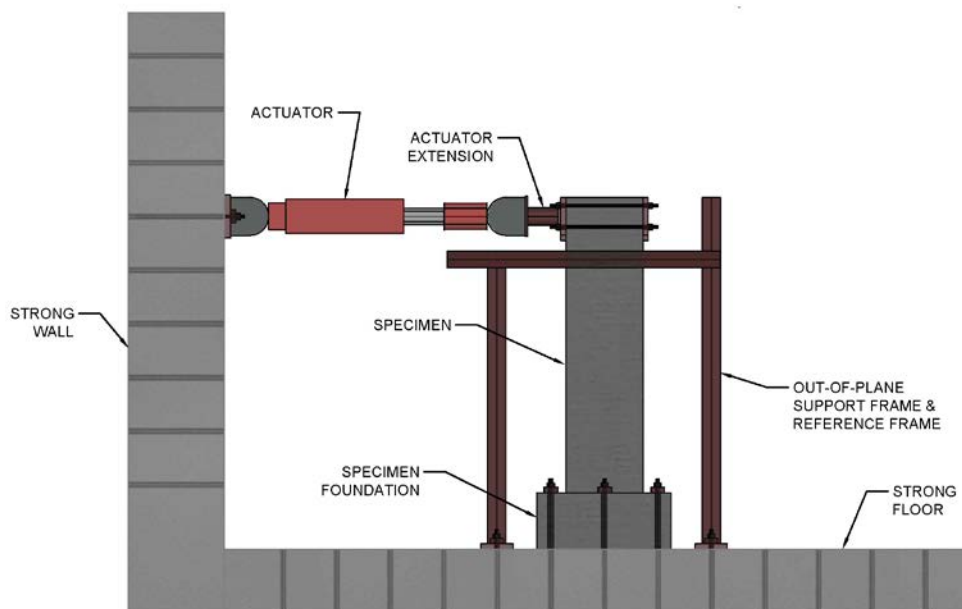
Fig.2 – Rendering of test set-up

An experimental program investigating the behavior of new, damaged, and repaired RC beams is underway as of the time of writing. A total of 14 identical large-scale cantilever beams are being tested, with the test set-up as shown in Fig.2. Given that the purpose of the research is to investigate the plastic hinging typical of capacity-designed buildings, the beam-column joint and column behavior is not included in the experiment, as they would be designed to remain elastic. Investigation of damaged buildings in Christchurch has shown the effectiveness of this design philosophy, with those elements showing at most only a few hairline cracks. Instead, a foundation designed to remain elastic and cast monolithically with the beam is used to anchor the specimens to the strong floor.

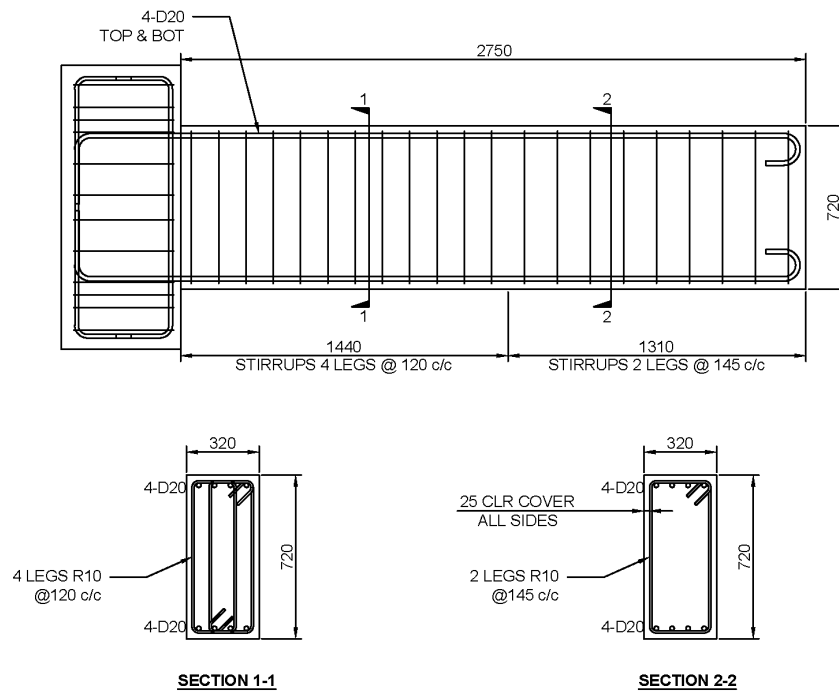
Fig.3 – Specimen detailing

The specimen design is a 4/5 scale beam meeting all requirements for maximum allowable ductility in modern RC code seismic provisions (e.g. special moment frame beam in ACI 318-11 or ductile beam in NZS 3101:2006). The beams were chosen to be relatively lightly reinforced (approximately 125% of minimum required) in order to accentuate potential crack widths and strain in the reinforcement. The relationship between reinforcing ratio and crack widths has been investigated in [11]. Full specimen details are shown in Fig.3.

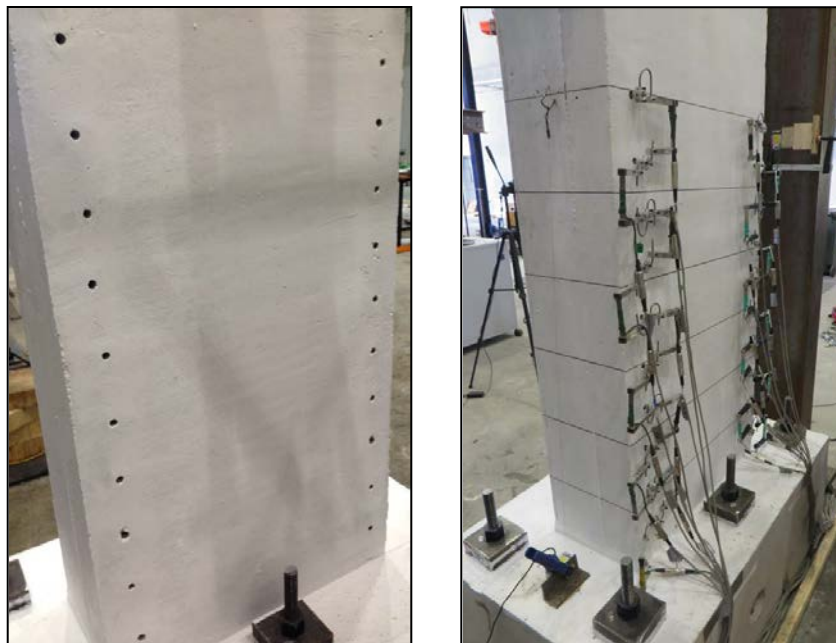
Fig.4 – Holes in cover concrete for access to threaded inserts on exterior reinforcing bars, before and after attachment of displacement gauges

The primary method of instrumentation in the plastic hinge zone consists of displacement gauges that measure the average strain in one exterior longitudinal reinforcing bar at increments of 120mm, both at the “bottom” and “top” of the beam. The gauges are attached to the reinforcing bar via threaded inserts that have been spot welded to the bar prior to pouring of the concrete. Tensile tests have shown that the spot welding does not affect reinforcement capacity, as necking failure does not tend to initiate near the weld locations. Plastic tubes with a wall thickness of 2mm have then been placed around the threaded inserts during pouring, creating a small void in the cover concrete surrounding the inserts, allowing for bond slip without distortion of the gauge readings. The finished specimen, both with and without displacement gauges attached, is shown in Fig.4.

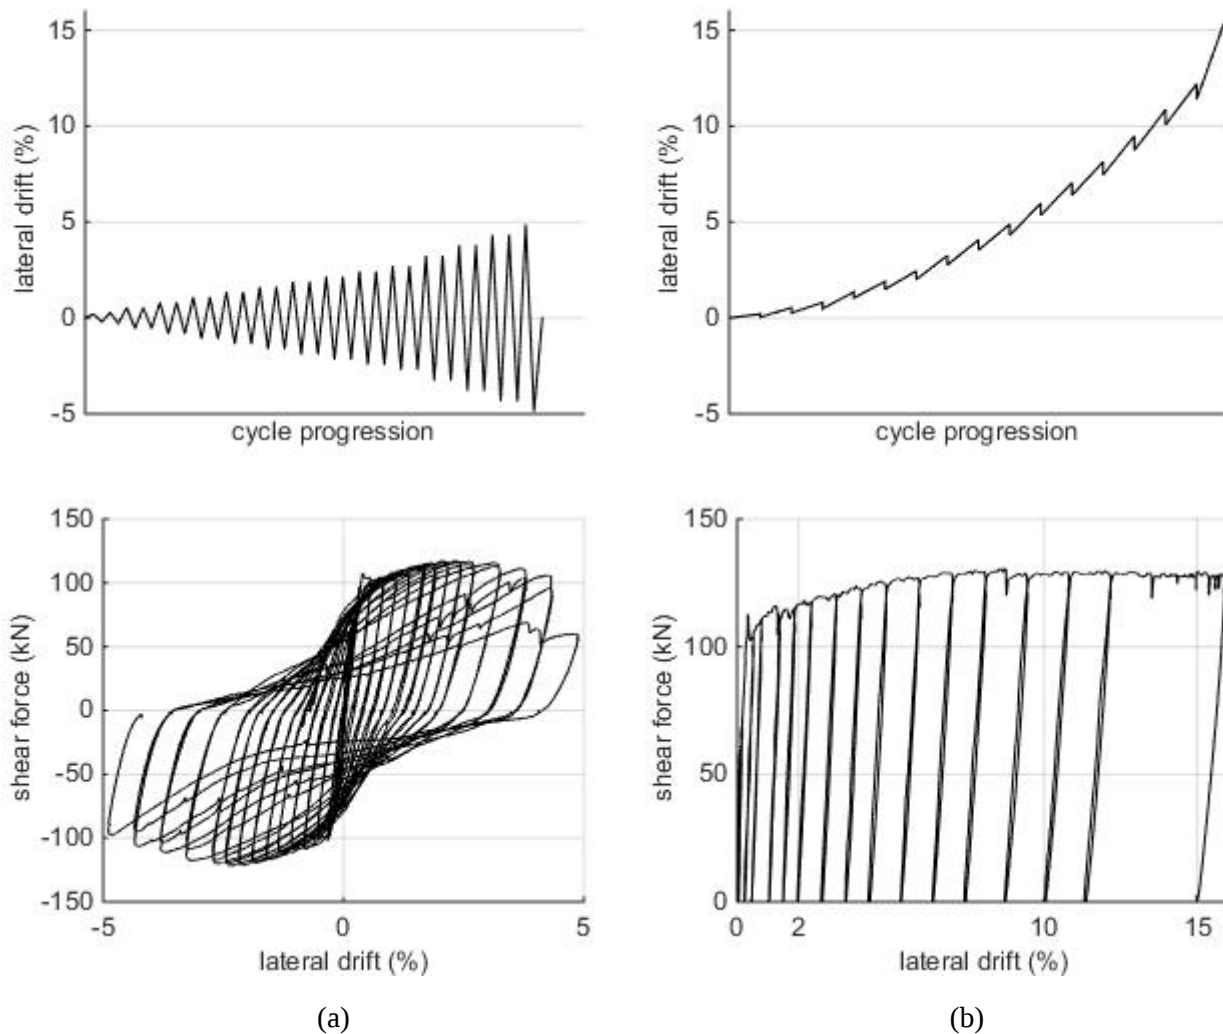
Fig.5 – Loading protocol and shear force vs lateral drift for specimen Cyc (a) and Mono (b)

As of the date of writing this paper, specimens Cyc and Mono have been tested. Loading protocols and hysteresis plots for the two specimens are shown in Fig.5. The plots illustrate the pronounced effect of loading protocol on drift at failure, here defined as the drift at which lateral load capacity drops below 80% of its peak value. It can be seen that the cyclic specimen lost lateral load-carrying capacity at the cycle to 4.88% drift, while the monotonic specimen maintained its lateral strength above 15% drift, at which point the test had to be stopped due to the actuator stroke limit being reached. Note that during the monotonic test the lateral load was dropped to zero after reaching specific peak drift demands to allow for residual damage states to be observed for comparison with Cyc after similar peak drift demands.

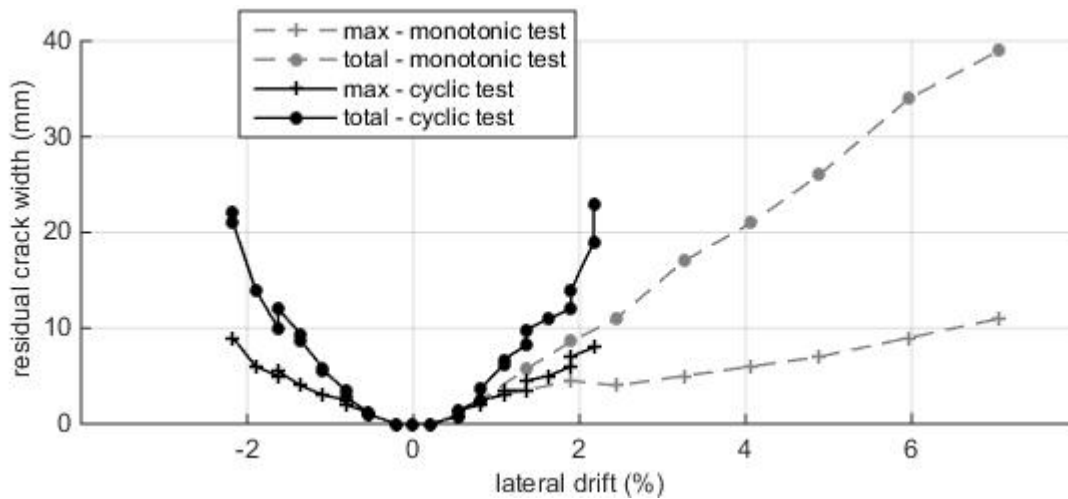
Fig. 6 – Residual crack widths (maximum and total) for specimen Cyc (black) and Mono (grey)

The recorded damage data during the tests includes residual crack widths, which were measured for all cracks over 0.2mm wide after each loading increment. As seen in Fig. 6, both the maximum and total crack widths exhibit a clear correlation with the maximum applied drift, although the ratio of total to maximum crack width increases with increasing drift due to formation of additional primary cracks. Note that total crack width is the sum of all crack widths over 0.2mm on the tension side of the beam. The maximum and residual crack widths in the cyclic test were larger than in the monotonic test, which can be explained by the increased beam elongation in the cyclic test.

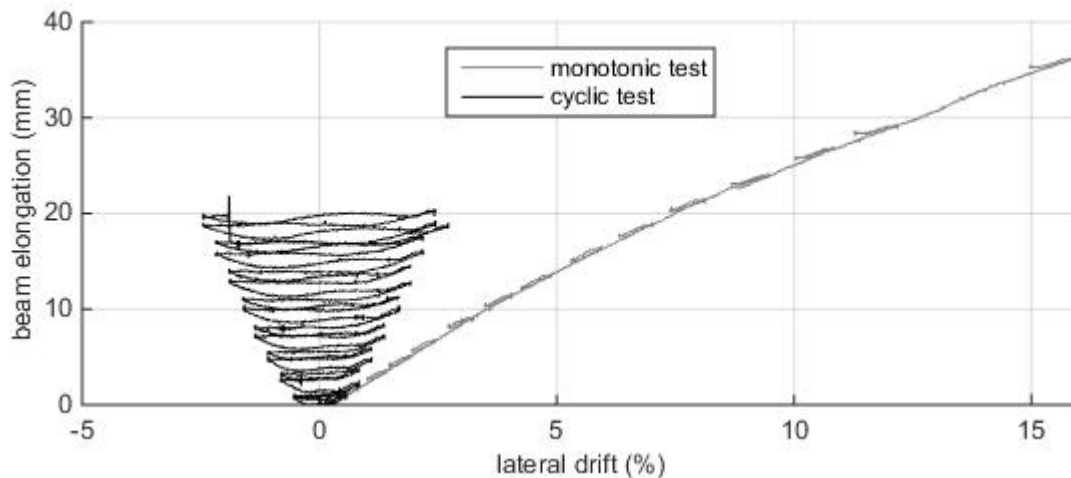
Fig.7 – Beam elongation for specimen Cyc (black line) and Mono (grey line)

Beam elongation, plotted in Fig.7, was found to have a substantial influence on the behavior of the cyclic and monotonic specimens. In the cyclic specimen, flexural cracks did not fully close upon loading reversal due to lack of axial load to help yield reinforcement in compression. This led to increased crack widths with each cycle and cracks extending through the depth of the beam, reducing the shear friction capacity in the plastic hinge zone and forcing shear to be transferred through dowel action of the longitudinal bars. This caused bending of the bars, which led to buckling of reinforcement on subsequent cycles. In the monotonic specimen, the lack of load reversals prevented this behavior from occurring, and elongation was entirely due to movement of the neutral axis in the cracked length of the beam. The beam elongation in the cyclic test was on the order of 3% of beam depth, which is consistent with results from previous test programs, as discussed in [12]. The mechanism of beam elongation is also further discussed in that reference. Note that in this test program, elongation was calculated as the average extension reading of two string potentiometers mounted at the beam centerline, with one on each side of the beam.

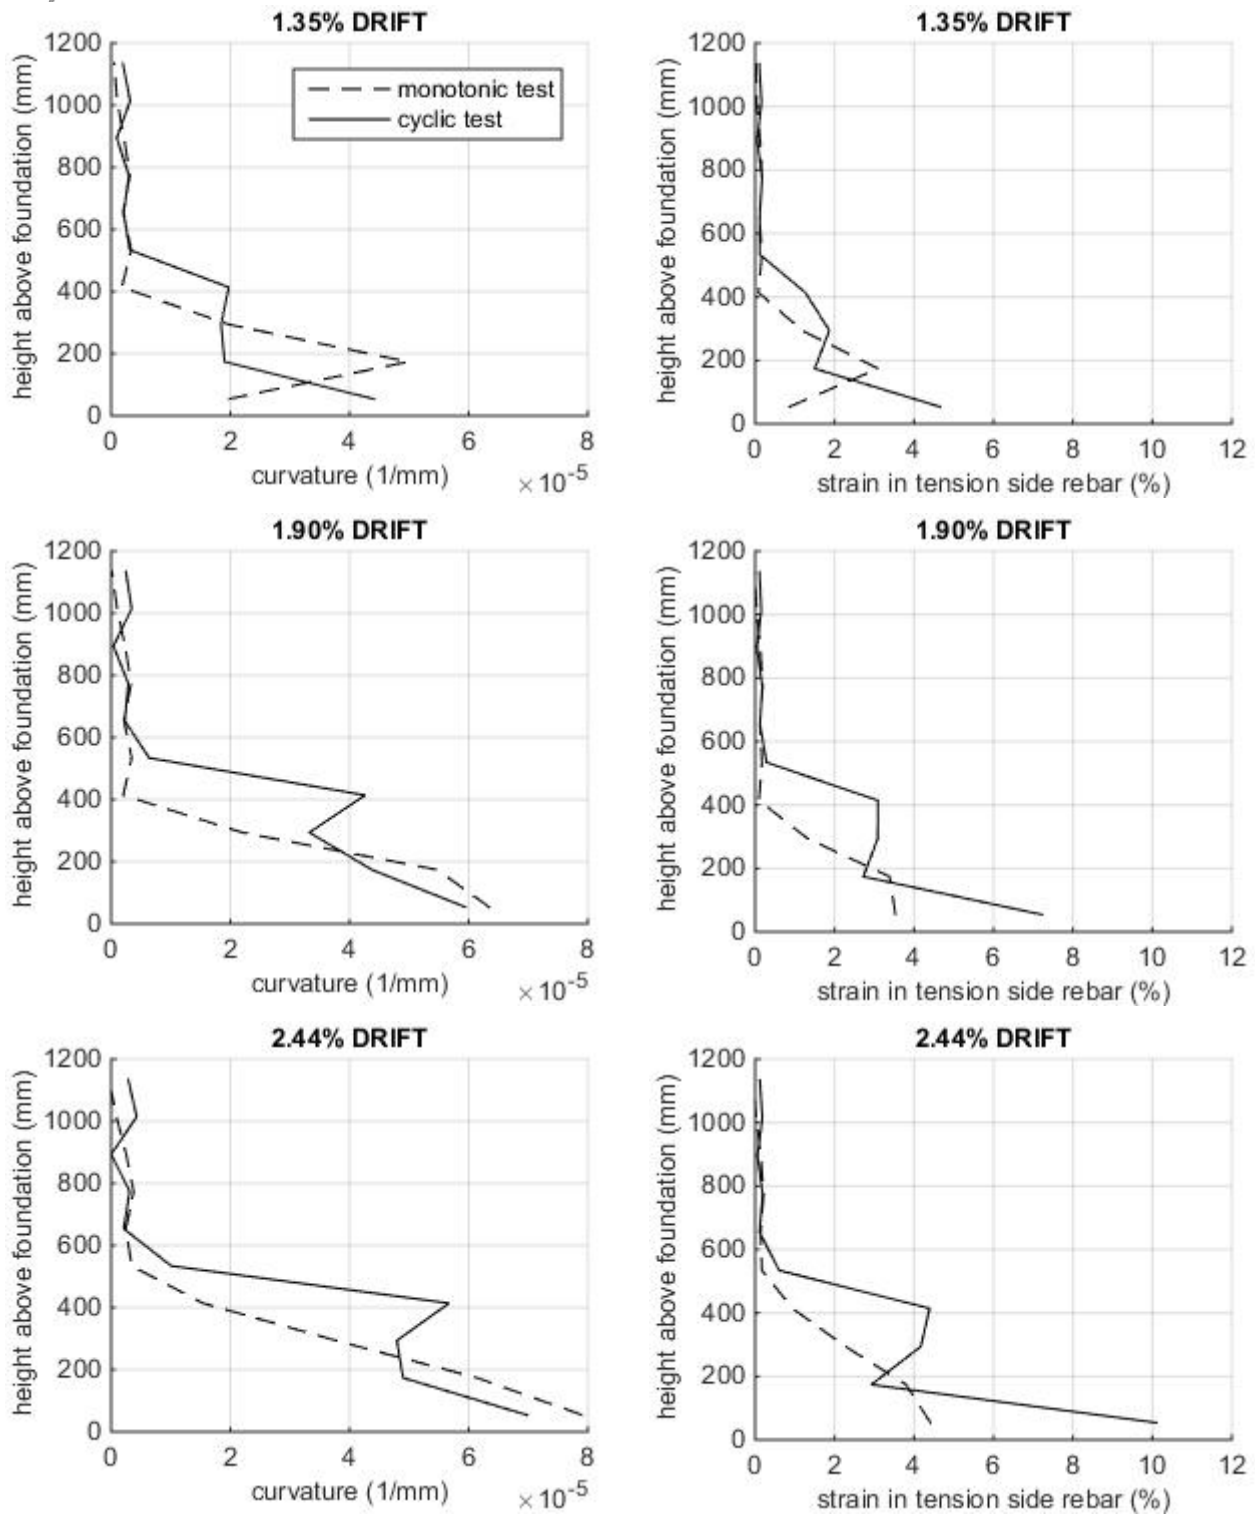
Fig.8 – Distribution of curvatures and strains in tension side reinforcement at increasing drift levels for specimen Cyc (solid line) and Mono (dashed line)

The permanent plastic strain in the longitudinal bars that creates the elongation is illustrated in Fig.8, showing the curvatures and strains in the tension reinforcement over the height of the specimen. It can be seen that the curvature distributions remain similar in both tests at increasing drift levels, but the strain in the tension side reinforcement diverges due to permanent growth in the cyclic test.
